Australian Air Publication **721.79**

## ROYAL AUSTRALIAN AIR FORCE

# VAMPIRE MODIFICATIONS

(Nos 101 to 200)

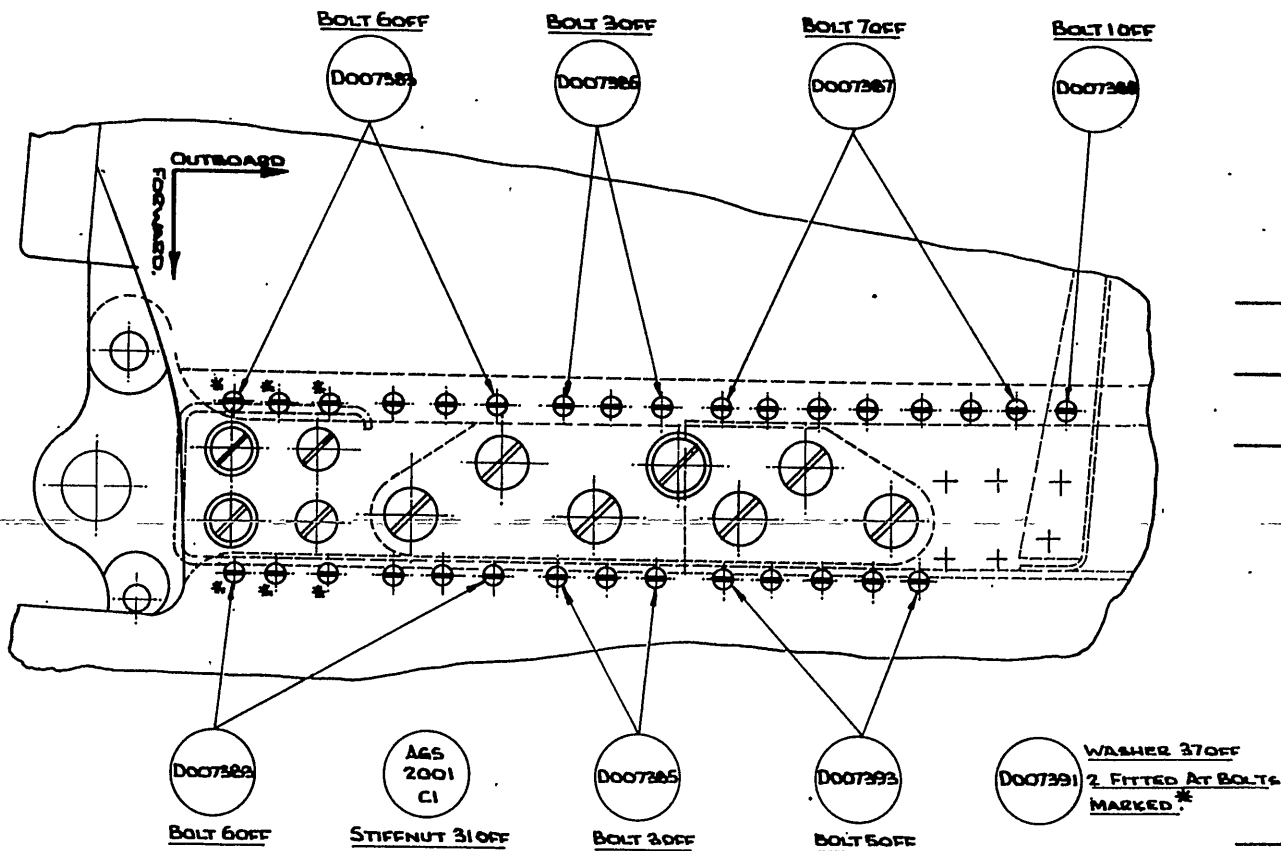
REPLACEMENT OF BOLTS & RIVETS BY BOLTS  
AT WING SKIN ATTACHMENT - TOP ROOT END.

1. This modification authorises the replacement of the existing bolts and rivets at the skin attachment to wing root, with bolts in fitted holes to obviate bolts working loose and rivets tilting.

ALL SCREWDRIVER SLOTS IN NEW BOLTS TO BE AS SHOWN.  
I.E. IN LINE WITH  $\frac{1}{2}$  OF SPAR. THE FINAL TIGHTENING UP  
BEING CARRIED OUT ON THE NUT. BOLT HEADS MUST NOT  
PROJECT ABOVE THE SKIN BY MORE THAN .005"

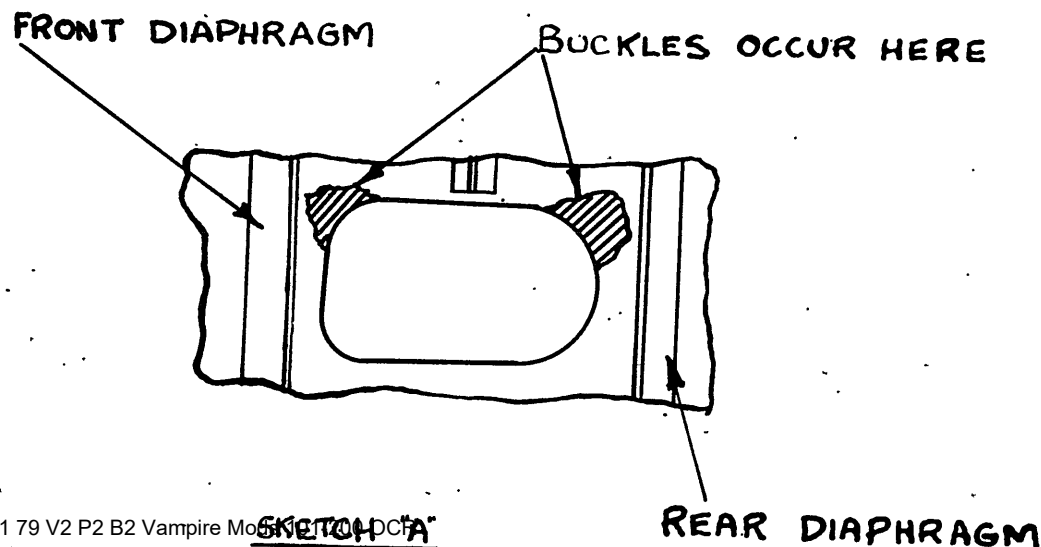
SKETCH 'A'

If ribs are cracked in the same place as where the buckles are shown in Sketch 'A' application should be made for a special repair scheme.

has been made, Rib 2 should be carefully examined for signs of damage. Access to the inboard side of the rib age should be thoroughly assessed so that the appropriate repair scheme may be selected from the information to be checked for buckling in the panel immediately above the undercarriage attachments, and, if damaged, repaired

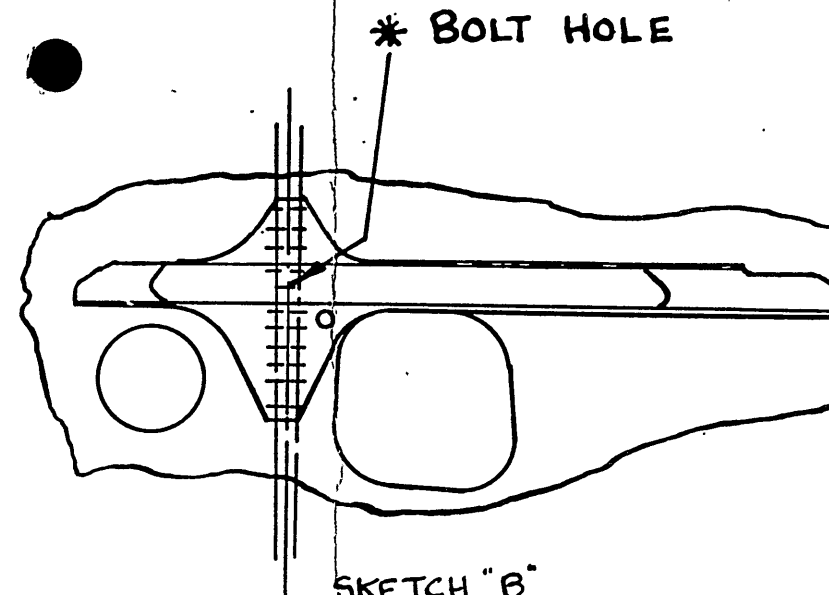
SKETCH "B"

If it is discovered that both reinforcing p main web are cracked beyond the hole marked in sketch 'B', application should be made for instructions.

It should be noted that the main web is on the outboard of the rib and is of thinner gauge than the reinforcing plate.
