Australian Air Publication 721.79

## ROYAL AUSTRALIAN AIR FORCE

# VAMPIRE MODIFICATIONS

(Nos 401 to 500)

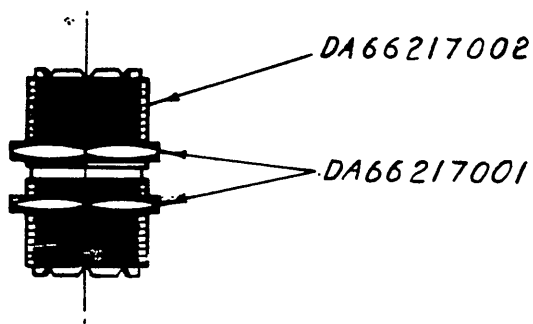
| DRAWN<br>H. WOLFE | CHECKED<br> | APPROVED<br> | MODIFICATION NUMBER<br>VAMPIRE MOD 451 | DRAWING NUMBER<br>DA66217000 |

Incidents of cable connectors at the wing break becoming loose due to high temperature changes and vibrations experienced in flight. When the connector becomes loosened, the fuel quantity indicator drops to zero or fluctuates wildly.

| <b>DEPARTMENT OF AIR</b><br>ISSUED BY<br>SENIOR TECHNICAL STAFF OFFICER<br>SUPPORT COMMAND | | | TITLE<br>PACITOR FUEL GAUGE SYSTEM<br>INTRODUCTION OF CONNECTOR<br>LOCK NUTS | |

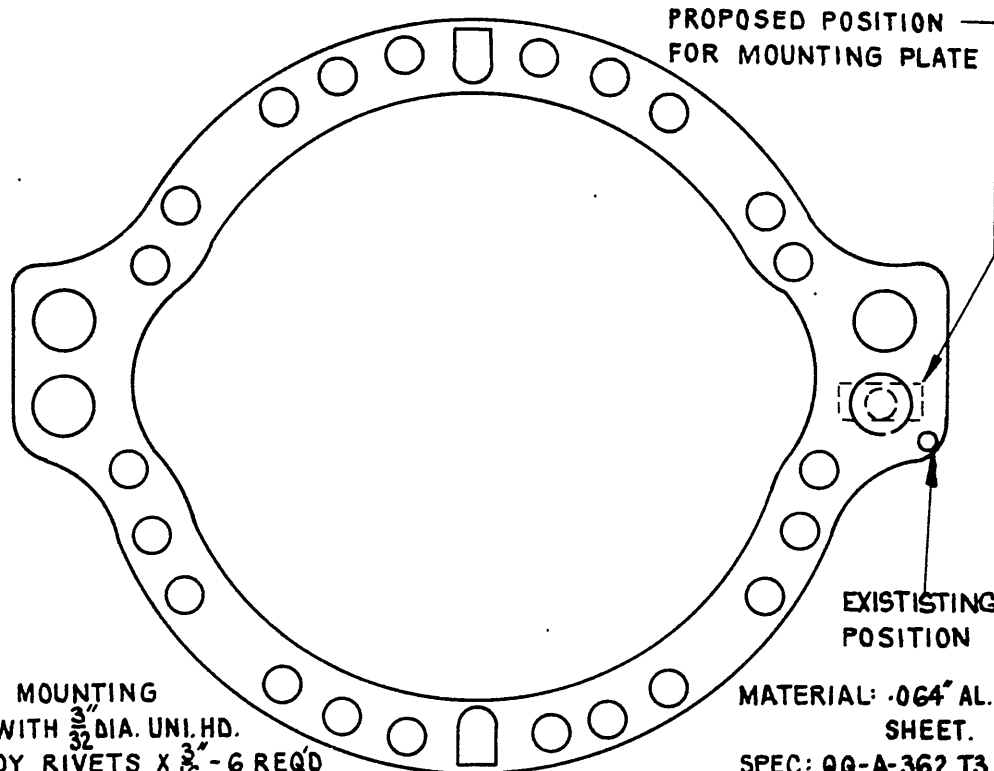
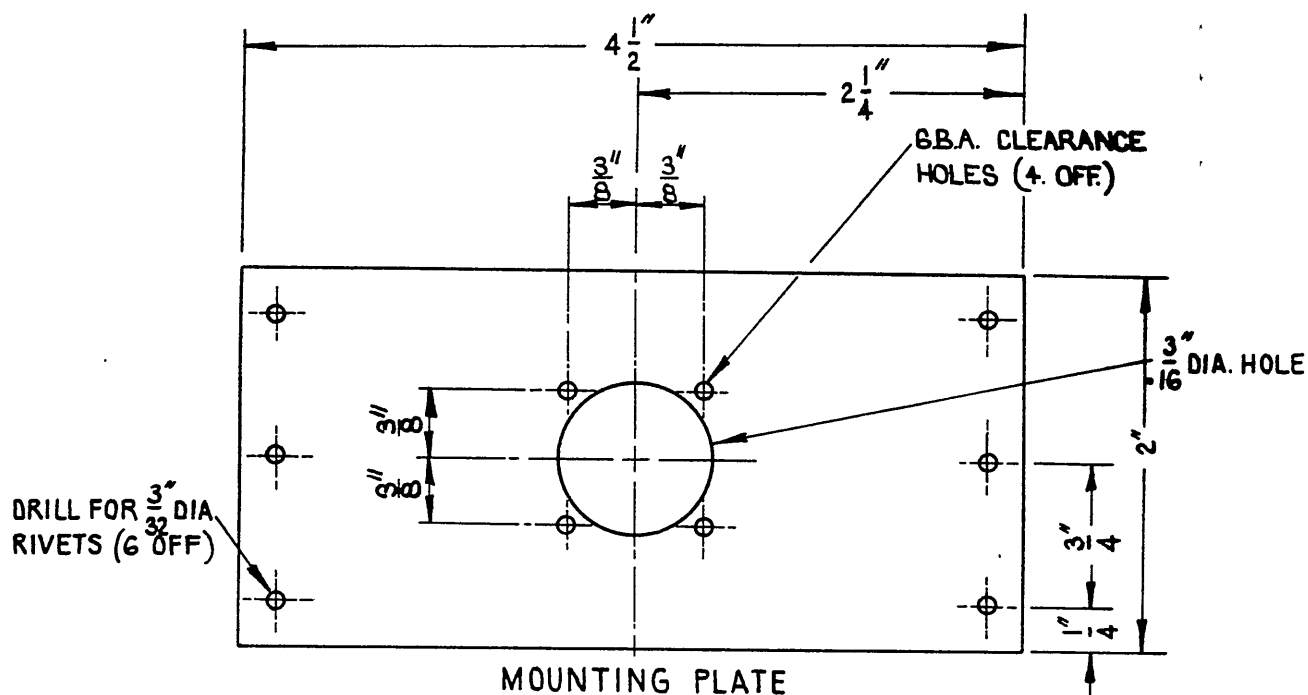
| DRAWN<br><b>MIF</b> | CHECKED<br><i>[Signature]</i> | APPROVED<br><i>[Signature]</i> | MODIFICATION NUMBER<br><b>VAMPIRE MOD N° 450</b> | DRAWING NUMBER<br><b>DAG66 212000</b> |

To facilitate mating of the electrical plug and socket constituting the electrical disconnect in the downward identification lighting circuit, and also to obviate chafing damage to the electrical cable.

**REPOSITIONING OF ELECTRICAL  
CONNECTOR ON FRONT BULKHEAD  
OF REAR CONE (VIEW LOOKING AFT)**

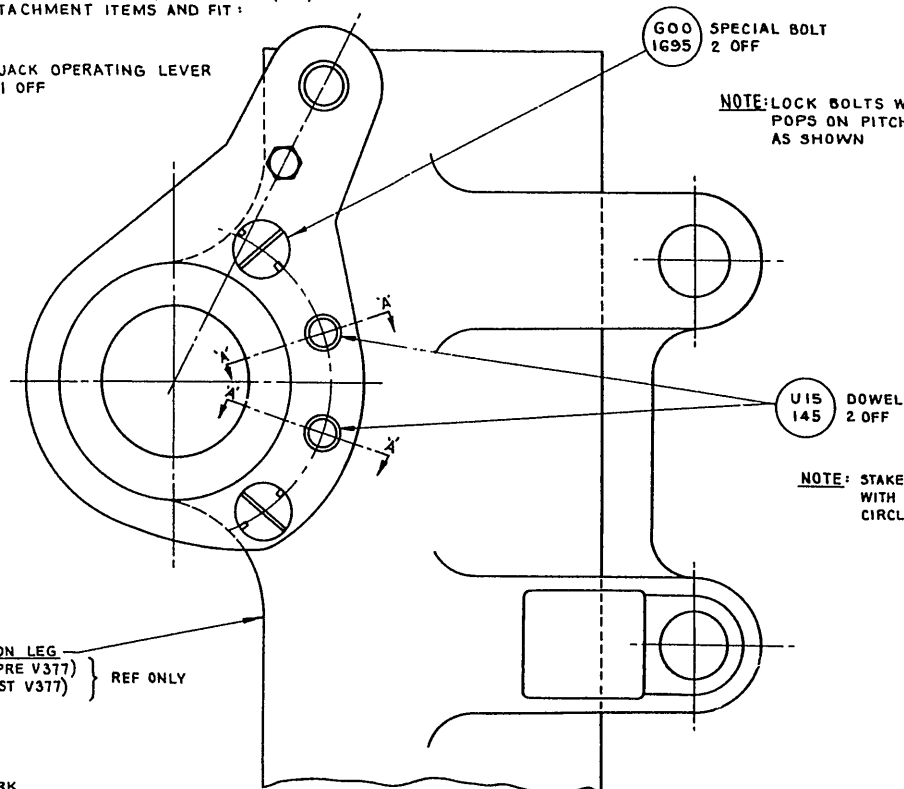
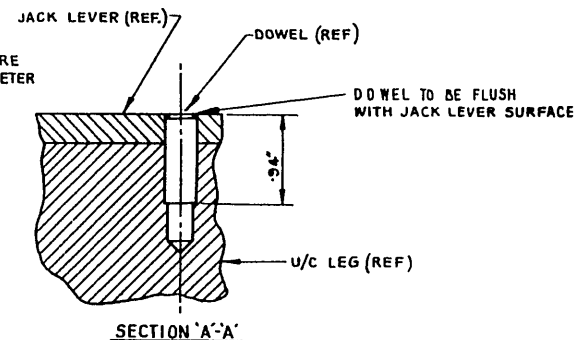
Cases have occurred of cracking of the main undercarriage jack operating lever through the area where a hole is drilled for insertion of a lock pin which retains the dowel introduced under Vampire Modification No 377. This modification standardizes the type and attachment of the jack operating lever on all compression legs.

The two centre jack lever attachment bolts or countersunk dowels are replaced by HT parallel locating pins which are locked to the lever arm with araldite and staking.

**OPEN OUT THE BOLT HOLES WITH A LETTER 'S' DRILL**

AND REAM TO  $.3594''$  DIA X  $.03''$   
 FILLET RAD

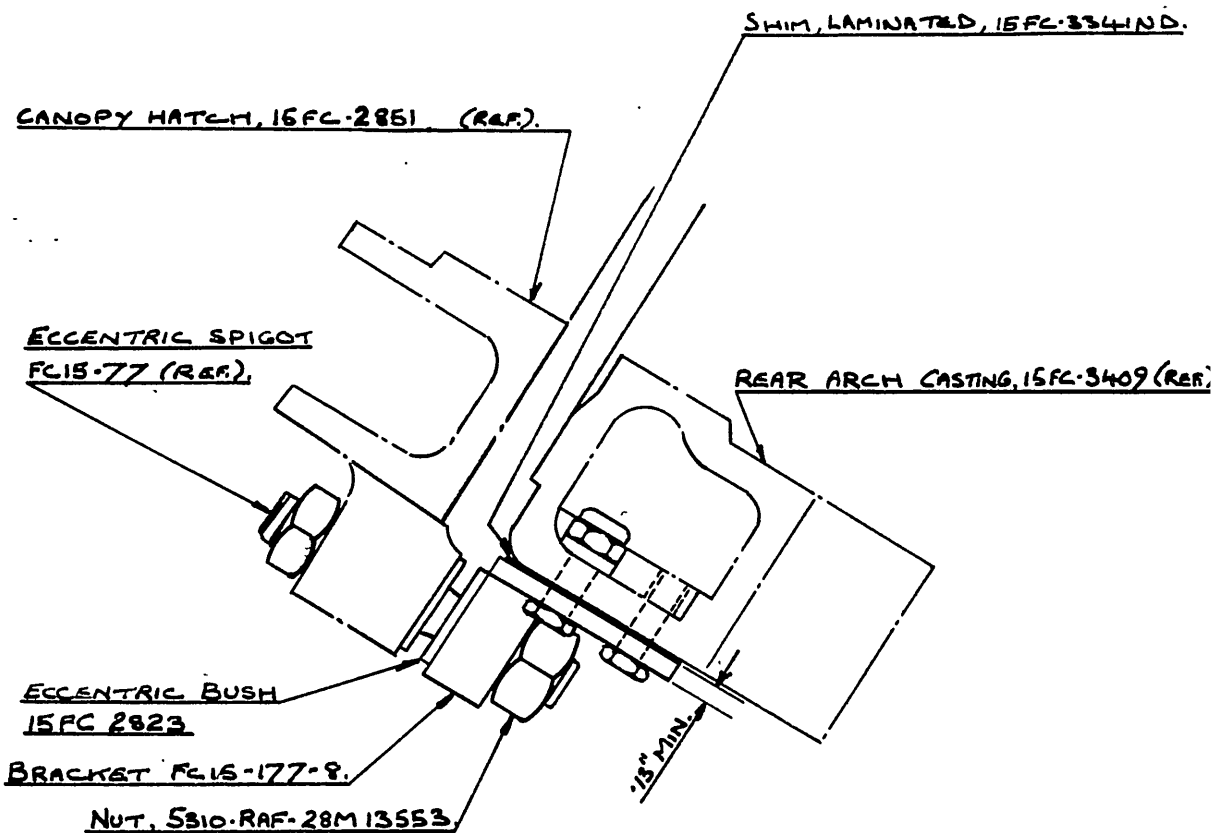
1. (a) The Reason for the Modification  
Cases have been reported of cracking of the canopy spigot brackets, Part Nos 15FC-2753 and 15FC-2754, causing the canopy to jam in the closed position.
- (b) Description and Features by which the Modification can be Recognised  
This modification replaces the existing bracket of magnesium alloy by one of steel.
- (c) Relationship with Other Modifications  
Not applicable.
- (d) Reason for Classification  
Safety is affected.
- (e) Effect on Servicing and/or Ground Handling  
Nil.
- (f) Effect on Aircraft Limitation  
Nil.
- (g) Effect on Aircrew Operation  
Nil.
- (h) Number of Parts Comprising the Order  
One.

CORRECT ADJUSTMENT MAY BE OBTAINED BY:

1. ADJUSTMENT OF ECCENTRIC BUSH AND/OR SPIGOT.
2. INTRODUCTION OF ATTWELL SHIMS AS SHOWN.
