NENE INSTRUCTION NO.3 (Issue 2)  
(Cancels and supersedes Issue 1)

Application: Nene (All types)

## NOZZLE GUIDE VANES - LIMITS OF CRACKING AND DISTORTION

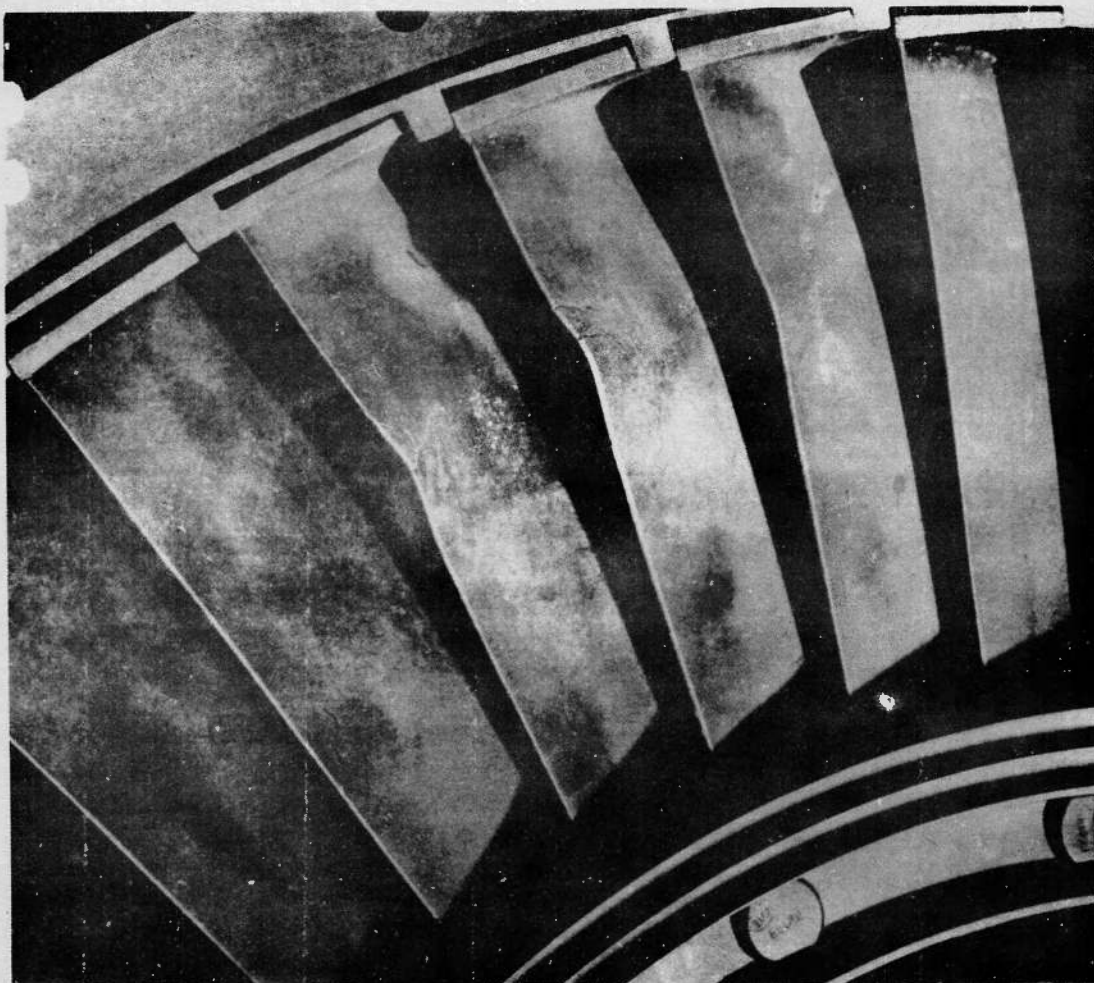
**Fig. 1**

- (a) The bow on the trailing edge exceeds .250 inch or a number of vanes are bowed to a lesser degree, but are considered to be responsible for a J.P.T. outside the operational limitations.
- (b) Thermal cracks in excess of .750 inch in length.
- (c) Multiple tears, with associated deformation of trailing edge caused by mechanical damage, or a single tear in excess of .300 inch in length.

View of N.G.V. trailing edges showing bowing and cracking at the limiting condition of the visual standard. When vanes are seen in this condition a further examination is necessary as detailed in the standard.

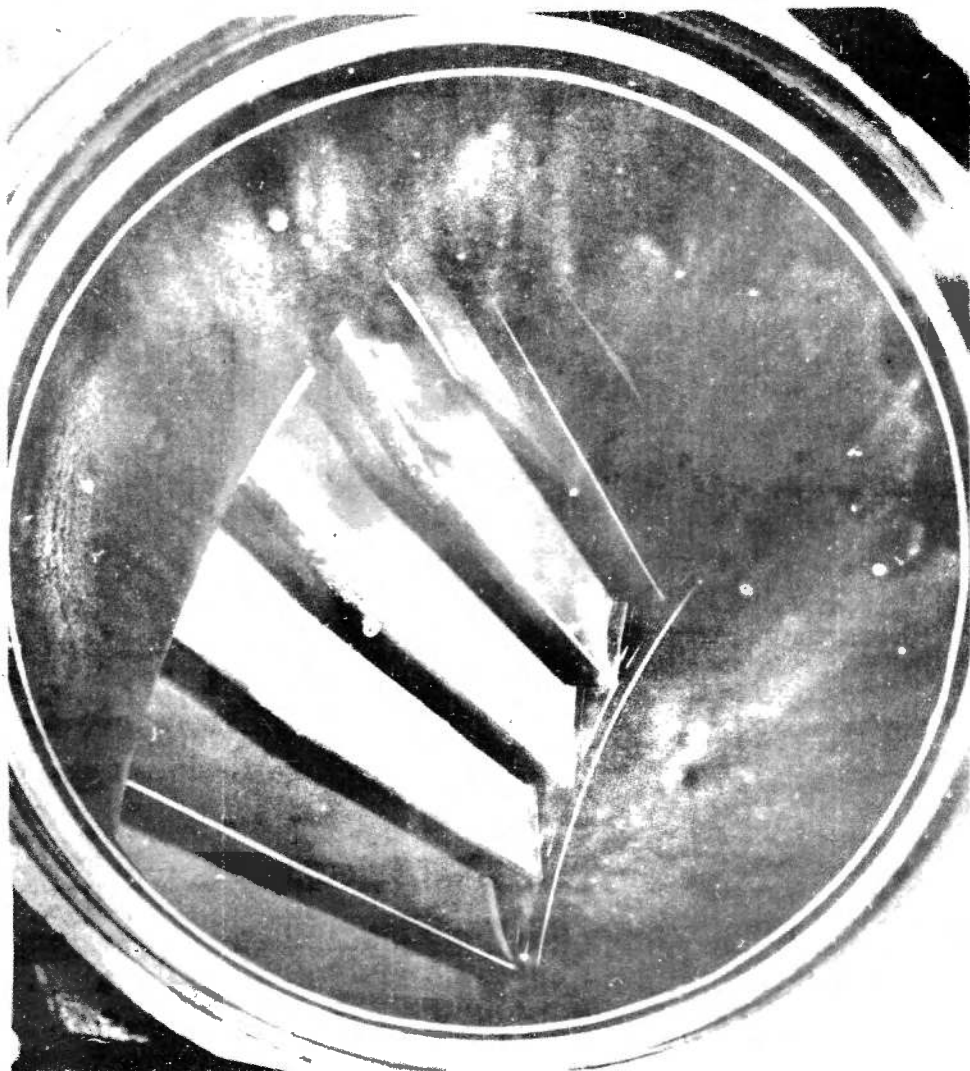
Fig. 2

View of N. G. V's with No. 3 (~~Port Torch Igniter~~) combustion chamber removed. Showing N. G. V's approaching the limit of acceptance for both bowing and cracking.

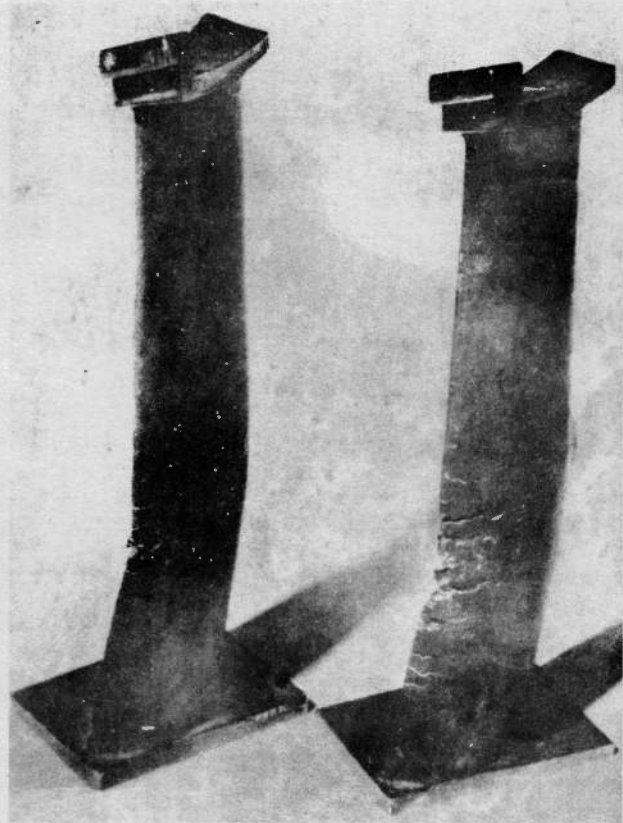
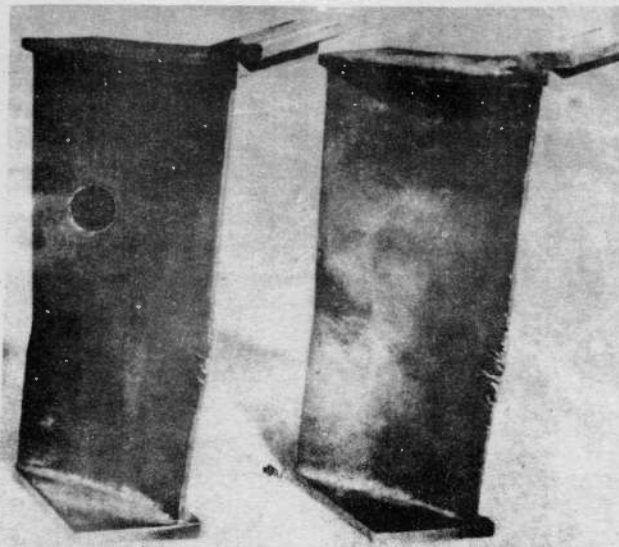
**Fig. 3**

**Views of the convex and concave surfaces of 2 N. G. V's, showing cracking and bowing of the leading edge at the limit of acceptance.**

**N. B. It is normal for cracking to progress further on the convex surface than on the concave as shown in photographs.**

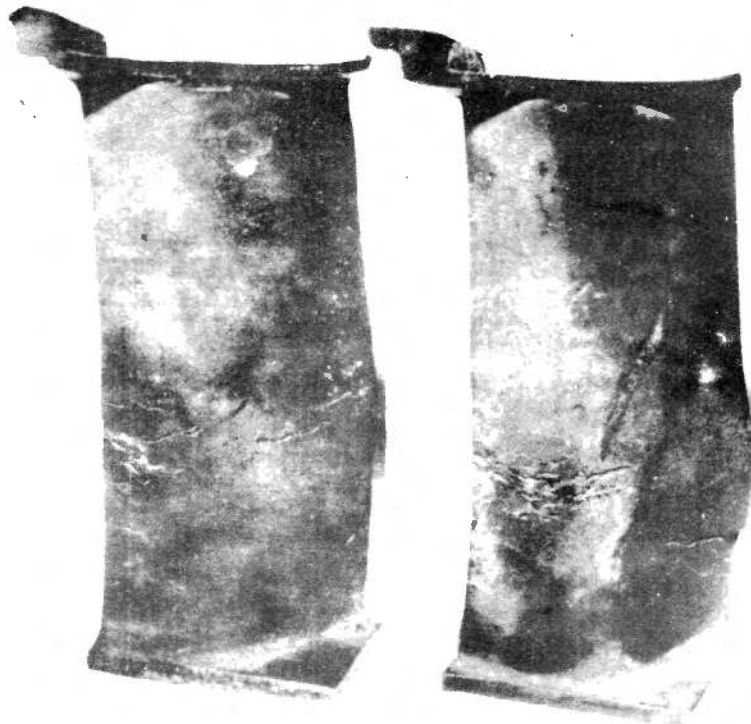
Fig. 4

View of two typical unacceptable Vanes showing cracking progressing across each vane.

7. In cases where N.G.V. deterioration is the criterion for engine rejection, up to 9 vanes may be changed with no throat area checks. It is important, however, that the replacement vanes are fitted in the original position of the rejected vanes. Serviceable vanes which, for any reason, have been removed must be replaced in their original positions.
