AIR FORCE HEAD-QUARTERS

NENE INSTRUCTION NO. 4

APPLICATION: NENE 2 VH

**TURBINE BLADE TIP CLEARANCES -  
METHODS OF CHECKING AND ADJUSTING**

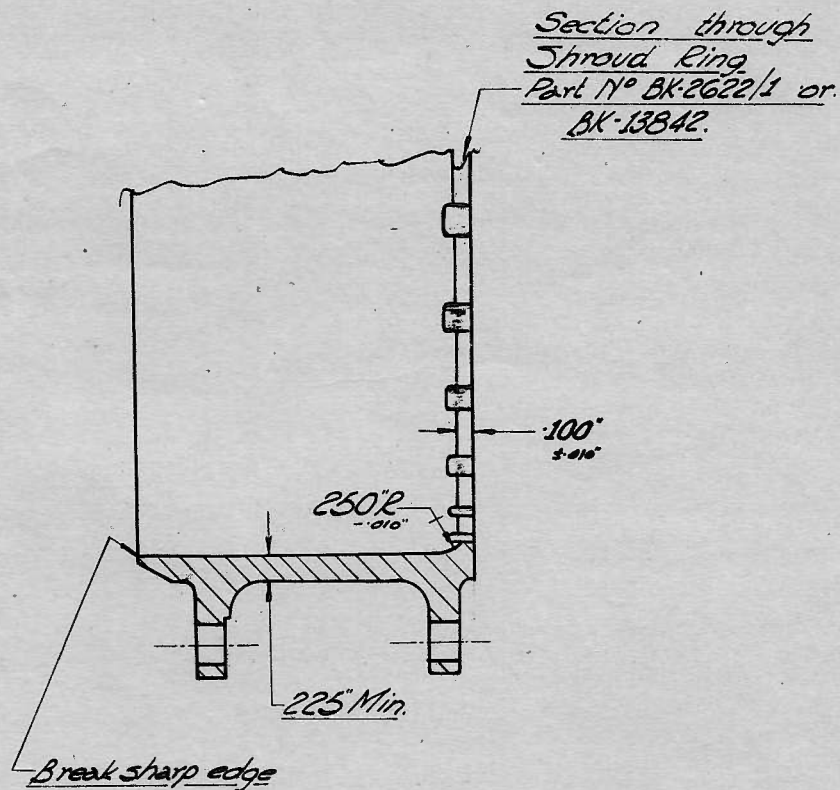
| REFERENCE | | ISSUED BY | | | TITLE | |
|---|---|---|---|---|---|---|
| SURFACE FINISH | | SCALE | | | DRAWING NO. | <i>B11179</i> |

- (a) See that the shroud ring is installed with the word "TOP" at the 12 o'clock position.
- (b) Mark with chalk the area at which tip clearance is to be increased.
- (c) Remove shroud ring.
- (d) Mount the shroud ring in a lathe and set up so that when the cut is taken metal will be removed from that portion indicated by the chalk marks. Care must be taken to ensure that the minimum wall thickness of the shroud ring is not reduced below .225 inch. See drawing No. B11179.

| REFERENCE | | ISSUED BY | | | TITLE | |
|---|---|---|---|---|---|---|
| | | <i>DIRECTORATE OF TECHNICAL SERVICES R.A.A.F.</i> | | | <i>SHROUD RING - LIMITS OF RE-WORK</i> | |
