*A.P.4347D, F, J, K & L, Vol.6, Part 2*

**GROUP D TAIL UNIT**

**Repair to fin main skin**

## Replacement of worn hinge blocks in tail-plane

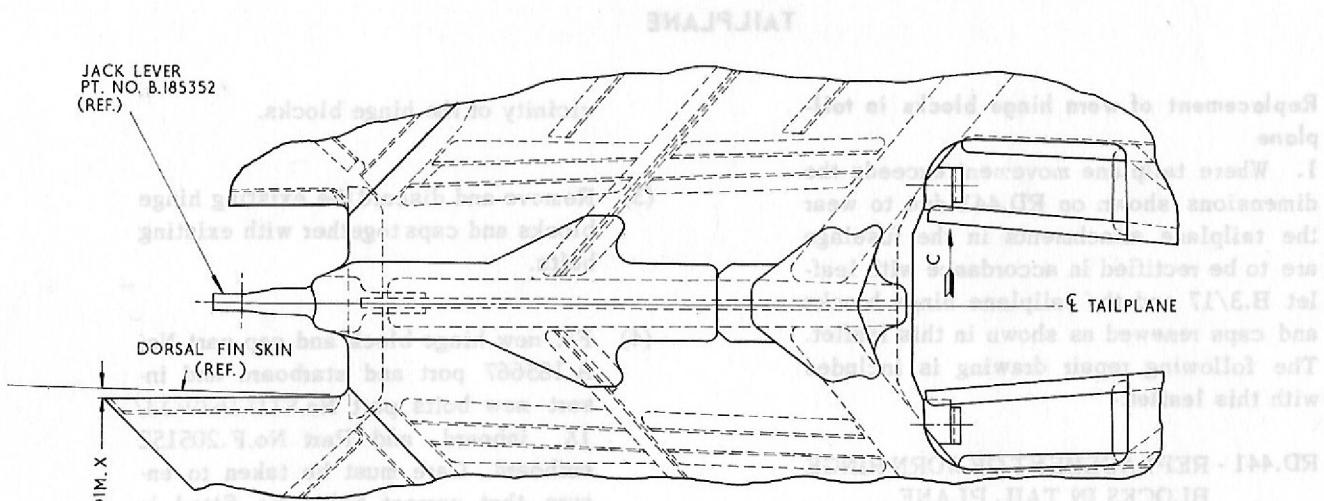
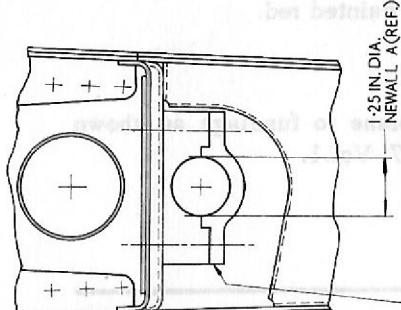
## RD.441 - REPLACEMENT OF WORN HINGE BLOCKS IN TAIL PLANE

1. Where tailplane movement exceeds the dimensions shown on RD.441 due to wear the tailplane attachments in the fuselage are to be rectified in accordance with leaflet B.3/17 and the tailplane hinge blocks and caps renewed as shown in this leaflet. The following repair drawing is included with this leaflet:-

1. WITH THE TAILPLANE INCIDENCE IN THE NORMAL POSITION DIMENSION X MUST NOT EXCEED .060 IN. WHEN MEASURED WITH A DIAL GAUGE. IF THIS DIMENSION IS EXCEEDED THE REAR FUSELAGE AT FRAME 52 MUST BE RECTIFIED IN ACCORDANCE WITH LEAFLET B.3/17 AND THE FOLLOWING ITEMS IN THE TAILPLANE ARE TO BE RENEWED.

- (3) Remove and discard the existing hinge blocks and caps together with existing bolts.
- (4) Fit new hinge block and cap part No. A.185667 port and starboard and insert new bolts part No. STD.1639/13/JX inboard and Part No. F.205152 outboard. Care must be taken to ensure that correct bolts are fitted in correct positions. Incorrect positioning of bolts will damage the threaded block attached to the tailplane rear spar. Heads of bolts Part No. F.205152 and hinge block cap in area of bolt head to be painted red.
- (5) Refit tailplane to fuselage as shown in A.P.4347, Vol.1.

HINGE BLOCK & CAP PT. NO. A.185667 PORT & STBD.  
BOLT STD. 1639-13-JX 4 OFF INBD.  
BOLT PT. NO. F.205152 4 OFF OUTBD.

2. HEADS OF BOLTS PT. NO. F.205152 AND AREA OF CAP LOCAL TO THESE BOLTS TO BE PAINTED RED.
