GROUP G SYSTEMS

Repair
FUEL SYSTEM Leaflet No.

Rectification of bowed top member of 230 gallon drop tank

Repair to 230 gallon drop tank

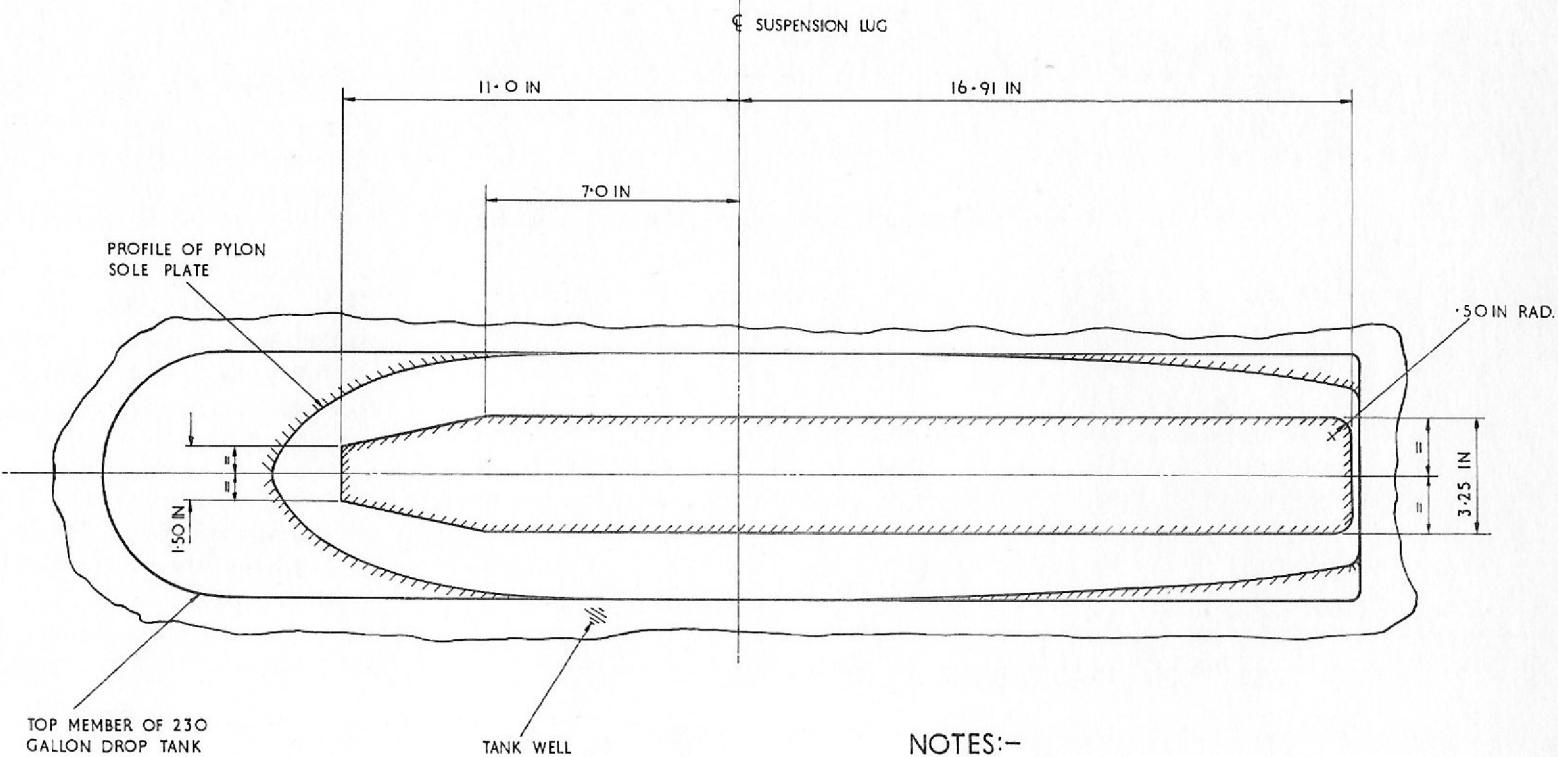
RD. 442

1. Where the top member of the 230 gallon drop tank is bowed after application of more than the limitation of +7g, it permits rocking of the tank on the pylon, this is not considered acceptable and may be rectified as shown in this leaflet. The following repair drawing is included with this leaflet:-

- (6) Any tank with less than 0.015 in. bow is acceptable.
- (7) Any tank with more than 0.050 in. bow is to be rejected.
- (8) Where the top member is bowed between 0.015 and 0.050 in. the tank is to be treated as shown in this leaflet. No tank previously treated with Double Bond Cream is to be treated again. These may be identified by the untreated portions, approximately 0.050 in. lower than the surrounding portions, as shown in RD.442, and the attachment bolt holes being completely covered.

REPAIR TO BOWED TOP MEMBER OF 230 GALL. DROP TANK

3. The recommended sequence of operations is as follows:-
- (1) Clean off sole plate of pylon removing all traces of fuel and loose paint. Apply masking tape in the apertures in the pylon sole plate for release unit and fuel and air valves and also the cutaway in the front end of the sole plate and the spigot bushes. The masking tape is to extend to the face of the sole plate but is not to project.

- (2) Apply release agent 33H/146 to the unmasked portions of the sole plate, ensuring that the edge all round is also covered, and allow to dry.
- (3) Remove the adaptors A.206906/1 (26FX/10501) for fuel and air connections from the tank, by using a rod through the holes provided to unscrew them, taking care to retain the bonded seals.

- (4) With the aid of a template mark off areas of the tank top member which are not to be treated with Double Bond, as shown in RD.442.
- (5) Abrade top member surface to remove chromate treatment down to bare metal except from areas defined above. Use of coarse emery cloth or a section of hacksaw blade is recommended.

- (8) Mix Double Bond Cream on clean surface in accordance with enclosed instructions. With the aid of a spatula, apply an even coat approx. 0.050 in. thick of Double Bond Cream over the surface except for the areas defined above.
- (9) Offer up tank to pylon and, after engaging the release unit, crutch the tank until surplus Double Bond Cream is squeezed out. Remove the surplus cream and tighten the release unit again. Repeat these operations removing surplus cream at each stage until the full crutching torque load is reached.
- (10) Leave tank and pylon for 12 hours.

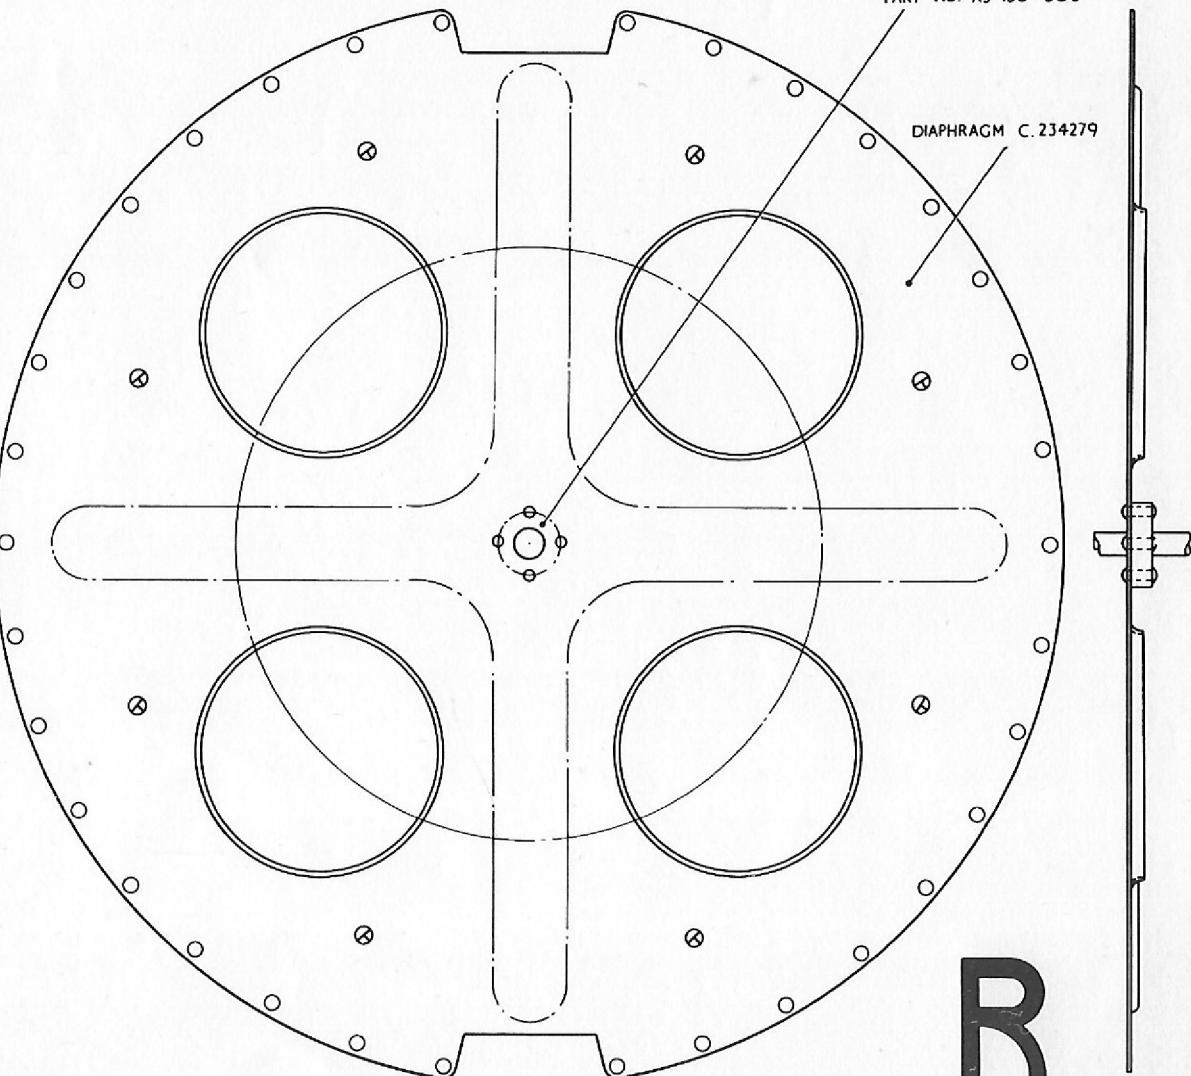
RD 446

Where a case has occurred of detachment of the bush Pt. No. F.224416 from diaphragm Pt. No. C.234279 in the nose shell of a 230 gallon drop tank due to failure of the two aluminium 1/8 in. dia. snap head rivets securing the bush to the diaphragm, repair may be effected as follows.

REPAIR TO 230 GALLON DROP TANK NOSE SHELL DIAPHRAGM

- (1) Remove the nose cone, drill out and remove the sheared rivets.
- (2) Mark off and drill two additional pilot holes at 90 deg. to the existing holes on the same radius.
- (3) Position the bush on the diaphragm so that the original holes are located, clamp in position and drill out all four holes in both bush and diaphragm using a Morse No.20 drill.
- (4) Clean the hole edges as necessary, insert four aluminium 5/32 in. dia. x 1/2 in. snap head rivets and rivet in position.
- (5) Clean away swarf and cuttings and replace the nose shell.

DRILL TWO ADDITIONAL DIAMETRICALLY OPPOSED PILOT HOLES IN BUSH PART No.224416 AT A SIMILAR RADIUS TO THE TWO EXISTING HOLES. OPEN UP ALL HOLES MORSE No.20 THROUGH BUSH AND DIAPHRAGM AND RIVET BUSH IN POSITION WITH SNAP HEAD RIVETS 5/32 IN. DIA. X 1/2 IN. LENGTH PART No. AS 156-508
