GROUP D TAIL UNIT

LIST OF CONTENTS

TYPE: HUNTER MK. 7, 8, 9, 10 & 11	UNIT: TAILPLANE	DATE: 7-6-67	DRAWN: J. TRETHOWAN	APPROVED: H.S.A. LTD.	RELEASER: J. Trethowan 1/1967
ISSUE NO. 1

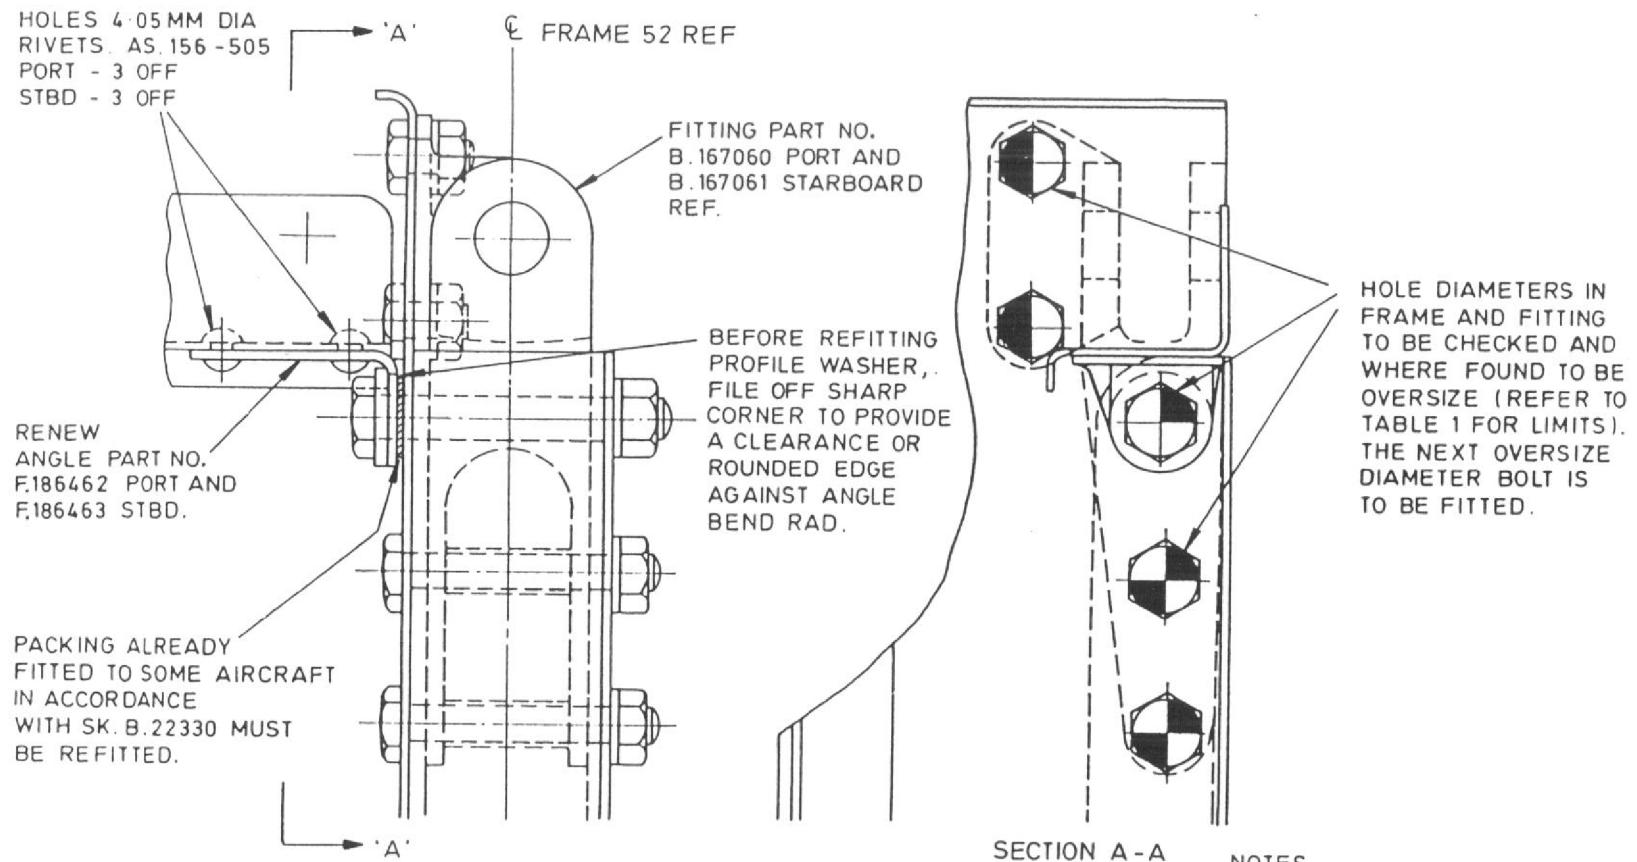
FIG. 1. VIEW ON FRONT ATTACHMENT FITTING FOR FIN

- Front fin attachment fittings at the top of frame 52 have become loose. Also the rivets holding the top skin to the attachment angles have become loose and in some cases, the attachment angles, which pick up the uppermost bolts in the fin fittings have been found broken. (SI/Hunter/133 refers).
- Repairs may be carried out in accordance with the following paragraphs and with reference to the repair figures 1 and 2 in this leaflet.

(2) Carry out repairs to port and starboard fittings as necessary as detailed in repair figures 1, 2 and using tables 1 and 2 for replacement items.

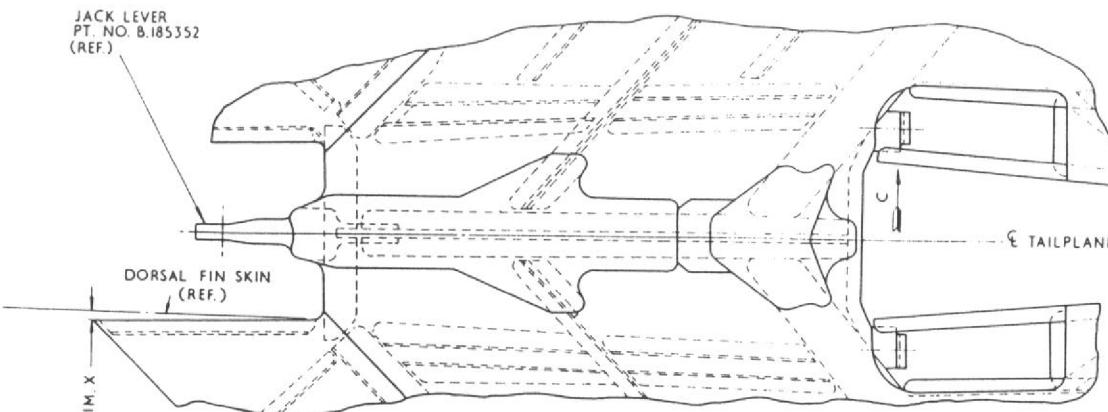
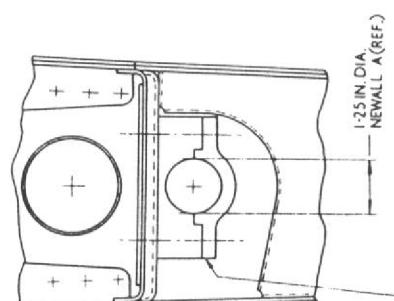
RD. 441

1. Where tailplane movement exceeds the dimensions shown on RD.441 due to wear the tailplane attachments in the fuselage are to be rectified in accordance with leaflet B.3/10 and the tailplane hinge blocks and caps renewed as shown in this leaflet. The following repair drawing is included with this leaflet:-

- (3) Remove and discard the existing hinge blocks and caps together with existing bolts.
- (4) Fit new hinge block and cap part No. A.185667 port and starboard and insert new bolts part No. STD.1639/13/JX inboard and Part No. F.205152 outboard. Care must be taken to ensure that correct bolts are fitted in correct positions. Incorrect positioning of bolts will damage the threaded block attached to the tailplane rear spar. Heads of bolts Part No. F.205152 and hinge block cap in area of bolt head to be painted red.
- (5) Refit tailplane to fuselage as shown in A.P.4347, Vol.1.

HINGE BLOCK & CAP PT. NO. A.185667 PORT & STBD.
BOLT STD. 1639 - 13 - JX 4 OFF INBD.
BOLT PT. NO. F.205152 4 OFF OUTBD.

2. HEADS OF BOLTS PT. NO. F.205152 AND AREA OF
CAP LOCAL TO THESE BOLTS TO BE PAINTED RED

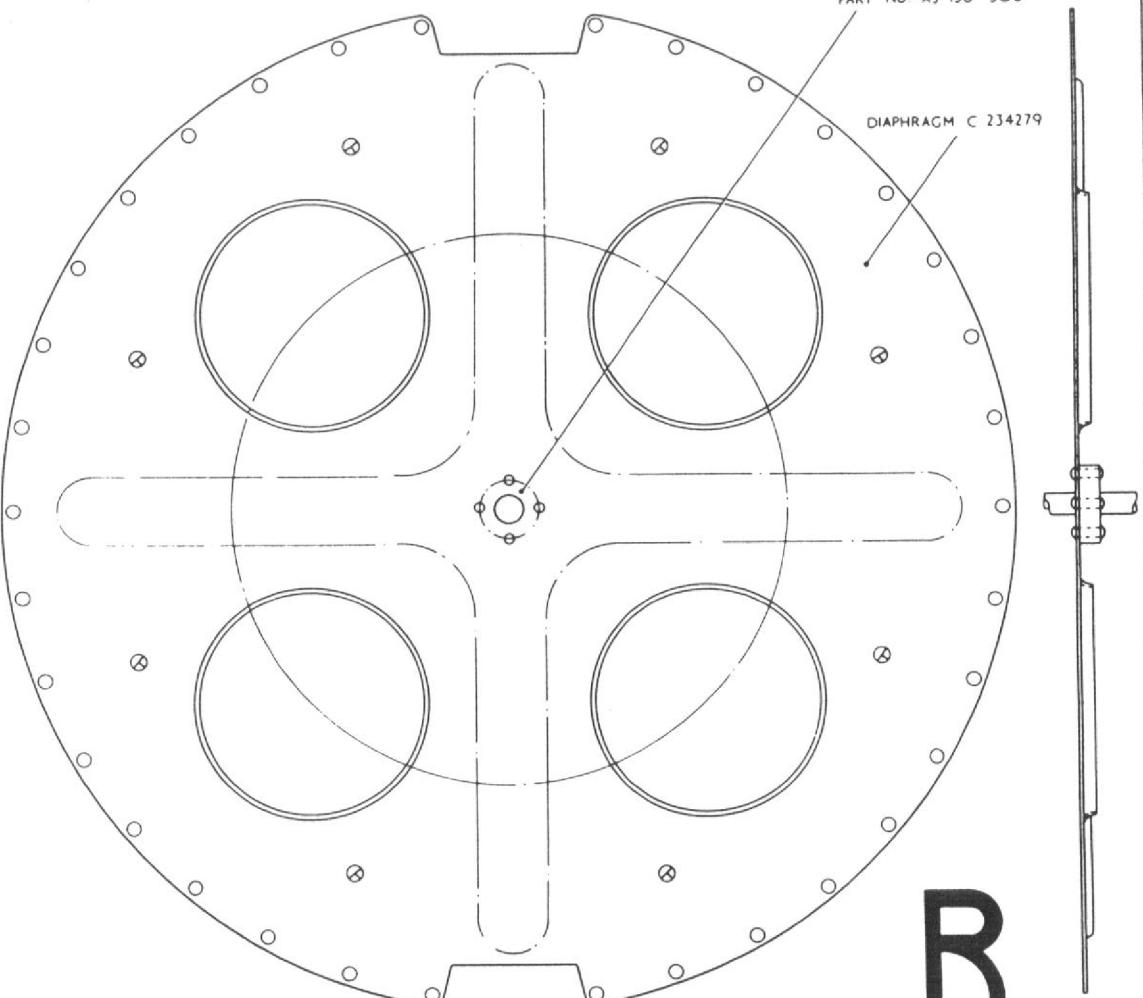
RD 446

Where a case has occurred of detachment of the bush Pt. No. F.224416 from diaphragm Pt. No. C.234279 in the nose shell of a 230 gallon drop tank due to failure of the two aluminium 1/8 in. dia. snap head rivets securing the bush to the diaphragm, repair may be effected as follows.

- (1) Remove the nose cone, drill out and remove the sheared rivets.
- (2) Mark off and drill two additional pilot holes at 90 deg. to the existing holes on the same radius.
- (3) Position the bush on the diaphragm so that the original holes are located, clamp in position and drill out all four holes in both bush and diaphragm using a Morse No.20 drill.
- (4) Clean the hole edges as necessary, insert four aluminium 5/32 in. dia. x 1/2 in. snap head rivets and rivet in position.
- (5) Clean away swarf and cuttings and replace the nose shell.

DRILL TWO ADDITIONAL DIAMETRICALLY OPPOSED PILOT HOLES IN BUSH PART No. 224416 AT A
SIMILAR RADIUS TO THE TWO EXISTING HOLES. OPEN UP ALL HOLES MORSE NO 20 THROUGH
BUSH AND DIAPHRAGM AND RIVET BUSH IN POSITION WITH SNAP HEAD RIVETS 5/32 IN DIA. X 1/2 IN LENGTH
PART No. AS 156-508
