GROUP D TAIL UNIT

Repair to fin main skin

Repair to fin attachments at frame 52

Replacement of worn hinge blocks in tail-plane

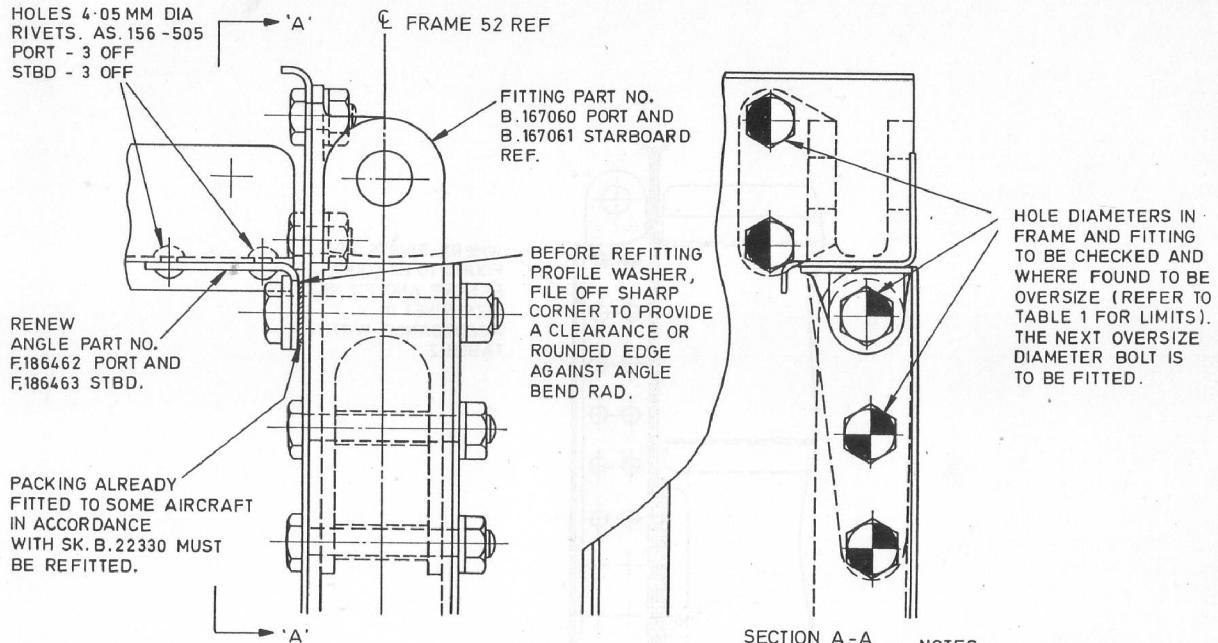
FIG. 1. VIEW ON FRONT ATTACHMENT FITTING FOR FIN

- Front fin attachment fittings at the top of frame 52 have become loose. Also the rivets holding the top skin to the attachment angles have become loose and in some cases, the attachment angles, which pick up the uppermost bolts in the fin fittings have been found broken, (SI/Hunter/133 refers).
- Repairs may be carried out in accordance with the following paragraphs and with reference to the repair figures 1 and 2 in this leaflet.

(2) Carry out repairs to port and starboard fittings as necessary as detailed in repair figures 1, 2 and using tables 1 and 2 for replacement items.

1. PORT VIEW SHOWN, STARBOARD SIMILAR.
2. SKIN COVERING OMITTED FOR CLARITY.
3. NUTS TO BE PEEN LOCKED.
4. BOLT HOLES TO BE C.SK. 90° X 0.03
0.04 IN. DEEP TO ACCOMODATE BOLT UNDERHEAD RADIUS.
5. ASSEMBLE WITH JOINTING COMPOUND TO DTD 369.
6. PAINT WITH EPOXY PRIMER TO DTD 5567 SCHEME 1.
