A. P. 4347J, Vol. 2  
Leaflet No. 0.1  
(Alteration 1)

Hunter F.G.A. Mk. 9 Aircraft - Emergency Oxygen Control Revised

A.P.4347J, Vol.2  
Leaflet No. 0.3

Hunter F.G.A. Mk.9 Aircraft - Emergency Oxygen Control revised to cater for Martin Baker Mod. No. ES.1150.

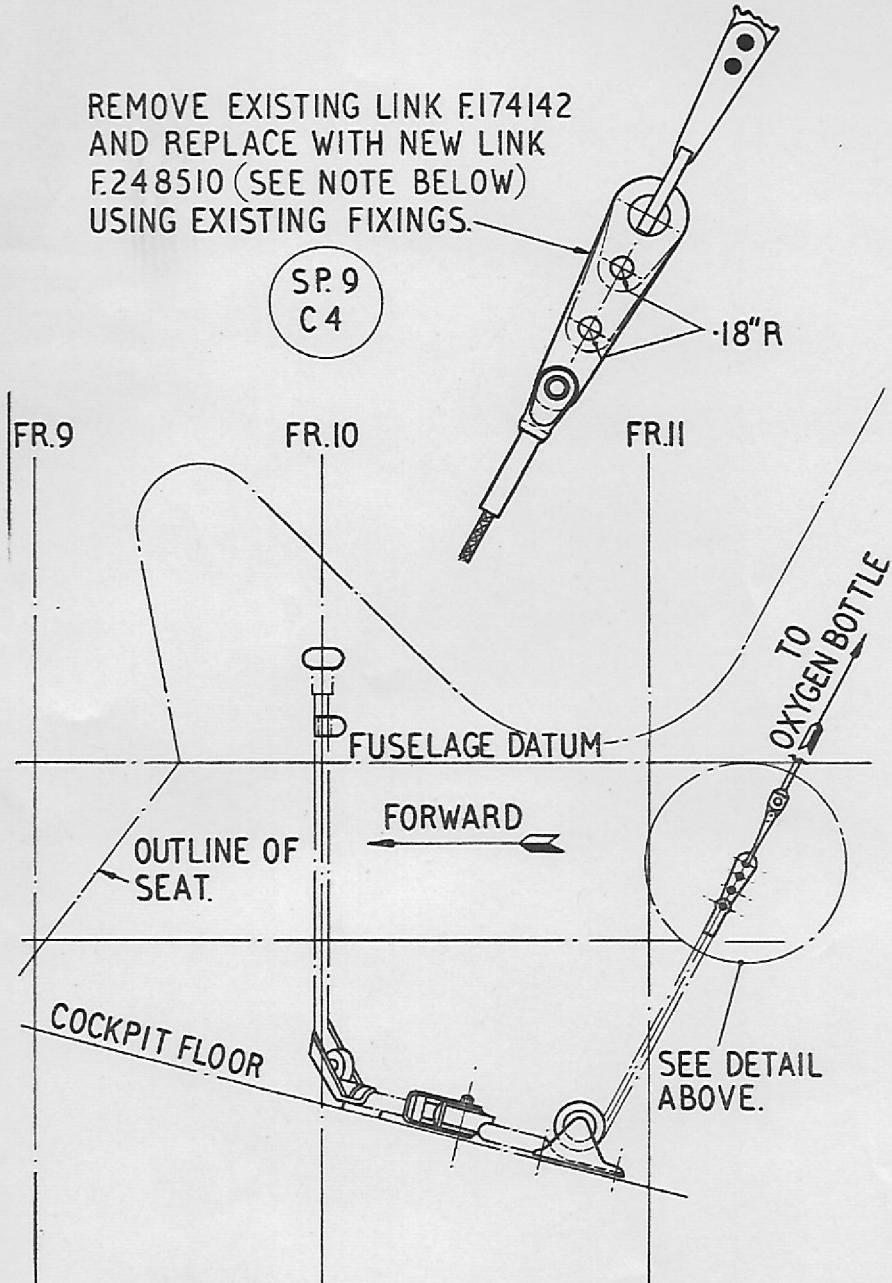
DRG. NO. AP4347J/02/62

Martin Baker Mod. No. ES. 1150 repositions the oxygen bottle on the Mk.2H ejection seat. In consequence, the link between the emergency oxygen control assembly has been redesigned to allow connection to the oxygen bottle in the new position.

Remove link, Part No. F.248510, and trim link to size about the fixing position, as shown on the drawing.

(4) Fit link to end of control cable, using existing pin with new split pin, Part No. Sp.9.C.4, as shown on the drawing.

(5) Re-connect the link to hook on oxygen bottle assembly, as shown on the drawing.

REMOVE EXISTING LINK E174142  
AND REPLACE WITH NEW LINK  
F248510 (SEE NOTE BELOW)  
USING EXISTING FIXINGS.

TO TAKE UP SLACK IN WIRE, ADJUST LENGTH BY  
PICKING UP APPROPRIATE HOLE IN LINK, AND IF  
NECESSARY CUT OFF REDUNDANT LENGTH OF LINK.
