A.P.4347J, Vol. 2
Leaflet No. T.1

Hunter F.G.A. Mk. 9 Aircraft - Centre Fuselage, Cabin Conditioning Feed Pipe, Expansion Joint Revised

A.P. 4347J, Vol.2
Leaflet No. T.2

Hunter FGA. Mk.9 Aircraft - Cabin conditioning System - Ductstat Guard Introduced

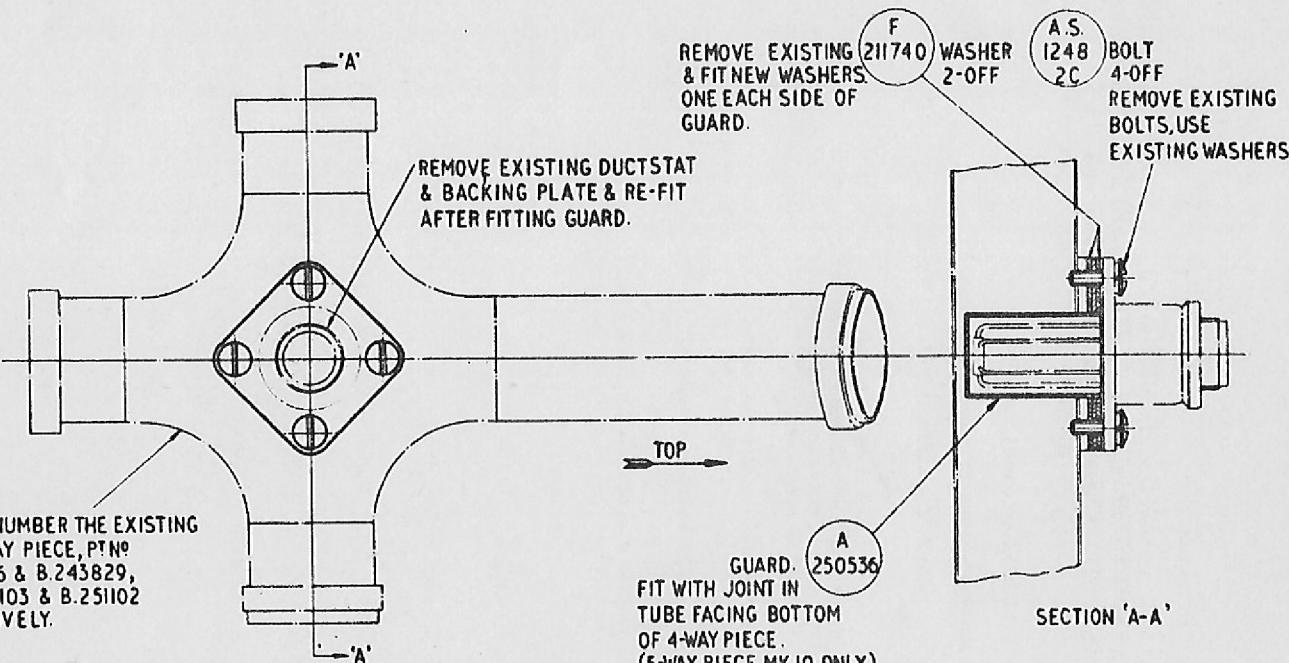
Drawing No. A.P.4347J/T.2/62

A guard is introduced to prevent ice fracturing the ductstat element.

RE-PART NUMBER THE EXISTING
4 OR 5 WAY PIECE, PTN#
C.205316 & B.243829,
AS C.251103 & B.251102
RESPECTIVELY.

- (4) Insert guard, Part No. A.250536; sandwiching between two new washers, Part No. F.211740, as shown on the drawing.
- (5) Re-assemble ductstat, Part No. F.H.G./A/49 complete with existing spring washers, Part No. SP.47.C (4 off) and backing plate, Part No. F.211739 using new bolts as shown on the drawing.

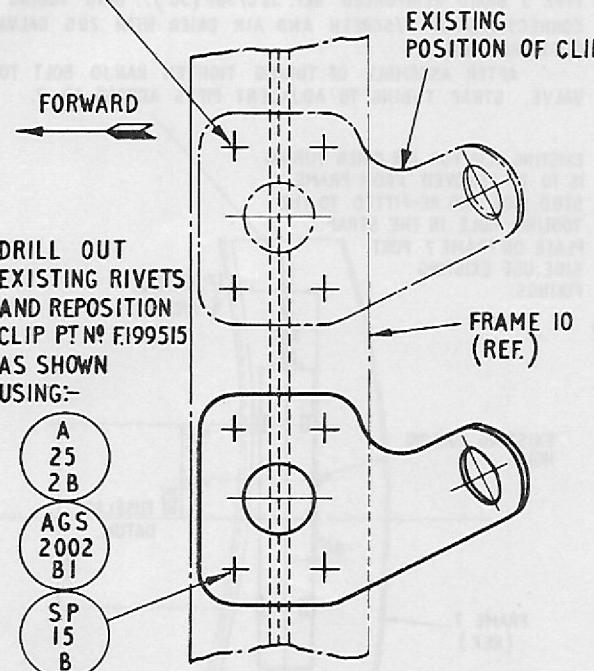
VIEW LOOKING OUTB'D.-STBD. SIDE.

CLIP FOR PILOT'S HARNESS
FR.10 REPOSITIONED.

FORWARD
DRILL OUT
EXISTING RIVETS
AND REPOSITION
CLIP PT N° F199515
AS SHOWN
USING:-

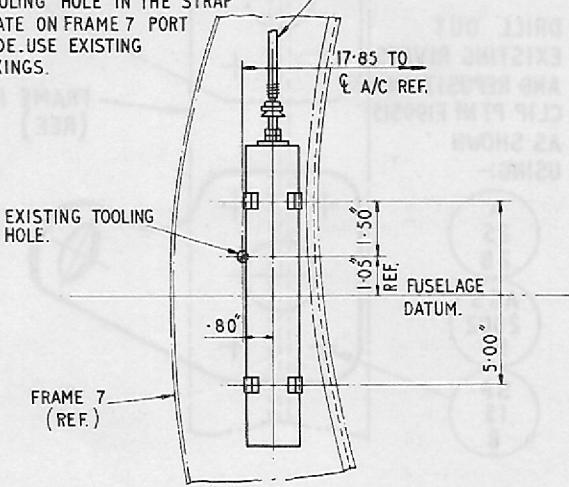
EXISTING CLIP FOR AIR DRIER TUBING
IS TO BE REMOVED FROM FRAME 7
STBD. SIDE AND RE-FITTED TO THE
TOOLING HOLE IN THE STRAP
PLATE ON FRAME 7 PORT
SIDE. USE EXISTING
FIXINGS

CLOSE THE DEHYDRATOR VALVE ON W/SCREEN BY SLACKENING BANJO BOLT. REMOVE EXISTING TUBING FROM BANJO CONNECTION AND AIR DRIER. (CARE TO BE TAKEN TO PREVENT INGRESS OF MOISTURE INTO AIR DRIER.)

AFTER ASSEMBLY OF TUBING TIGHTEN BANJO BOLT TO OPEN VALVE. STRAP TUBING TO ADJACENT PIPES ACROSS FR. 7.

REMOVE AIR DIER FROM FORWARD FACE OF FR. 8 ST.B'D. SIDE.
REPOSITION AS SHOWN ON PORT SIDE - FR.7-FT. FACE USING
EXISTING SPRING CLIPS AS. 2294/9 (2-OFF) ATTACH CLIPS TO
FRAME WITH: - A 25 AGS SP DRILL FRAME 7
