Hunter GA Mk.11 and PR Mk.11 Aircraft – Alighting Gear – Brake Units AH 50247 and AH 50248 – Introduction of locking plate assy. AH 083817 in lieu of AH 082987 (27G/6900)

(Mod No Hunter 1278)

Hunter GA Mk.II and PR Mk.II - Main Undercarriage - Mk. 2
Maxaret installations AH.50720 and AH.50721. To provide for
Removal and Replacement of Maxaret Units (Dunlop Mod. No.3160)

Hunter MK.GA MK.11 & PR MK.11 Aircraft - Alighting Gear - Main Undercarriage To Introduce Jack 103665001 (Port), (Ref.No. 27Q/) and 103665002 (Starboard), (Ref.No.27Q/), in lieu and by conversion of 07965.P.A03 (Port) (Ref.No.27Q/1877) and 07965.S.A03 (Starboard) (Ref.No.27Q/1878).

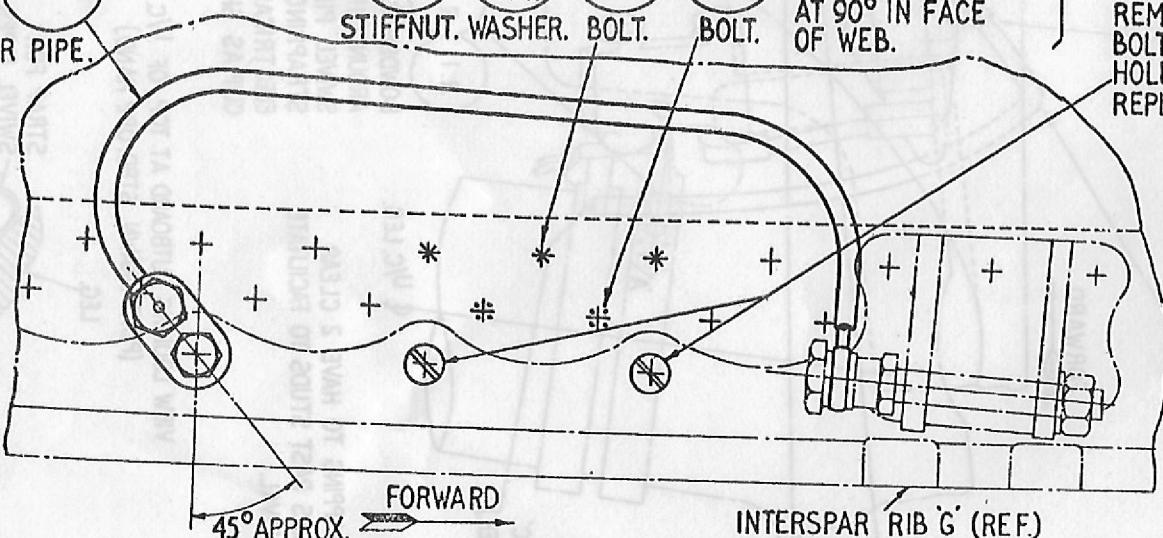
REMOVE 2 EXISTING
BOLTS A.25. 6.C. C'SK.
HOLES .08" DEEP AT 90°
REPLACE WITH:-

A.S.
1242
6.C.
BOLT.

(22) Modify interspar rib 'G' (port and starboard) and fit new bolts, Part No F.179820 and F.187605 and replace bolts, Part No A.25.6.C with bolts, Part No AS.1242/6/C as shown on Sheet 1 of the drawing.

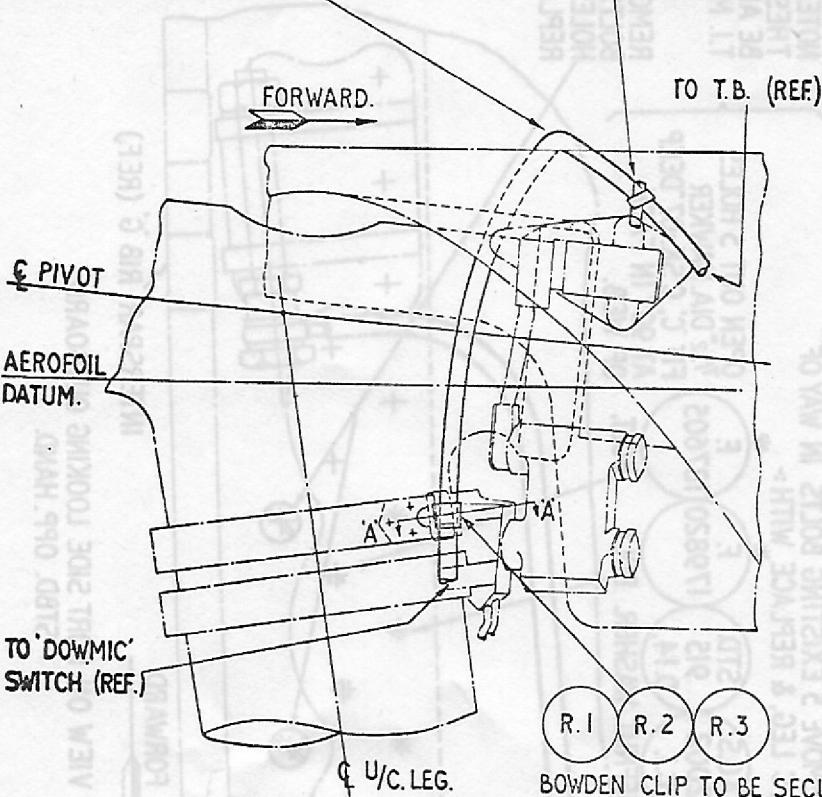
ELECTRIC CABLES TO BE RUN AS SHOWN. CARE TO BE TAKEN TO ENSURE THAT CABLES ARE NOT STRAINED WHEN LEG IS RETRACTED.

ELECTRICAL CABLE TO BE STRAPPED TO HYDRAULIC PIPE.

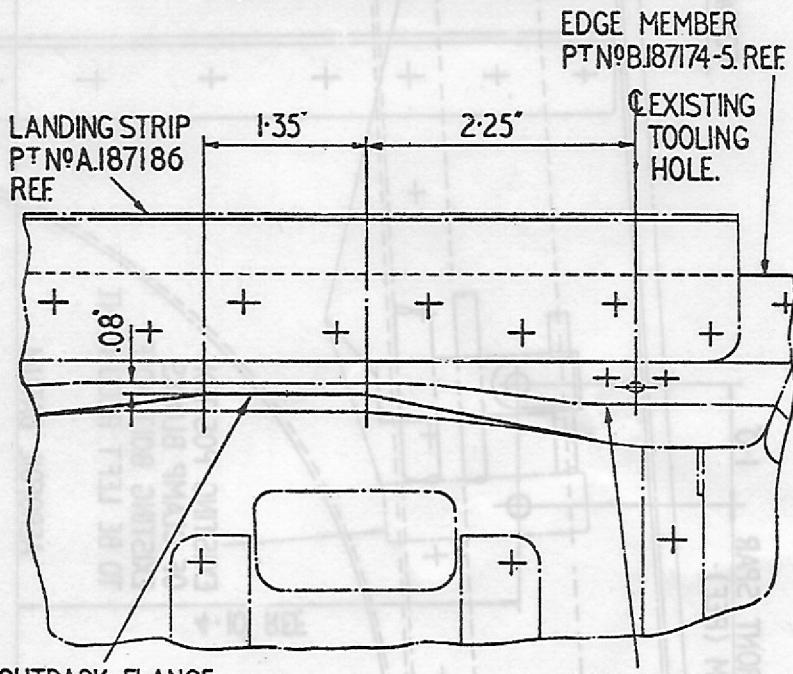
DETAIL 'A'
VIEW LOOKING OUTBOARD ON
OUTBOARD EDGE MEMBER.
(PORT AS DRAWN. STBD. OPP. HAND.)

CUTBACK FLANGE
OF EDGE MEMBER
AS SHOWN &
THEN BLEND IN
CUT-OUT TO HIGH
POINTS OF THE
FLANGE.

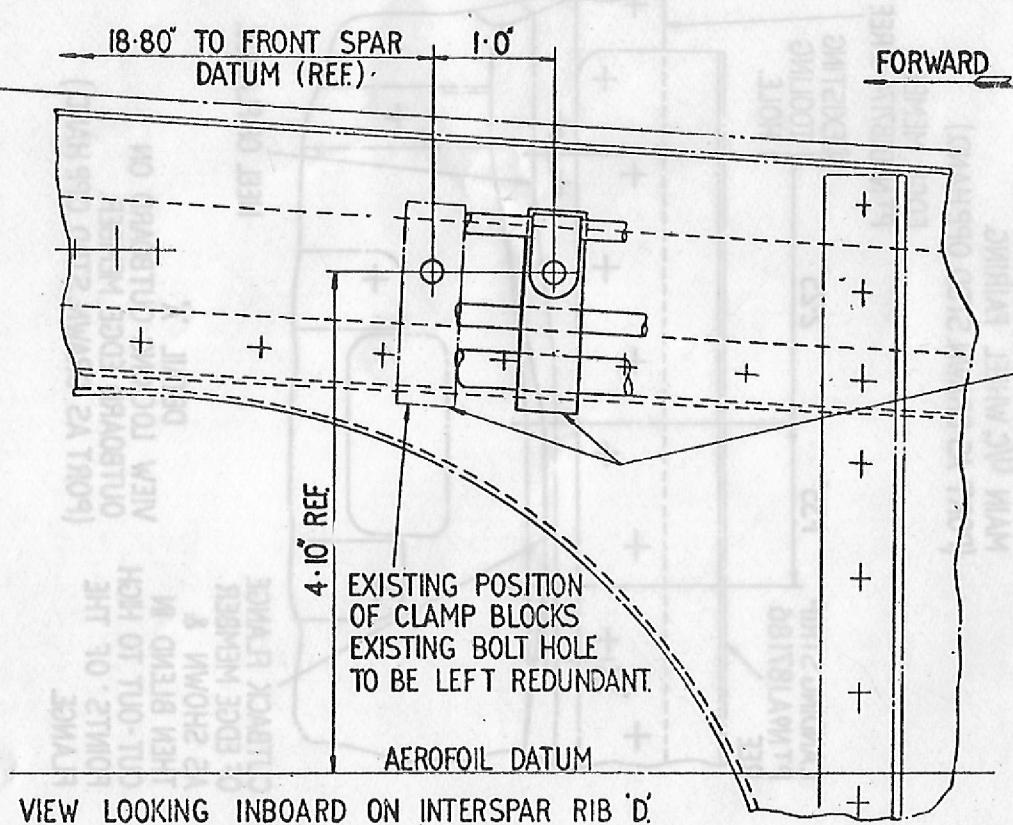
REMOVE EXISTING CLAMP BLOCKS
PT. N° F203780 & I, CLIP STD. 1959/1
& REPOSITION AFT AS SHOWN.
DRILL HOLE MORSE N° 25.

NOTE:-
THIS DRAWING APPLIES
TO PORT RIB ONLY.

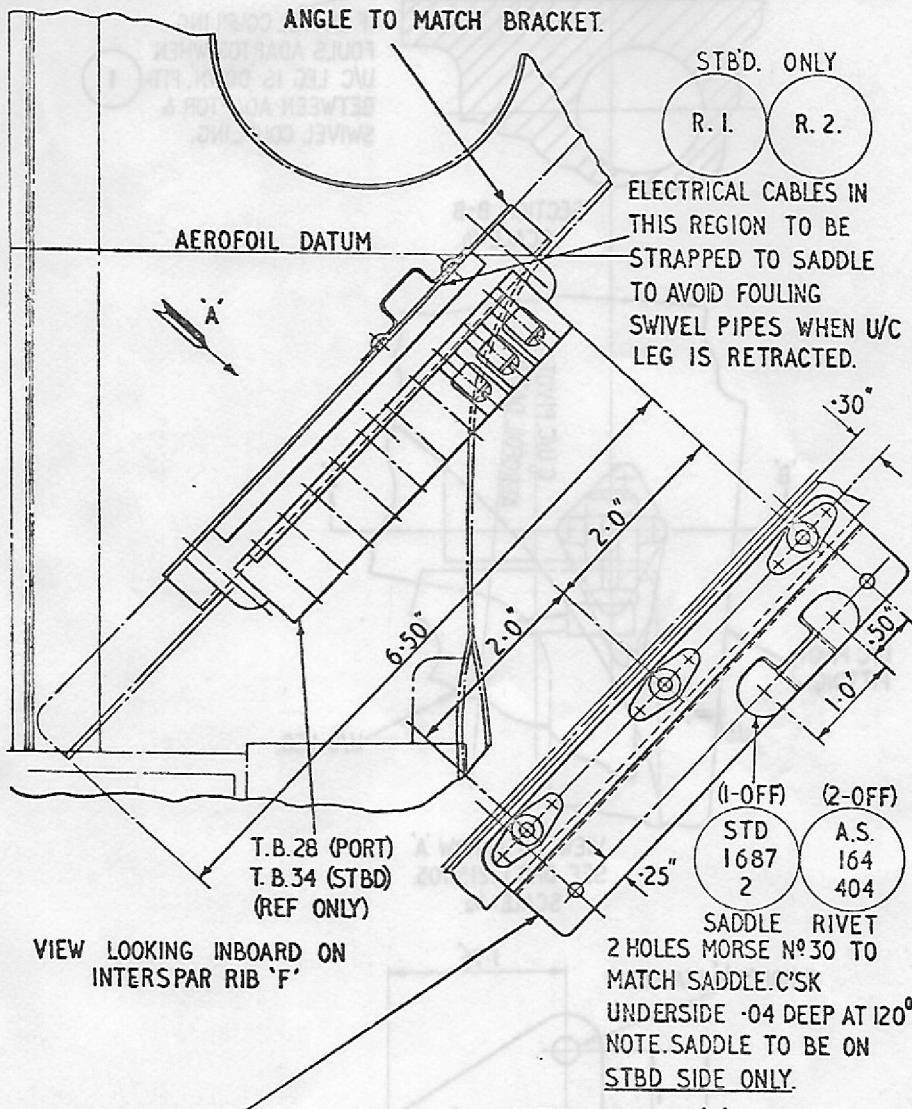
REMOVE EXISTING MOUNTING BRACKET
FOR TERMINAL BLOCK PART NO F.205956
AND REPOSITION TO DIMENSIONS GIVEN
BELOW. DRILL 3 HOLES MORSE NO25 IN
ANGLE TO MATCH BRACKET.

NOTE. THIS MOUNTING BRACKET
PART NO F.205956, TO BE
RE-PART NUMBERED F.217326
AFTER ASSY. OF SADDLE
ON STBD SIDE.
