Contents List

A.P.4347L, Vol. 2
Leaflet No. H.1

Hunter GA. Mk.11 Aircraft-Fuel System - De-fuelling Cock, Locking Improved

Hunter G.A.Mk.11 and P.R.Mk.11 Aircraft-Fuel System-Air Supply-To introduce Non-Return Valve, Part No. 708AA25/B (Ref.No.27FC/145562) in lieu and by conversion of NRV. Part No. 708AA17/B/1 (Ref.No. 27F/7869). Part A: In Air Pressure Line to Engine. Part B: In Air Pressure Lines to Wing Tanks.

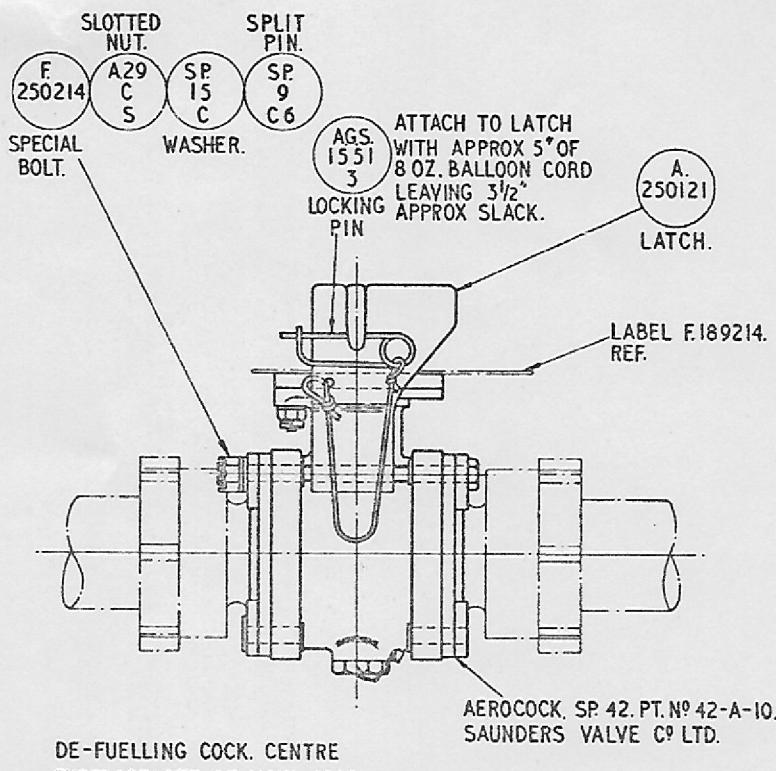
DRG. NO. AP4347L/H1/62

To prevent the possibility of engine flame-out due to the de-fuelling cock not being fully closed, a locking latch is introduced to ensure that the cock is fully closed before final locking.

DE-FUELLING COCK. CENTRE
FUSELAGE AFT OF MAIN SPAR
PORT SIDE.

- (1) Remove the engine starter access door.
- (2) Locate the de-fuelling aercock, Type SP.42, Saunders Valve Co. Ltd., Part No. 42.A.10, situated aft of the main spar on the port side, and fit latch, Part No. A.250121, as shown and in accordance with the instructions on the drawing.
- (3) Replace the engine starter access door.

ASSEMBLE LATCH BY SCREWING IN SPECIAL BOLT, ALLOWING LATCH TO ASSUME ANY MID-POSITION CLEAR OF EACH END OF THREADED INSERTS. ASSEMBLE SLOTTED NUT AND WASHER, ENSURING THAT BOLT IS FREE TO ROTATE. ADJUST LATCH BY TURNING BOLT SO THAT SLOT ENGAGES THE LEVER, ALLOWING NO MOVEMENT OF LEVER WITH THE COCK IN THE FULLY CLOSED POSITION.

NOTE: LOCKING OF BOLT TO LATCH IS UNNECESSARY AS NYLON THREAD IS PROOF AGAINST VIBRATION.

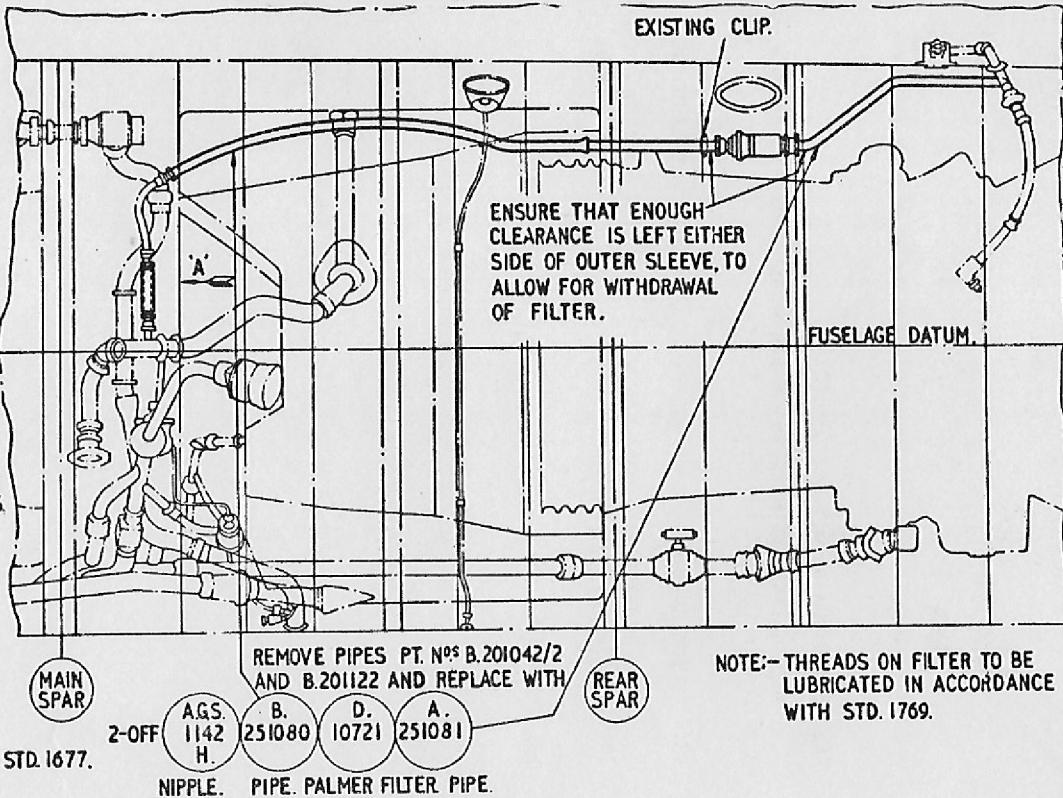
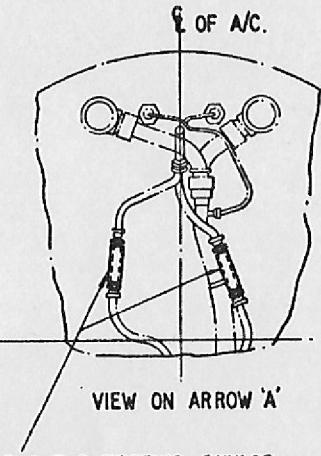
DRG. NO. AP4347L/H2/63

A single air filter, Part No. D.10721 (Ref. No. 27VC/89) has been introduced into the fuel system in place of the two existing air filters, to increase protection against dirt particles damaging the hydraulic pressure reducing valves.

- (1) Remove the E.C.U. (A.P. 4347, Vol. 1, Sect. 4, Chap. 1 refers).
- (2) Refer to the drawing and disconnect and remove the Dunlop air filters, Part No. B.218125, port and starboard, and replace with link pipes, Part No. A.251082, using new connecting nipples, Part No. AGS.1170.F.
- (3) Disconnect and remove air pipe, Part No. B.201122 between frames 28 and 33, and branch pipe, Part No. B.201042/2, between frames 33 and 36.
- (4) Fit new air pipe, Part No. B.251080 between frames 28 and 33 and new branch pipe, Part No. A.251081 between frames 34 and 36.
- (5) Fit air filter, Palmer Aero Products Ltd., Part No. D.10721 (Ref. No. 27VC/89) between new pipes, Part Nos. B.251080 and A.251081, using nipples Part No. AGS.1142.H.

REMOVE 2 EXISTING DUNLOP
FILTERS PART NO. B.218125 & NIPPLES.
AND REPLACE WITH:-

A. 251082 A.G.S. 1170
LINK NIPPLE.
PIPE. 4-OFF.
2-OFF.

PIPE COUPLINGS TO BE WIRE LOCKED TO STD.1677.
