AP 101B-1309-2  
Leaflet No. J.1

HUNTER G.A. MK. 11, P.R. MK 11 - AIRCRAFT - Wing - To introduce  
Socket Part No. B. 250315 in lieu and by conversion of B.198325  
(26FX/12878).

(Mod. No. Hunter 1334)

Fuselage - Improved Fatigue Meter Access AP101B-1309-2  
Leaflet No J2

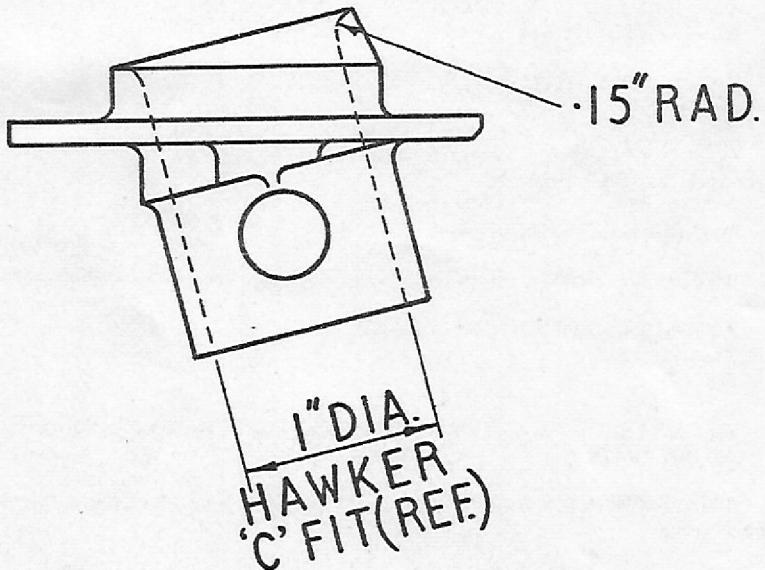
DRG. NO. AP101B-1309-2/J1/68

Following on the introduction by Mod. Hunter 1327 of a radiused spigot fitting on the centre fuselage, the mating wing socket is correspondingly radiused.

HOLE IN FITTING TO BE  
CHAMFERED AS SHOWN.  
IT IS IMPORTANT THAT  
THIS RADIUS IS STRICTLY  
ADHERED TO AND THAT  
THE SURFACE IS FREE  
FROM ALL TOOL MARKS.

- (1) With wings removed, at root end of wings (Port and starboard) adjacent to leading edge of nose rib 'A', locate socket, Part No. B.198325.
- (2) Using radius cutter tool, Part No. T.609117JD, form .15 in. radius as shown in the Drawing.
- (3) Remove all tool marks from socket
- (4) Re-part number modified socket as B.250315.

RE-PART N° SOCKET B.250315
