**Hunter G.A Mk. II - Cabin Conditioning System - To Introduce Controller Type A (Ref. No. 27KD/510) with Enlarged Orifice (Mod. No. Normalair 146)**

AP 101B-1309-2

Hunter GA Mk 11 Aircraft

Cabin conditioning - Electrics, Amplifier Type FLM/A/5, (Ref No 5CZ/4335604) Introduced in place of FLM/A/1.

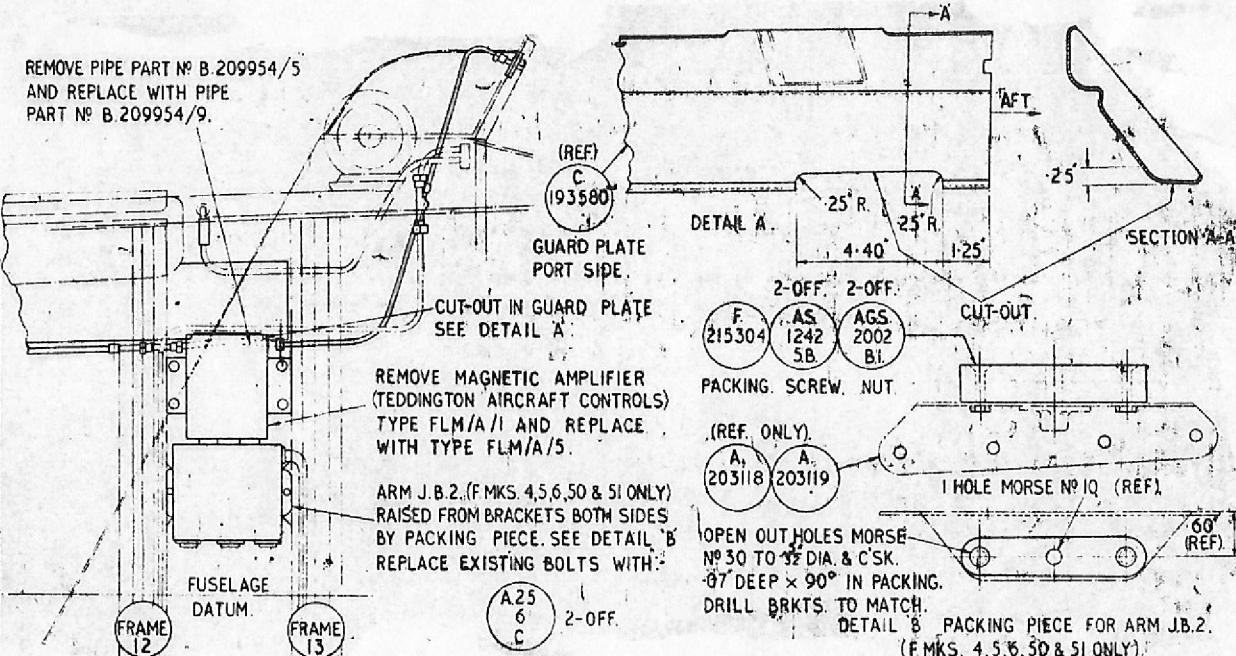
Drg. No. AP101B-1309-2/T2/74

A magnetic amplifier type FLM/A/5 has been introduced into the Cabin Conditioning System in lieu of type FLM/A/1 to give longer life under tropical conditions.

CABIN CONDITIONING ELECTRICS,  
AMPLIFIER TYPE FLM/A/5  
INTRODUCED IN LIEU OF FLM/A/1

(5) Modify the guard plate, Part No C193580 as shown on the Drawing.

(6) Fit packing Part No F215304 to armament JB 2 mounting brackets, Part No A203118 on frame 13 and Part No A203119 on frame 12 using bolts, Part No AS1242/5/B and nuts Part No AGS 2002/B/1 as shown on the Drawing.
