AP 103D-0208-2

# ENGINE STARTING SYSTEMS, PLESSEY, TYPE I.P.N.

## GENERAL ORDERS AND MODIFICATIONS

AP 103D-0208-2  
Leaflet No 4

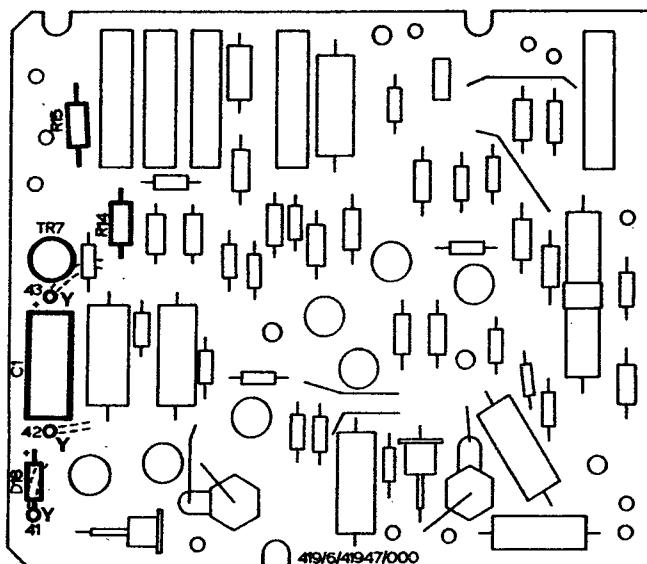
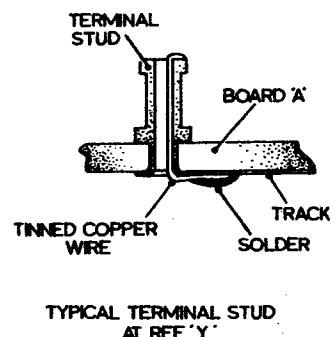
FIG1

(4) Refer to Drawing Plessey / 2635 Fig 1. From Board A Part No 419/1/09599 unsolder and remove the following:

(5) Drill out three existing holes, Ref Y, to 1.95 mm diameter and fit Terminal Studs (Qty 3), Part No 999/4/01135/004. Studs to be swaged and wired to track using Tinned Copper Wire 0.5 mm diameter and Solder, Multicore 22 SWG (See sketch).

(6) Remove Board Part No 419/1/09599. Using white ink re part number to 419/6/41947/000. Code reference identity of new Terminal Studs 41, 42, 43, alongside each as shown. Using varnish, reprotect exposed areas.

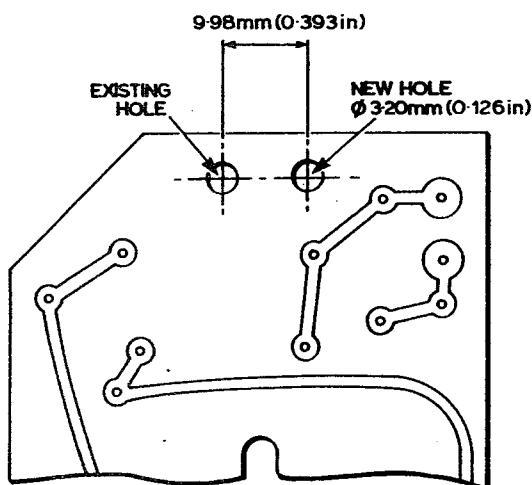
FIG2

(7) Refer to Drawing Plessey / 2635 Fig 2. Rework Board 'B' Part No 700/1/12711 by drilling hole 3,20 mm diameter at position shown. Recode Board as 419/1/41975/000.
