AP 113D-0721-2

# CONTROL PANEL TYPE 12 LUCAS AEROSPACE TYPE F2801

## GENERAL ORDERS AND MODIFICATIONS

Mod No LG2257 Rev 1 (Class C/3) on replacement

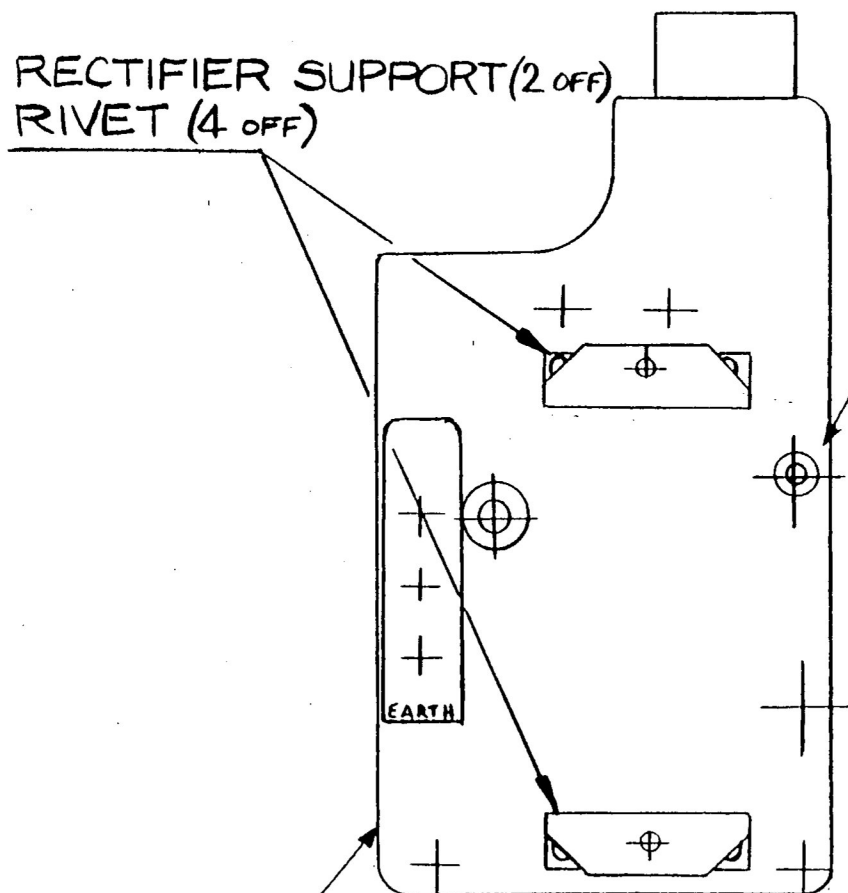
# FIGURE 1

REMOVE AND DISCARD SCREW NL519L  
COUNTERSINK EXISTING HOLE TO  
0.218"/0.228" DIA. x 90° FROM THIS SIDE.

RECTIFIER SUPPORT (2 OFF)  
RIVET (4 OFF)

- (1) Remove mounting plate assembly N45465.
- (2) Remove terminal block N64112, rectifier N45583, rectifier N45583-1 and their associated fixing components. Discard rectifiers and nuts NK10009L.
- (3) Remove and discard 2 rectifier supports N45455 and 4 rivets NK18206M.
- (4) Remove and discard screw NL519L from the position marked reference drawing no LG2257 Rev 1 Fig 1.
- (5) Countersink the hole to 0.218"/0.228" diameter x 90° in the position shown in Fig 1.
- (6) Protect the machined surface using Alocrom 1200 (33C/1835).

- (7) Assemble 2 new rectifier supports 80229223 and secure using 4 rivets NK18206M.
- (8) Assemble screw NK3817L in the position marked reference Fig 1.
- (9) Assemble new Rectifier 80229156, Rectifier 80229160, 4 off Nuts 91412134, the retained fixing components and new Insulation 80229159 in the position as shown in Fig 2.
- (10) Re-assemble the control panel as stated in AP113D-0721-16.

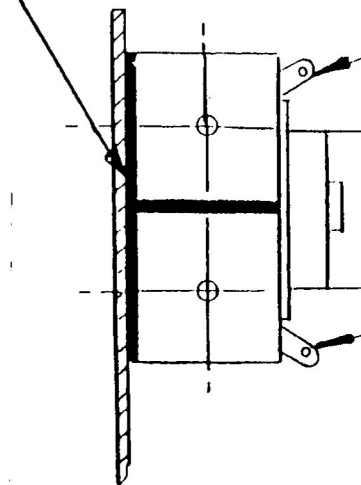
# FIGURE 2

INSULATION  
80229159

RECTIFIER  
80229156

RECTIFIER  
80229160
