CHAP. 4 AIRFRAME S.P. 417 A.L. 5 SHEET 1 OF 2	SERVICING PROCEDURE F53 T55	BAC F53 & T55 (SA) 5A3A Section 1 2nd Edition
Mainplane Centre Rib - Cracking	AFSC 43151	TIME EST
Safety and Servicing Notes are to be complied with throughout the work detailed on this card.		
SPECIAL TOOLS AND EQUIPMENT Ardrox dye penetrant kit.		ASSOCIATED PROCEDURES
<p>NOTE 1: During this Servicing Procedure access can be gained to centre-rib front vertical flange which mates with Spar 1 web plates and centre rib via No.2 engine intake duct.</p> <p>NOTE 2: Where cracks are found which connect any two bolts holes or which total 2 in. or more in length, repeat examinations are to be carried out at CHECK 1 servicing.</p> <p>NOTE 3: Where cracks are found which connect more than three 0.3125 in. diameter bolt holes on either left or right side of flange or which total more than 4 in. in length, aircraft is to be placed unserviceable pending further instructions which can be obtained from: Saudi Technical Support Dept., Warton, Lancashire, England.</p>

BAC F53 & T55 (SA)

5A3A Section 1

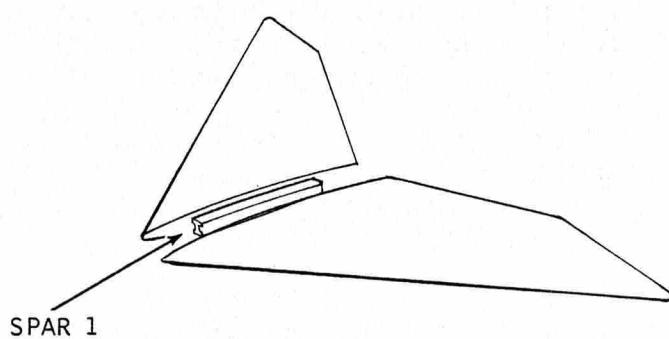
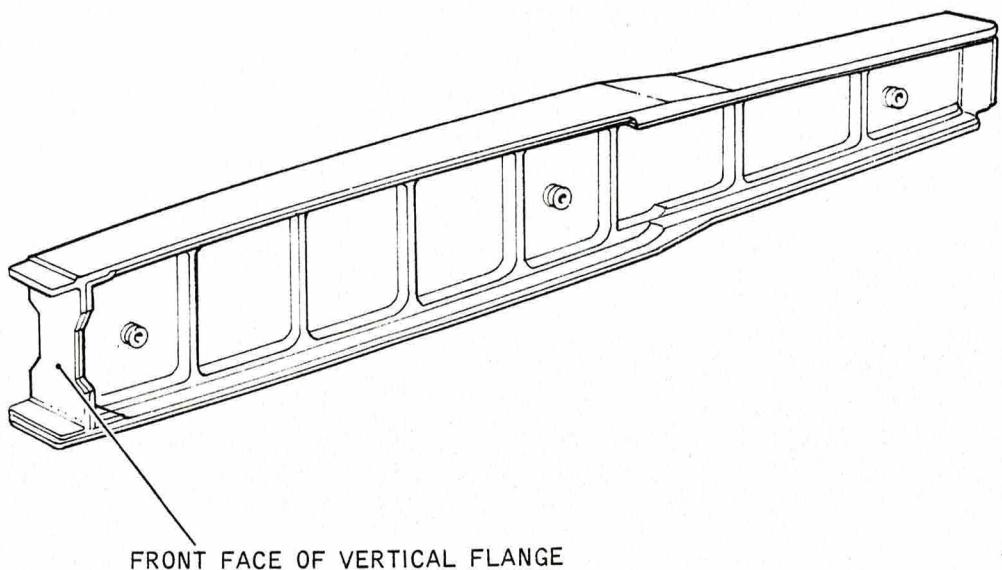
FIGURE 1

<u>43151</u>		
<ol style="list-style-type: none"> <li>1. PREPARATION (See Fig.1)             <ol style="list-style-type: none"> <li>1.1 Front face of vertical flange. Remove sealant.</li> </ol> </li>   <li>2. EXAMINATION (See Fig.1)             <ol style="list-style-type: none"> <li>2.1 Front face of vertical flange. Examine, particularly for cracks, using Ardrox dye penetrant kit.</li> </ol> </li>   <li>3. COMPLETION (See Fig.1)             <ol style="list-style-type: none"> <li>3.1 Front face of vertical flange. Restore sealant.</li> </ol> </li> </ol>		
		Continued Overleaf
SERVICING PROCEDURE INSPECTION STAGES DO NOT EXCLUDE ADDITIONAL INSPECTION STAGES INCORPORATED AS NECESSARY IN MAINTENANCE CERTIFICATION DOCUMENTS

MAINPLANE CENTRE RIB
