CHAP 4 AIRFRAME SP 430 AL 1 SHEET 1 OF 3	SERVICING PROCEDURE F53 T55	BAC F53 & T55 (SA) 5A3A Section 1 2nd Edition
D-door Operating Arm Brackets - Cracking	AFSC 43151 43171	TIME EST
Safety and Servicing Notes are to be complied with throughout the work detailed on this card.		
SPECIAL TOOLS AND EQUIPMENT		ASSOCIATED PROCEDURES
Nil.		
<u>43151</u>		
<p>1. EXAMINATION</p> <p>1.1 D-door operating arm brackets (forward) (left - Part No. EB1-20-2436, right - Part No. EB1-20-2435) (See Fig.1).</p> <p>1.2 D-door operating arm brackets (aft) (left - Part No. EB1-20-2435, right - Part No. EB1-20-2436) (See Fig.1).</p>		
<p>Using torch and mirror. Inspect each bracket for cracks.</p>		
<p>2. RECTIFICATION</p> <p>NOTE: Sub-item 2.1 is applicable only if one bracket per door is found to be cracked.</p> <p>2.1 The aircraft may continue to fly with a suitable Deferred Discrepancy Entry subject to inspection at each post flight servicing providing that not more than one bolt is eliminated, that is, that bolt-to-edge cracks are confined to one bolt position only, and any other cracking particularly along the heel line of the bracket does not extend for more than 50 per cent of the length of the br

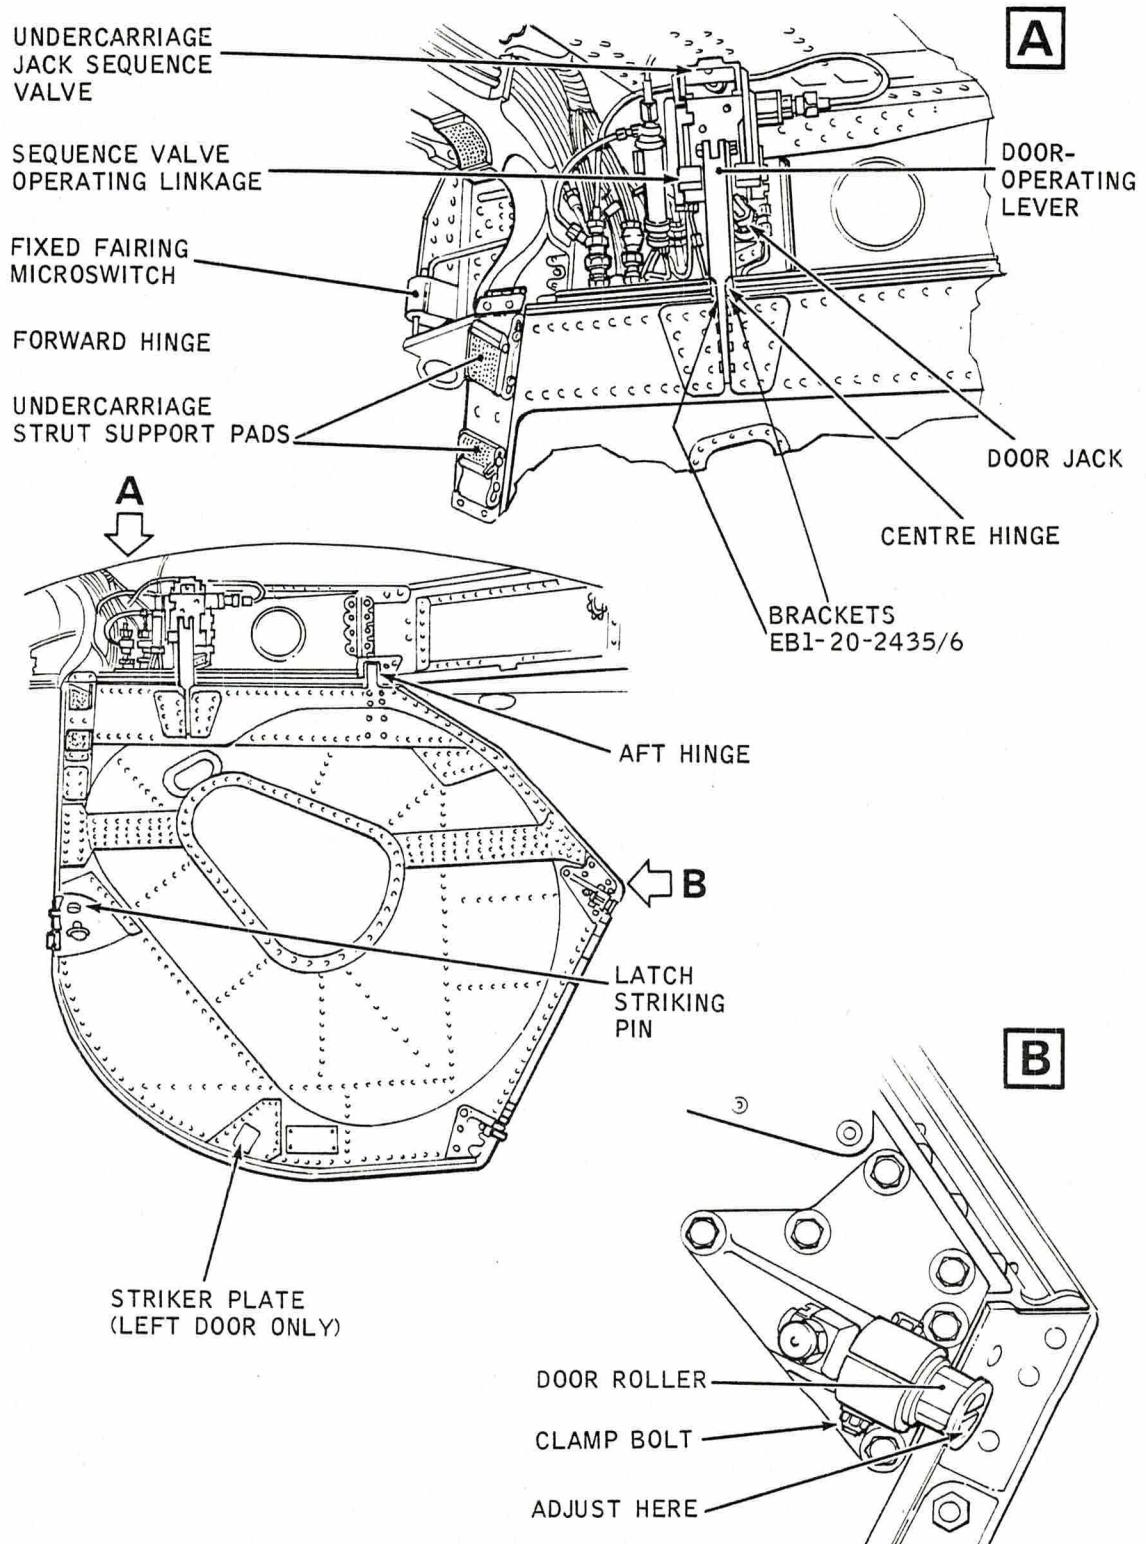
FIGURE 1

To replace a cracked bracket Part No. EB1-20-2435/6, operators should note that there is no access to the bolt head inside the box structure.

Locate and drill off the exposed portion of the two A25/2E bolts, drive the head and shank portion into the cavity. PRC 1422BT is to be than injected through the holes to trap the debris in the corner formed by the lever assembly Part No. EB2-20-3041/2.

The new bracket is to be attached to the channel members Part No. EB2-20-3041/2 using Jo-bolts (Avdel) 210/0803 or 210/0804 depending on whether or not the SP 13/E washer remains on the inside face of the channel member (to be checked). Bracket to lever assembly attachment to be by A60/4E shear bolts in lieu of A25/4E bolts, to provide clear clearance for the Jo-bolt heads. Holes in the new bracket to be reamed:-

0.25 DIA + 0005) to match existing  
+ 0002) holes.

NOTE: The anchoring fillet of PRC Sealant for the sharp edged bolts debris must be seen to have been effective (through the 0.25 in. dia. holes) and have had full curing time before assembling Jo-bolts finally.
