CHAP. 4 AIRFRAME S.P. 436 A.L. 1 SHEET 1 OF 1	SERVICING PROCEDURE F53 T55	BAC F53 & T55 (SA) 5A3A Section 1 2nd Edition
Rear Fuselage Skin Immediately Beneath Mainplane - Cracking		AFSC 43151
Safety and Servicing Notes are to be complied with throughout the work detailed on this card.		TIME EST

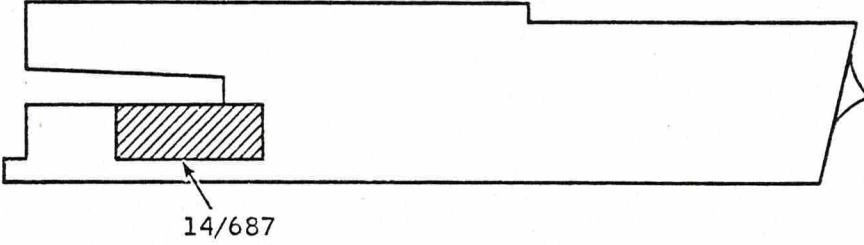
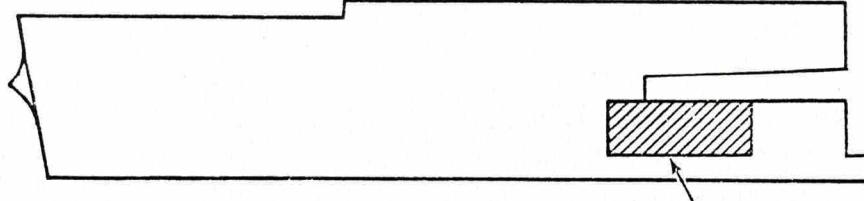
REAR FUSELAGE SKIN - CRACKING	
FIGURE 1

SPECIAL TOOLS AND EQUIPMENT	ASSOCIATED PROCEDURES
Ardrox dye penetrant kit.	
NOTE 1: Cracks found during this Servicing Procedure, not exceeding 0.5 in. in length, do not impose any restriction on aircraft provided that a close pattern of cracks do not link or line up in such a way to obviously affect the strength of the local structure.	
Isolated cracks up to 0.75 in. in length are also acceptable.	
NOTE 2: Cracks in excess of those quoted in NOTE 1, up to 3 inches in length, restrict flight of aircraft to a limit of 3g with fuel in ventral tank and 4g with ventral tank empty. These limitations are subject to continued inspection of cracks at each Post Flight Servicing (BPO).	
NOTE 3: Cracks in excess of 3 inches render aircraft unfit for flight until repair is carried out.	
<u>43151</u>

1. EXAMINATION	
1.1 Rear fuselage panels between Frames 34 and 44 (left and right) (14/687) (See Fig.1).	Look for cracks (Ardrox dye penetrant).
