CHAP. 4 AIRFRAME S.P. 445 A.L. SHEET 1 OF 3	SERVICING PROCEDURE F53 T55	BAC F53 & T55 (SA) 5A3A Section 1 2nd Edition
Lower Boom Angle at Frame 57 - Cracking		AFSC 43250 43151 53450
Safety and Servicing Notes are to be complied with throughout the work detailed on this card.		TIME EST
SPECIAL TOOLS AND EQUIPMENT Ardrox dye penetrant kit.		ASSOCIATED PROCEDURES SP 5 (P) 6 (P)
<u>43250</u>		
<p>1. PREPARATION</p> <p>1.1 No.1 reheat jet pipe. Remove (SP 5 (P)).</p>		
<u>43151</u>		
<p>2. PREPARATION</p> <p>2.1 Heat shields left and right (tailplane PFCU). Remove.</p>		
<p>3. EXAMINATION</p> <p>3.1 Frame 57 lower boom angle, Part No. EB2-11-10605 (See Fig.1). (i) Thoroughly clean visible surfaces. (ii) Look for cracks using Ardrox dye penetrant.</p>		
<u>53450</u>		
<p>NOTE: Item 4 is applicable only if cracks are found in Sub-item 3.1.</p>		
<p>4. RECTIFICATION</p> <p>4.1 Frame 57 lower boom angle, Part No. EB2-11-10605. Repair using drawing SRO/11/249.</p>

BAC F53 & T55 (SA)
5A3A Section 1
2nd Edition

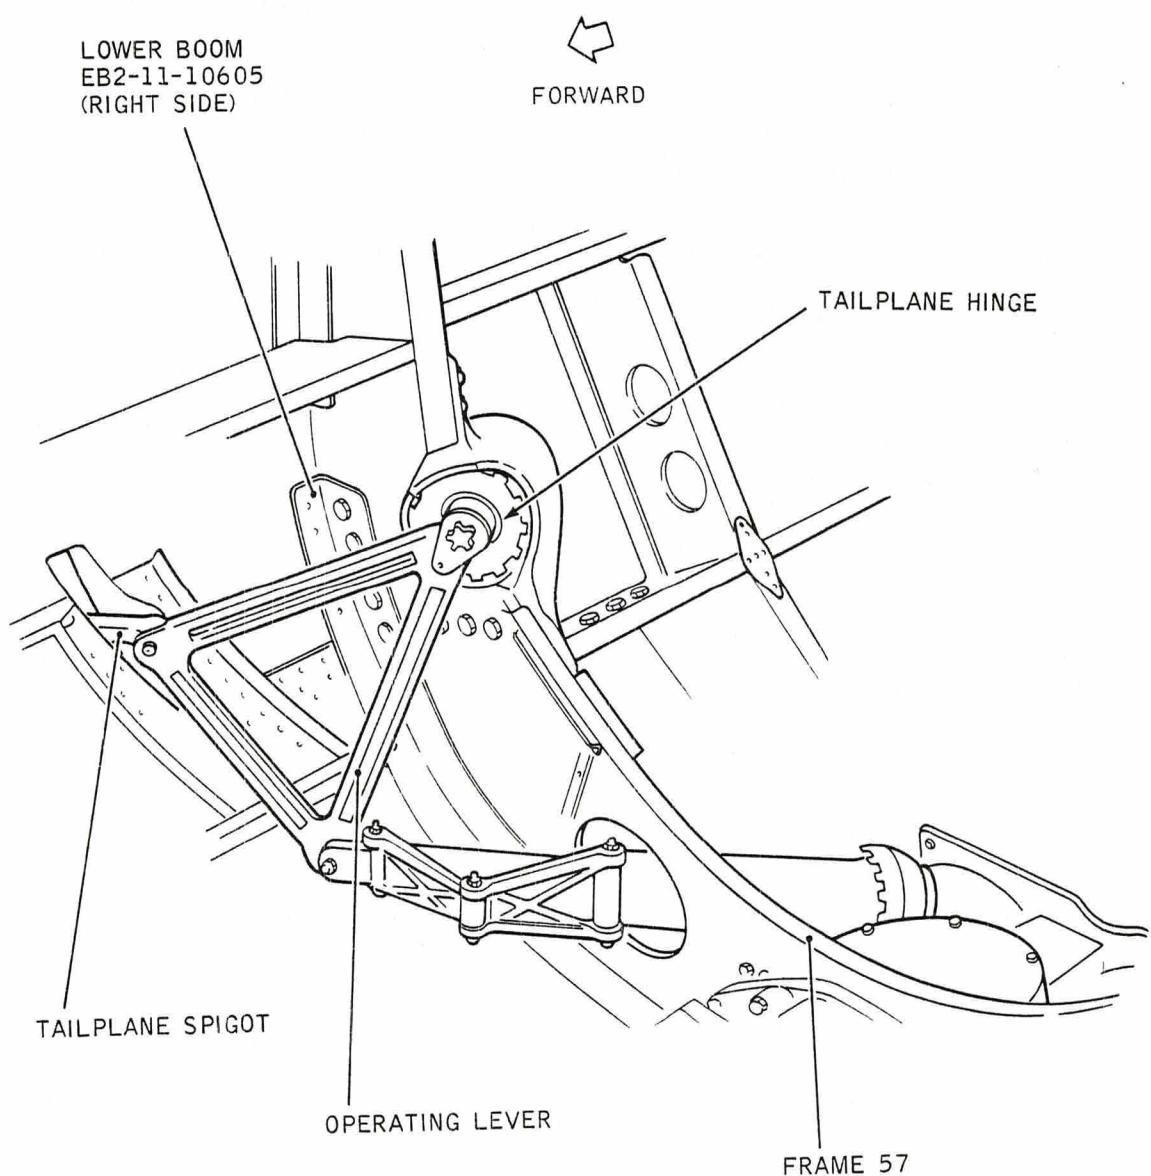
FIGURE 1

LOWER BOOM ANGLE CRACKING - FRAME 57
