CHAP 4 AIRFRAME SP 456 AL 10 SHEET 1 OF 3	SERVICING PROCEDURE F53 T55	BAC F53 & T55 (SA) 5A3A Section 1 2nd Edition
Left and Right Mainplanes Spar 4 Rib 7 Vertical Members - Cracking	AFSC 43151	TIME EST
Safety and Servicing Notes are to be complied with throughout the work detailed on this card.		
SPECIAL TOOLS AND EQUIPMENT		
Allen light probe kit, 5A/4310 containing:- Mirror, 1½ inch, 5A/4345579 Probe, flexible, 5A/9238375 Case, battery, 5A/4662049.		
<u>43151</u>		
<p>1. PREPARATION</p> <p>1.1 Mainplanes. Ensure defuelled.</p> <p>1.2 Access panel to No.4 D.C. fuel pump. Remove.</p> <p>NOTE: At item 2.1 where no crack is found no remedial action is required. The lengths and locations of all cracks found are to be reported (see NOTE below). Cracks are to be examined for propagation every 28 days and all instances reported.</p> <p>2. EXAMINATION</p> <p>2.1 Spar 4/Rib 7 junction, aft members Pt.Nos. EF3-20-225 (left) and EF3-20-226 (right) (MSL 010640 and 010738), (i) Examine for cracks, (see Fig.1). (ii) Measure lengths of cracks.</p> <p>NOTE: When replacing an aft vertical member as at item 3.1 examine the matching forward vertical member Pt. No. EF3-20-223 (left), EF3-20-224 (rig

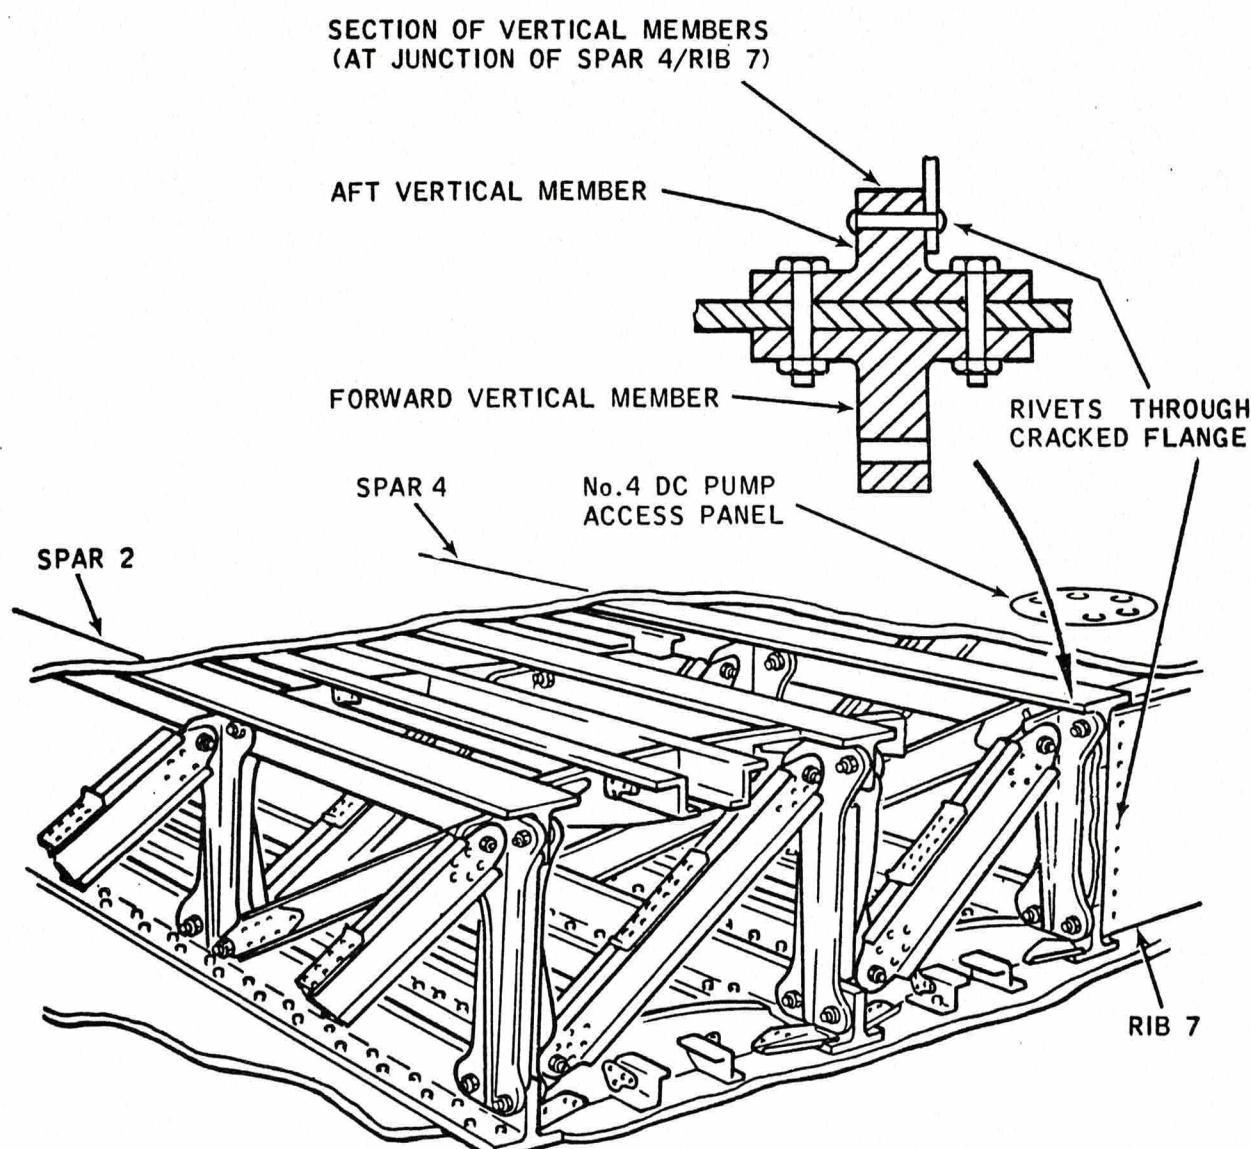
FIGURE 1

LEFT WING STRUCTURE, SPAR 4 RIB 7

3.1 Aft vertical member with crack exceeding 3.0 inches in length (i) Replace.
