CHAP 4 AIRFRAME	SERVICING PROCEDURE	BAC F53 & T55 (SA)
SP 457 AL 11	F53 T55	5A3A Section 1
SHEET 1 OF 3		2nd Edition
Mainplane Lower Skins. Left and Right in Area of Main Wheel Bay Cut-out/Spar 3/Ribs 8 and 9-Cracking		AFSC 43151 53650
Safety and Servicing Notes are to be complied with throughout the work detailed on this card.		TIME EST
SPECIAL TOOLS AND EQUIPMENT (See Appendix 1)		ASSOCIATED PROCEDURES TECH/NDT/ LTG/13
<u>43151</u>

CHAP 4	AIRFRAME	SERVICING PROCEDURE	BAC F53 & T55 (SA)
SP 457	AL 11	F53 T55	5A3A Section 1
SHEET 2 OF 3			2nd Edition

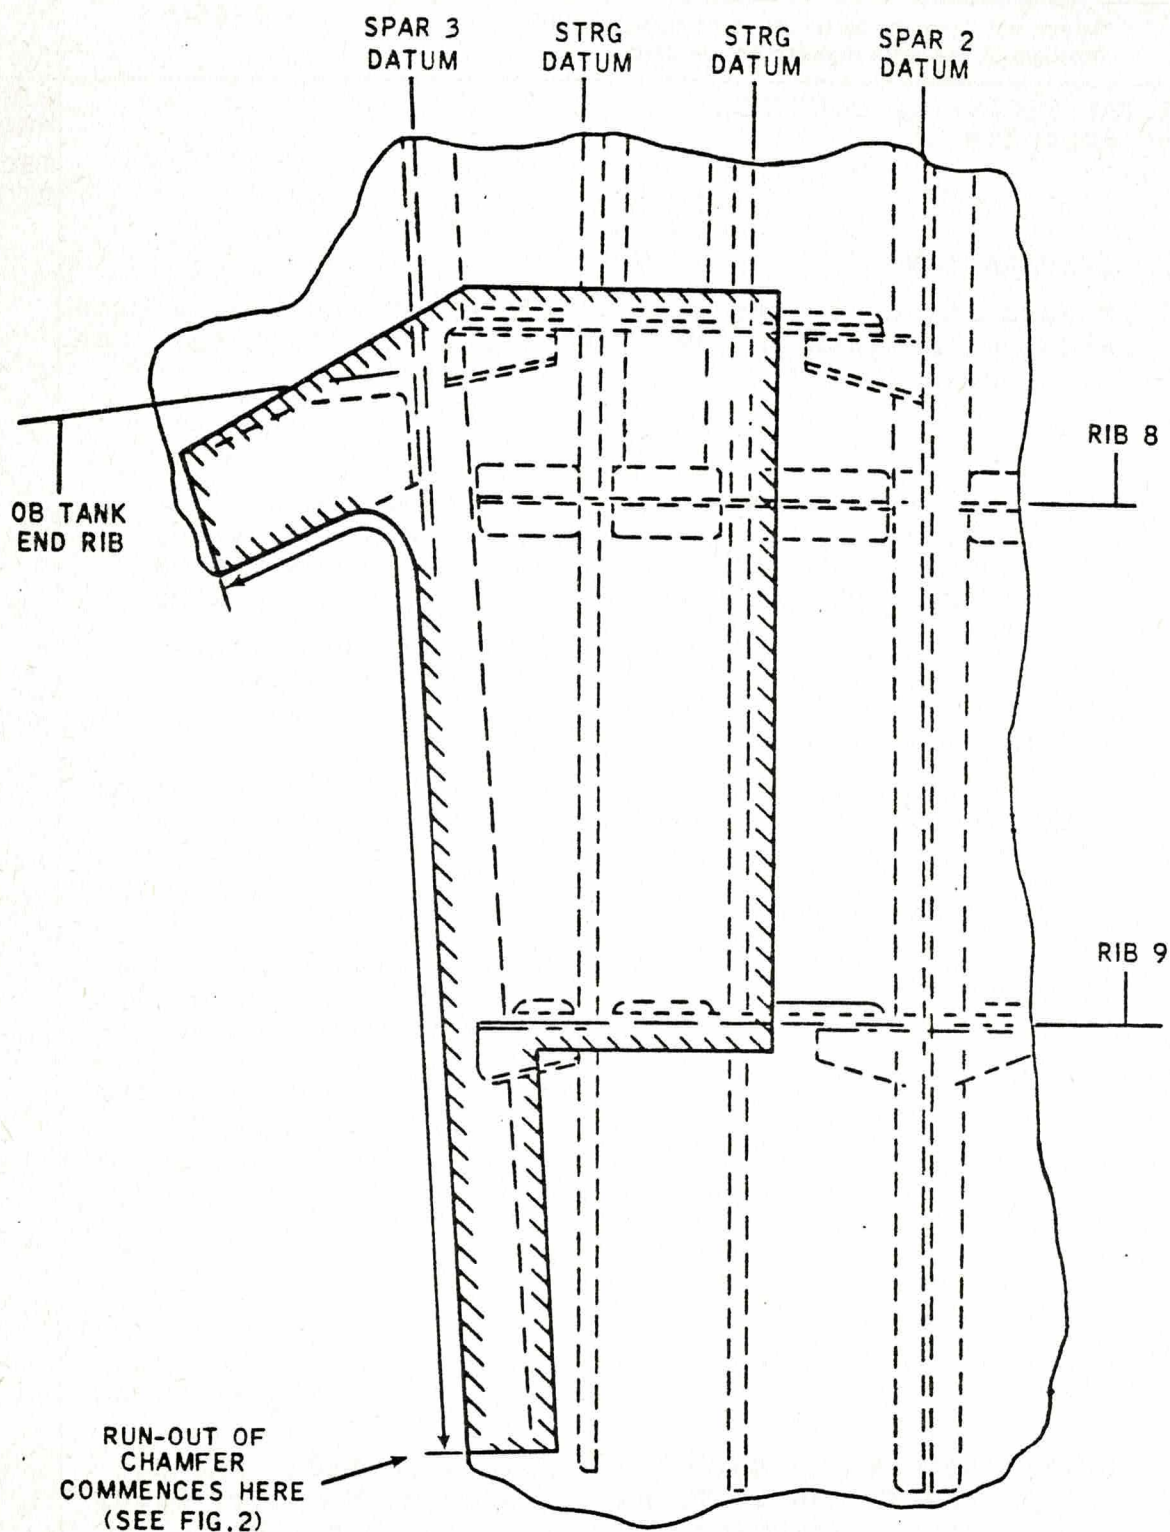
FIGURE 1

2. EXAMINATION		
2.1 Under surface of mainplanes.	Carry out NDT examination in accordance with Technique NDT/LTG/13	
3. EXAMINATION		
3.1 Under surface of mainplanes	Using a lamp and at least a 5x magnifier, visually examine for cracks in the skins particularly in the immediate vicinity of the bolt and rivet holes positions indicated in Fig.1	
<u>43151</u>

1. PREPARATION		
1.1 Undersurface of Left and Right mainplanes in the area shown in Fig.1.	Remove PRC and any external finish, and clean the area.	
<u>53650</u>		
NOTE: If, when carrying out Item 2, no crack originating at the skin edge is found, then, chamfer the left and right skin edges to the extent shown in Figure 2 if not already done. If any cracking is found retain the aircraft serviceable and report as detailed below.
