From: CENTRAL DEFECT AUTHORITY
 Ministry of Technology, St. Giles Court, St. Giles High Street, W.C.2.
 Tel. No. 01-636-3644, Ext.474

- (A) Servicing Instruction/Hunter/100A
Main Undercarriage Wheel Doors: Possibility of Jamming
- (B) Hunter Mk.4, 6, 7, 7a, 8, 9, 10, 11, & 12 Aircraft.
- (C) Reluctance of the main undercarriage to lower, on the first selection, (particularly after low level, high speed flight) has been experienced on a number of aircraft. The application of negative 'g' has, in most cases, enabled the undercarriage to be lowered satisfactorily. Provided the undercarriage hydraulic components are serviceable (covered under separate S.I. action), it is considered that the cause is attributable to either excessive backlash in the wheel door operating linkage or unsatisfactory adjustment or distortion of the wheel doors, causing a jamming effect on the wheel fairing door, particularly under the application of positive 'g'.

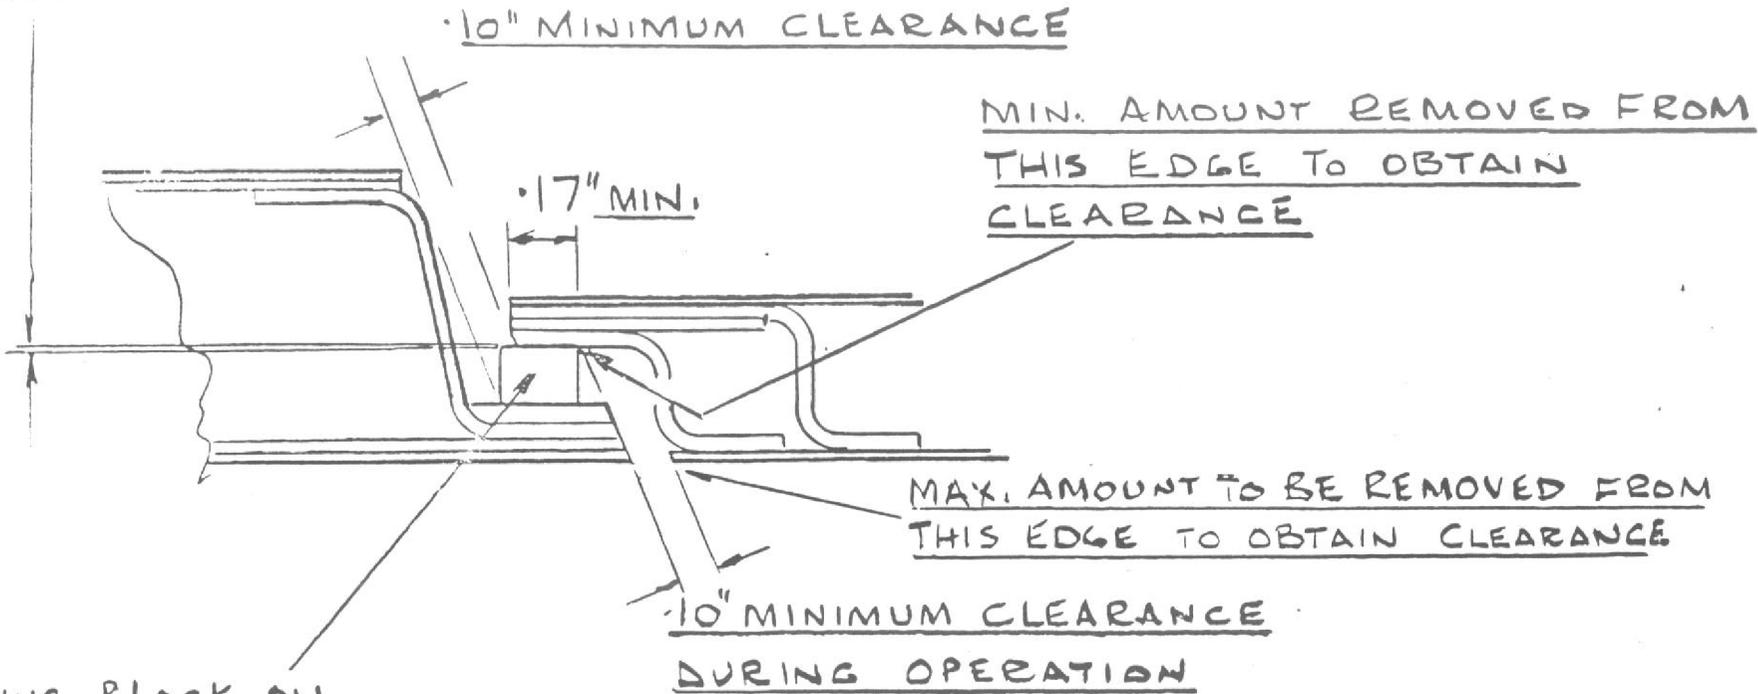
S.I / HUNTER / 100
WHEEL DOOR
ADJUSTMENTS.

- (j) Using Plasticine placed along the upper face of the packings on the wheel door lands, determine that with both wheel door and leg retracted, the packings on the wheel door lands contact (or nearly contact) the lands on the leg wheel fairing in at least three reasonably spaced positions along the edge of the wheel door. A maximum gap of 0.030 inch is permissible at these points (see attached sketch).

- (l) Determine, by use of Plastiline, that a ^{Maximum} maximum gap of 0.10 inches exists between the moving surfaces of the wheel door and the wheel fairing as shown in the attached sketch. Rectify as necessary.
- (m) Effect a full retraction test, disconnect the hydraulic rig, and remove the jacks.

GAP 'X'

- (k) Where the gap exceeds 0.03 inches, the packings on the wheel door lands are to be shimmed using a locally manufactured shim of L.72 of a suitable gauge or replaced by new items. Where the gap is caused by distortion of the wheel door, the door is to be replaced by a new item.
