29 March 1976

From: CENTRAL DEFECT AUTHORITY  
Procurement Executive, Ministry of Defence, St Giles Court, St Giles Hill, London WC2E 9JF  
Tel No: 01-632-6209

- A SI/HUNTER/126A  
(SUPERSEDING STI/HUNTER/397)  
TAIL UNIT: FIN: REAR ATTACHMENT FITTINGS: CRACKING
- B 1 Hunter, All Marks  
2 Hunter Fins Pt No D183036 (Reference 26FX/67); D207585 (Reference 26FX/7985); D223171 (Reference 26FX/9338); F222286; D232192; D281363; and D311880 held as spare or in store.

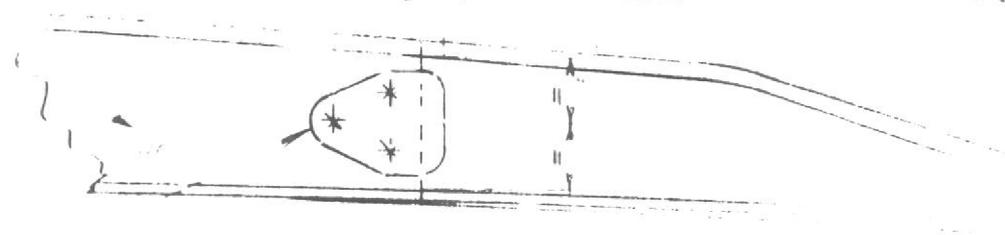
### SIDE VIEW OF TOP FAIRING - PORT

CUT LINE  
25" TYPICAL

7.3" TO 7.5" APPROX TO MATCH  
EXISTING CUT-OUT IN ATTACH  
FLANGE.

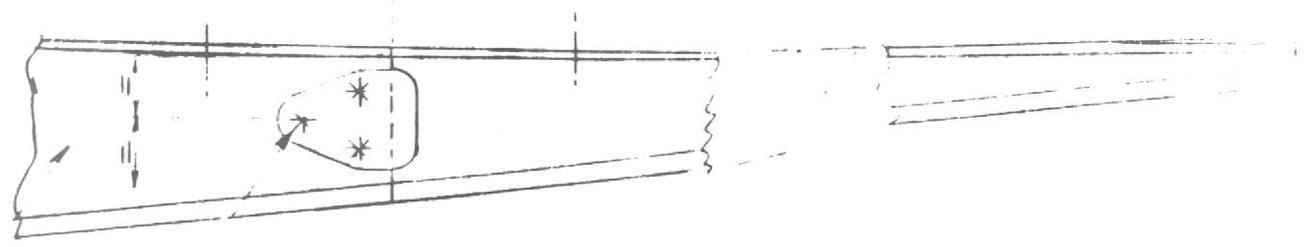
### SIDE VIEW OF BTM FAIRING - PORT

CUT LINE 11.50"

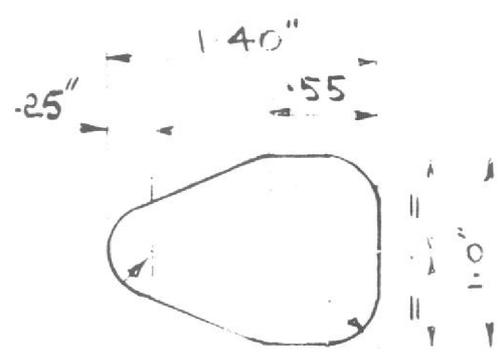
### DETAIL OF ITEM 1

MATL: 18 SW.G. STAINLESS STEEL SHEET 5520  
REF. NO: 30A/2515  
4 OFF PER AIRCRAFT. 10 OFF PER FAIRING  
SCALE: FULL SIZE.
