SI/Hunter/135

25 April 1973

A SI/HUNTER/135A  
 (SUPERSEDING SI/HUNTER/126D)  
 FIN REAR ATTACHMENT FITTINGS, CRACKING.

B 1 Hunter, all marks.

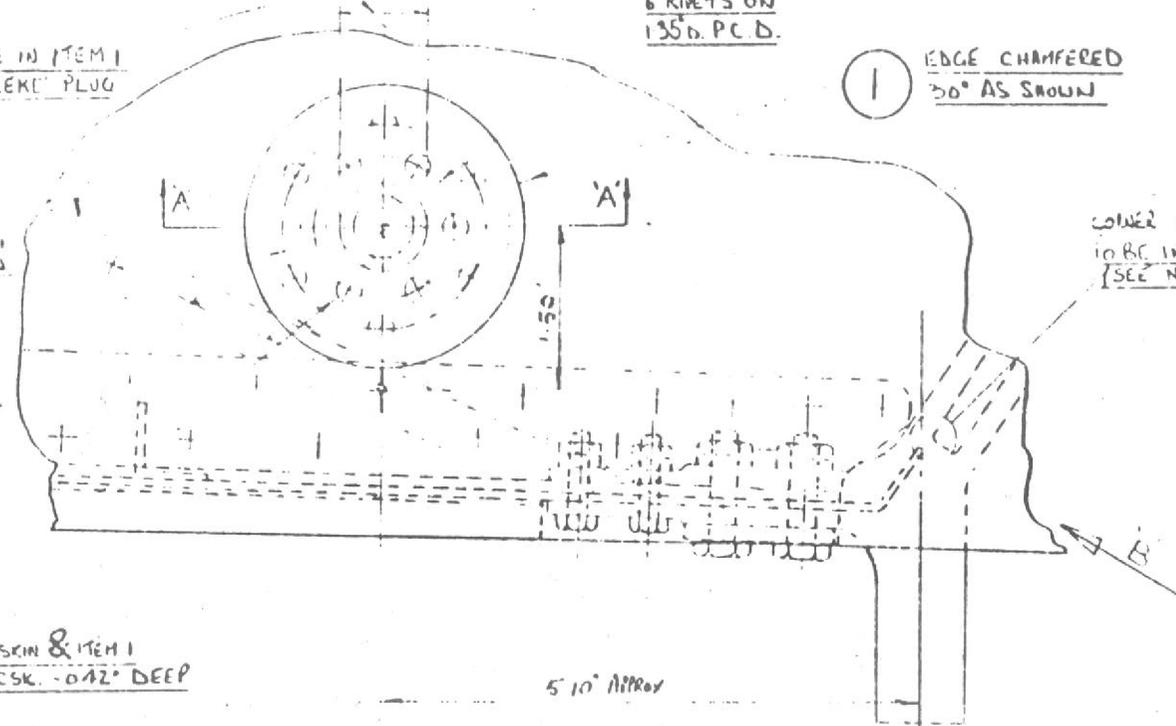
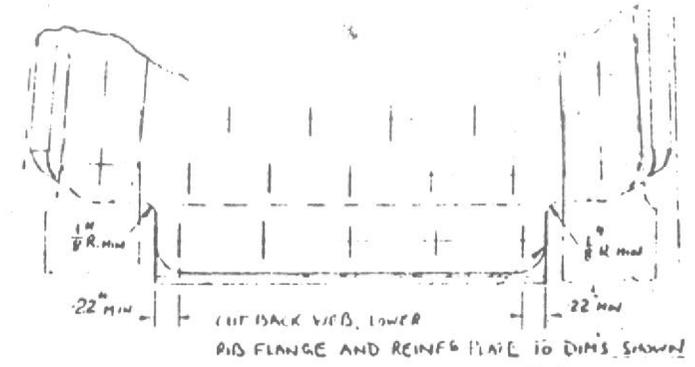
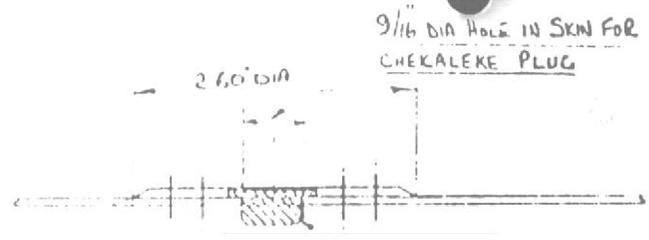
FIG 1  
SI/HUNTER/135

C Examination of fin rear attachment fittings has revealed cases of cracking,  
 due to fatigue, at the spar arms lower bolt holes and the inboard forward corner  
 of the fittings at the base of the slot in the rear spar fork. It has been  
 decided therefore to introduce periodic NDT examinations of the fittings.

CORNER OF REAR ATTACHMENT FITTING TO BE INSPECTED PORT & STBD. (SEE NOTE 1)

1. ACCESS HOLES ARE REQUIRED PORT & STBD SIDES FOR ENDSCOPE INSPECTION OF CORNERS OF REAR ATTACHMENT FITTINGS
2. NO ADHESIVE TO BE USED TO RETAIN CHEKALEKE PLUG.
3. FOR ALL FURTHER DETAILS SEE DRG. NO. D.281863

(1) Introduce inspection holes and reinforcing plates port  
 and starboard IAW HSA Sketch No E.44312 attached as Fig 1.

(2) Cut back web lower rib flange and reinforcing plate,  
 if required, to gain access for NDT examination. Scrap view on  
 sketch B.44312 refers.
