SI/HUNTER/137

From: CENTRAL DEFECT AUTHORITY

MAINPLANE: UNDERCARRIAGE PIVOT FITTINGS: CRACKING:

B. 1 Hunter all marks.

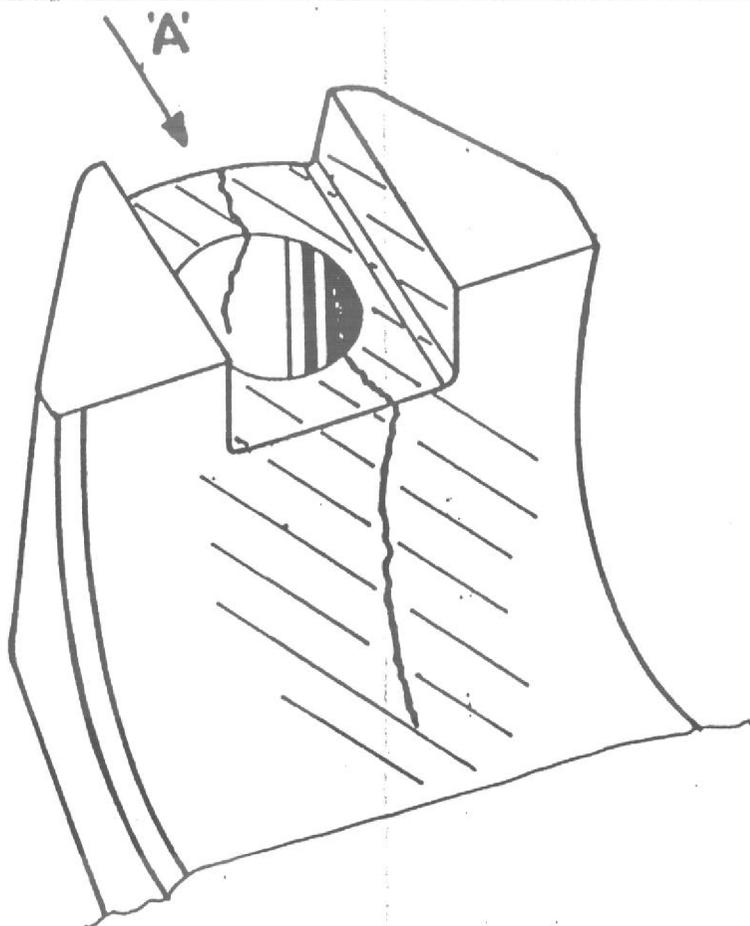
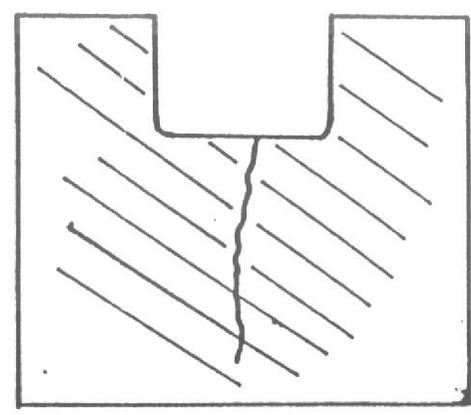
FIG 1

C. Further cases of undercarriage pivot fittings cracking have been reported since complying with STI/HUNTER/375, additionally a case of a bearing cap failure has been reported. STI/HUNTER/419 was raised to deal with the pivot fitting but not proceeded with. R.E.I 852 was raised to check the bearing caps but was never issued. This instruction introduces regular checks on both items.

(5) Check the Bearing Caps for cracks using CSDE/TECHNIQUE PFD6 (AP119A-20003-1)(RAF), NATEC/HUNTER/DYE PENETRANT/No 1 (RN) in the areas indicated in fig 1 attached.

AREA SUBJECT TO
STRESS CORROSION CRACKS
TO BE INSPECTED USING
DYE PENETRANT

(7) Renew any Caps or Fittings found cracked.

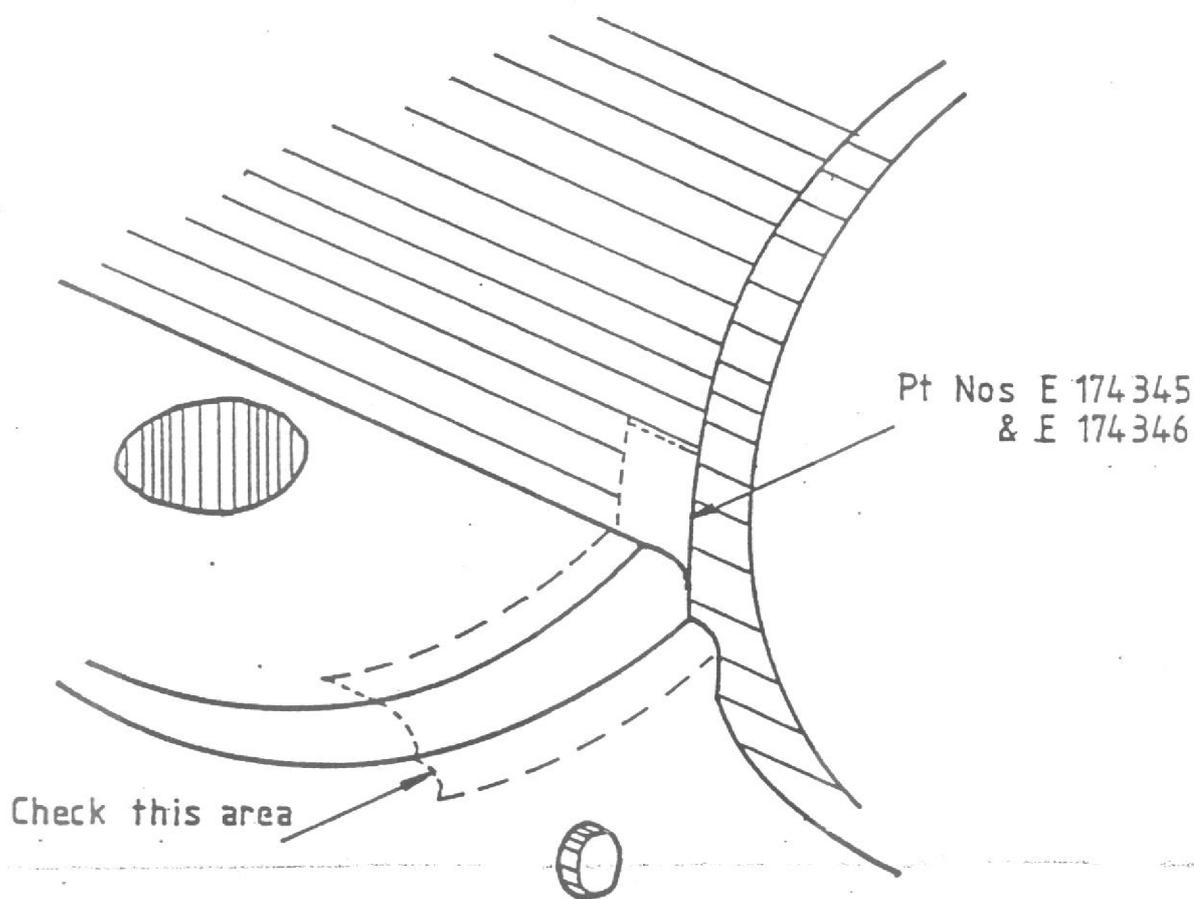
Fig 2

(6) Check the Pivot fittings for cracks using CSDE/TECHNIQUE PFD6 (AP119A-20003-1)(RAF), NATEC/HUNTER/DYE PENETRANT/No 1 (RN) in the areas indicated in fig 2 attached.

Port inboard drawn,
outboard opp hand,
Stbd opposite.
