ADP No HUU 1380C
SI/HUNTER/138C
31 August 1983

A SI/HUNTER/138C
NOSE UNDERCARRIAGE: PIVOT BRACKET: FRETTING IN PIVOT PIN BORE

SERVICING INSTRUCTION/HUNTER/138C

NOSE UNDERCARRIAGE : PIVOT BRACKET : FRETTING IN PVIOT PIN BORE

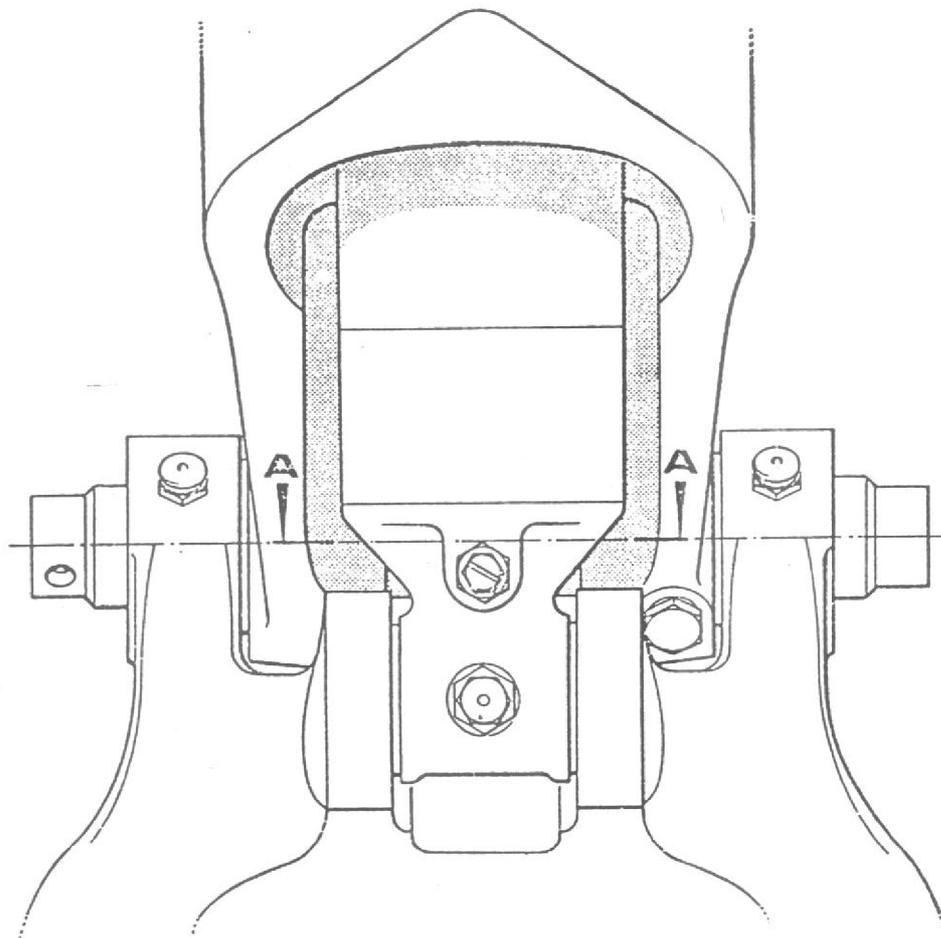
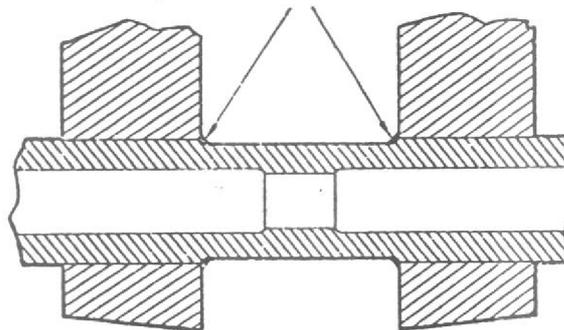
FIGURE 1 APPLICATION OF SEALANT

SEALING COMPOUND
TO FORM FILLETS 0.0625 MIN.

PART SECTION **A - A**

"(6) Ensure areas to be sealed are free from grease and produce a fillet of sealant PR1422 on the inner faces of wheel fork as shown on Figure 1 (attached)"
- 5 Fig 1: Attach new Fig 1 at rear of Instruction.
- 6 Insert vertical marginal lines against the amendments introduced by this Instruction.
