Servicing Instruction/Hunter/53B.

Empty Case Chutes, Inboard and Outboard: Inner Welded Seams - Opening.

Servicing Instruction/Hunter/53A.

SI/HUNTER/53B
INBOARD CASE CHUTE REINFORCED.

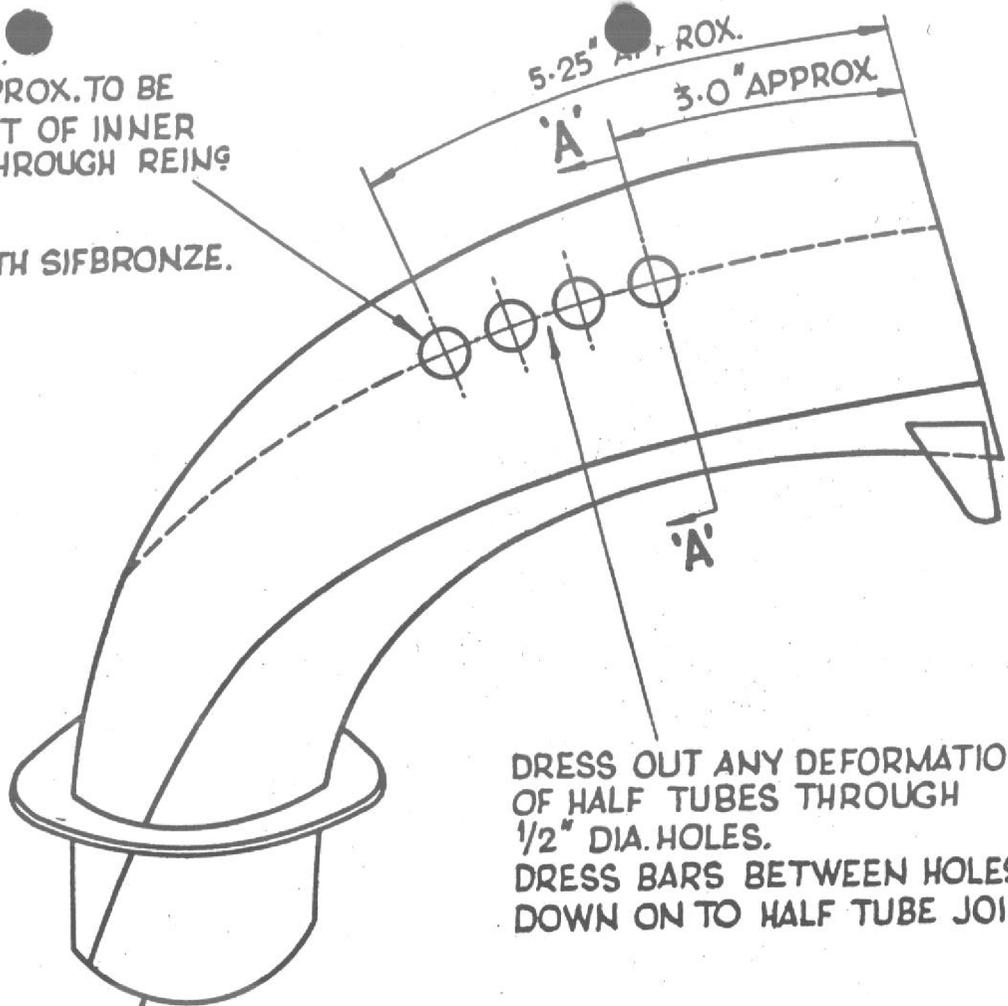
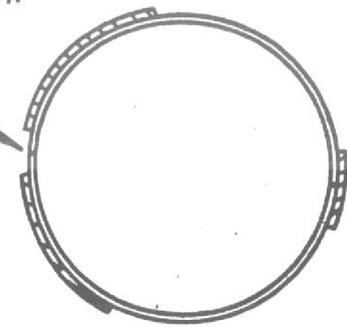
A. SK. NO 28725.

- (A) Servicing Instruction/Hunter/53
Empty Case Chutes, Inboard and Outboard: Inner Welded Seams : Opening.
- (B) Hunter Mk.1, 2, 4, 5, and 6 aircraft with Mods. 645 and 646 embodied.
- (C) Cases reported of internal welded seam opening between weld points, leaving depression which is suspected of causing case pile up with possibility of guns jamming.
- (D) 1. Within 7 days of receipt of this Instruction and subsequently after each gun firing sortie, proceed as follows:-
- (a) Lower the Radio Access Doors and check that the unwelded portion of the internal seam in the inboard and outboard case chutes has not opened out.
- (b) Where the seam has opened out the chute is to be removed and a new replacement chute to Issue 2 standard, fitted.

1. Para.(D)1(b). After this sub-paragraph add the following:-
"Alternatively, defective chutes may be repaired in accordance with the attached sketch, and re-fitted."

HOLES 1/2" DIA.
 SPACING APPROX. TO BE
 OF JOINT OF INNER
 TUBES THROUGH REINFORCING

HOLES WITH SIFBRONZE.

DRESS OUT ANY DEFORMATION
 OF HALF TUBES THROUGH
 1/2" DIA. HOLES.
 DRESS BARS BETWEEN HOLES
 DOWN ON TO HALF TUBE JOINT.

HOLES THROUGH
 REINFORCING ONLY.

CLEAN OFF
 INSIDE.
