(A) SERVICING INSTRUCTION/HUNTER/71AB

RUDDER CONTROLS IN FRONT FUSelage: MOUNTING FOR INBOARD BEARING
LEVER B.183970 - FORWARD ANGLE CRACKED

- (B) Hunter Mk. 4, 6, 9 and 10 aircraft.
- (C) A number of Mark 6 aircraft returned to the Contractor for conversion to Mark 9 were found with angle P.183898 cracked. Cracks started at the lower end close to the edge of the profile washer and extended in some cases to more than half the length of the angle.

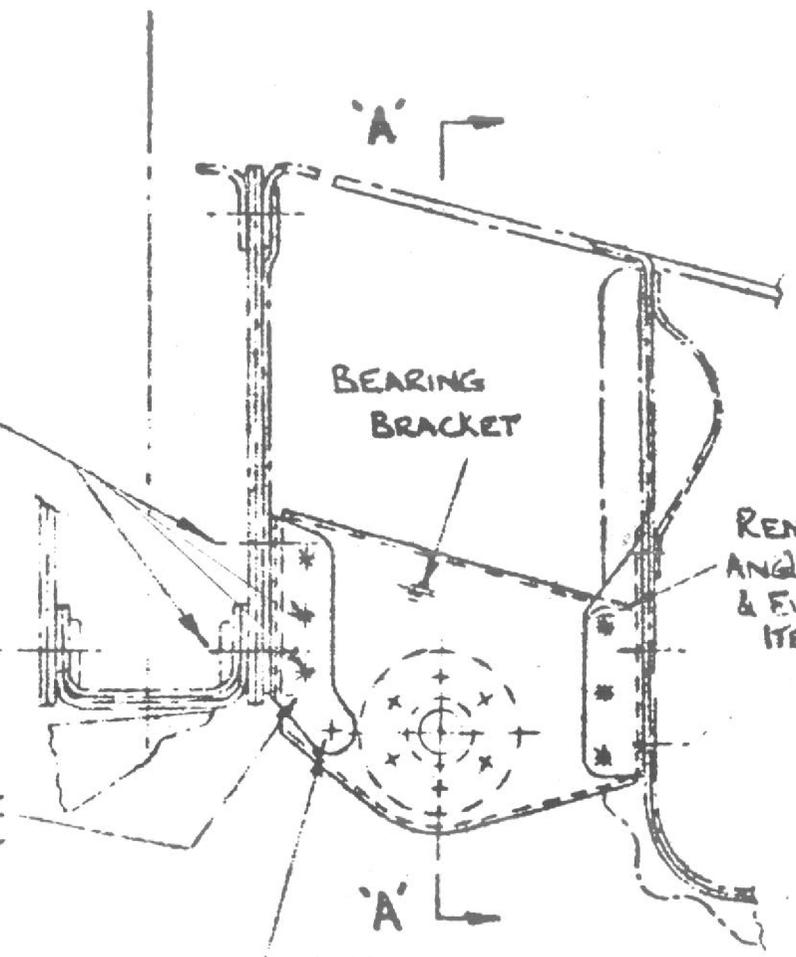
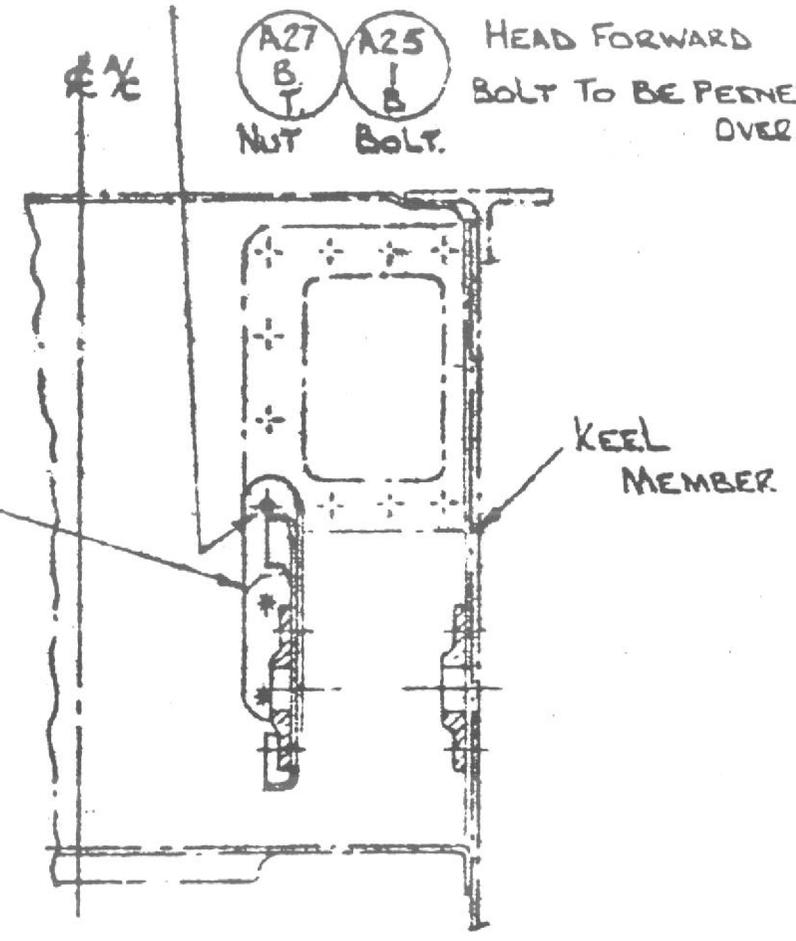
SKETCH N° 1

LEADS FORWARD.
EXISTING PROFILE
& UNDER NUTS

EXISTING ANGLE
F183898 AND FIT
ANGLE ITEM 1.
* AS156-505

REMOVE EXISTING
ANGLE PT N° F181881
& FIT NEW ANGLE
ITEM 2.

to the following:- "Drill out the three
1/8" Dia. rivets and open holes to Morse No. 25
Replace with:-"

REPLACE WITH:-

- A25 BOLT
1 OFF
- A25 BOLT
1 OFF
- A27 NUT
2 OFF

- A27 B NUT
- A25 I B BOLT
- HEAD FORWARD
BOLT TO BE PERINED
OVER.

DRILL ADDITIONAL HOLE
MORSE N° 21 IN BEARING BRKT
TO MATCH ANGLE.
RIVET + AS156-505
