5th January, 1962.

CLASS 'B'

- (A) Servicing Instruction/Hunter/74A.
Starboard Instrument Panel : Chafing of Rigid Pipes
- (B) Hunter Mk. 7 and 8 aircraft *Post Mod 779*
- (C) It has been reported that on some aircraft there has been inadequate clearance between the rigid pitot-static pipes from airspeed indicator to machmeter and the body of a Plessey plug to camera recorder on the starboard G.G.S. This has resulted in serious chafing of pitot system pipes with possible failure of system. This is considered due to deformation of pipes during the removal or change of an instrument.

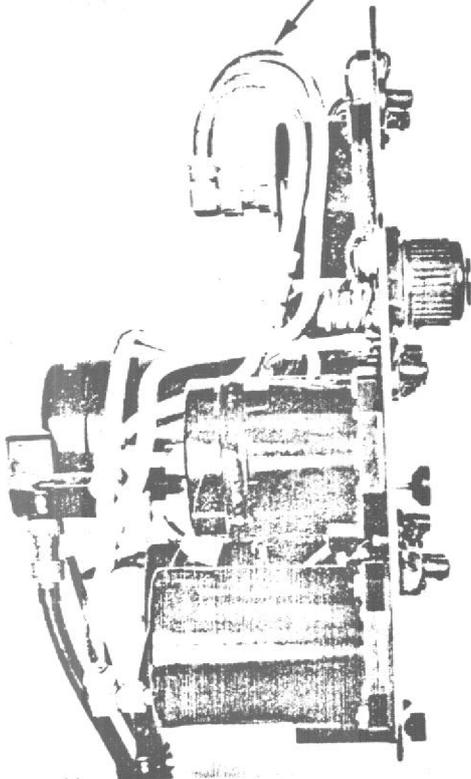
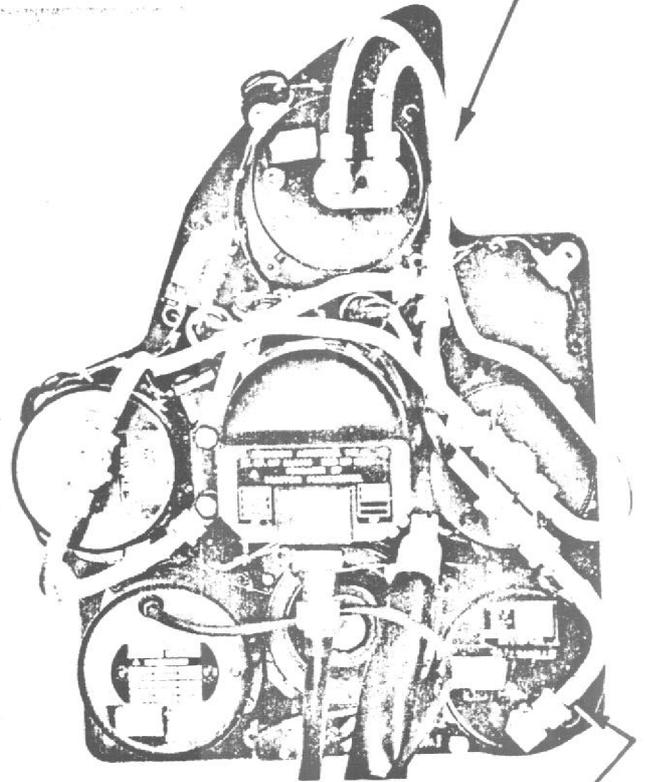
S.I./HUNTER/74

ENSURE THAT THESE PIPES ARE
POSITIONED AS SHOWN AND DO
NOT PROJECT BEYOND THE BOUNDARY
OF THE PANEL

ALL PIPES TO ENTER STRAIGHT
AND AT RIGHT ANGLES TO CONNECTIONS

- (a) Remove pilot's starboard instrument panel.
 - (b) Check pitot and static pipes from airspeed indicator for signs of chafing. Renew pipes where necessary, and ensure that the pipe runs conform to the attached photograph.

NOTE:- PANELS TO BE CHECKED TO THIS
STANDARD AFTER ANY REMOVAL
OR CHANGE OF INSTRUMENTS
