- (A) Servicing Instruction/Hunter/77A
(Cancelling STI/Hunter/131):
Main Undercarriage: Maxaret and Recuperator Return
Pipes - Identification.
- (B) 1. Hunter Mk.4, 6, 7, 8, 9, 10, 11 aircraft embodying
MODS. 197 and 198.

MAIN UNDERCARRIAGE
MAXARET AND RECUPERATOR
RETURN PIPES
IDENTIFICATION

S.I./HUNTER/77

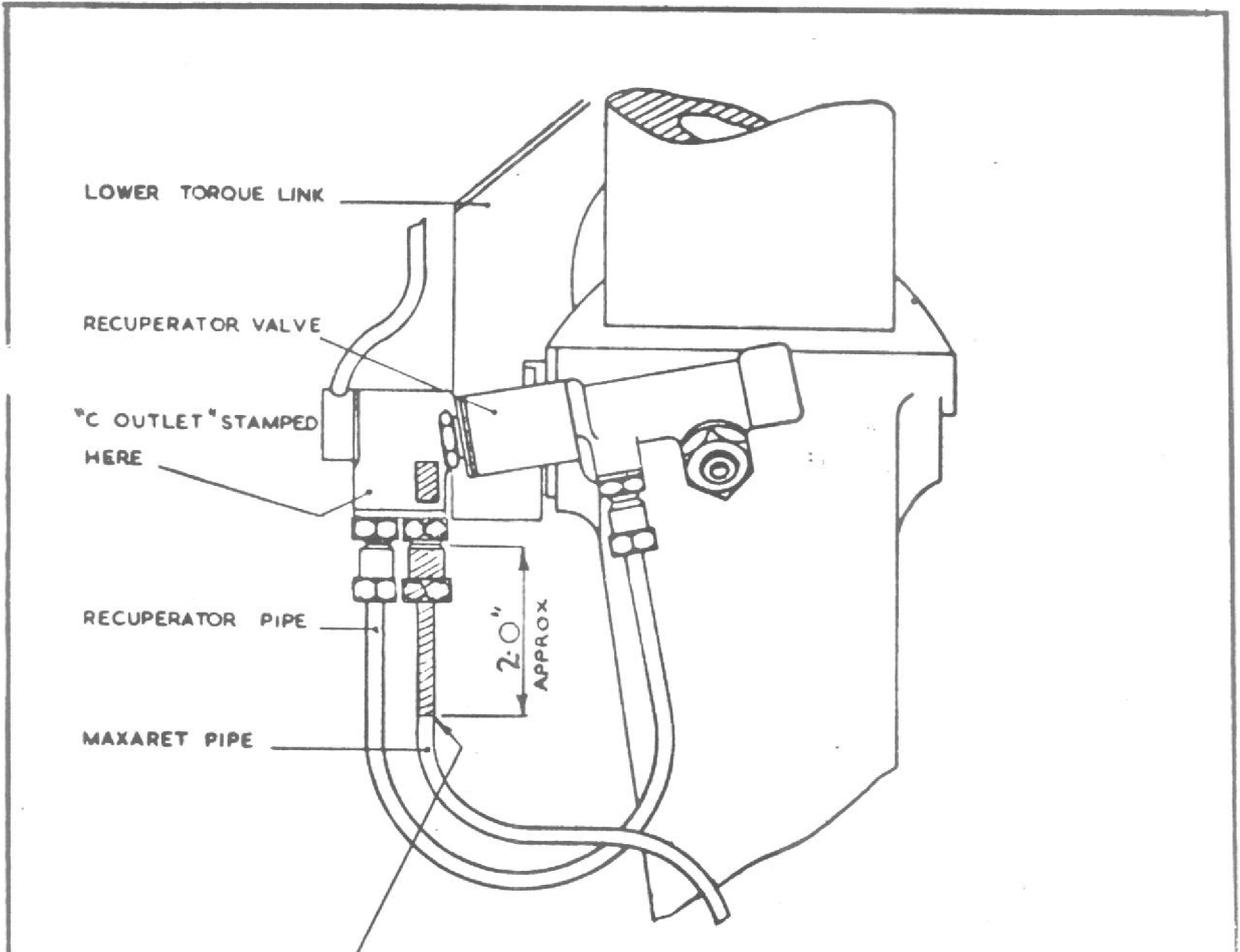
- (C) Cases reported of colour identification of Maxaret
unit pipes introduced by S.T.I./Hunter 131 becoming
obliterated or non-existent due to replacement of
items.

AREA SHOWN SHADED
TO BE PAINTED WITH
GOLDEN YELLOW PAINT
REF N° 33A/~~106814~~ 9106814

- (a) Referring to the attached sketch, check that the recuperator pipe line is connected to the outer connection adjacent to the lower torque link.
- (b) Check that the Maxaret pipe shown, is connected at its lower end to the forward of the two adjacent connections on the Maxaret unit. This connection is shorter and lower than the other.
- (c) Pipelines incorrectly connected are to be rectified ensuring that the pipelines are fully primed before reconnection.
- (d) Colour code both ends of the Maxaret return pipe and its end fittings using Golden Yellow paint Ref. 33A/406874, and similarly paint the Maxaret unit and swivel coupling in the immediate vicinity of their connection with the lower and upper end of the Maxaret return pipe.
