TAIL PLANE

Repair of damage affecting the spar flange and bottom skin of the tail plane

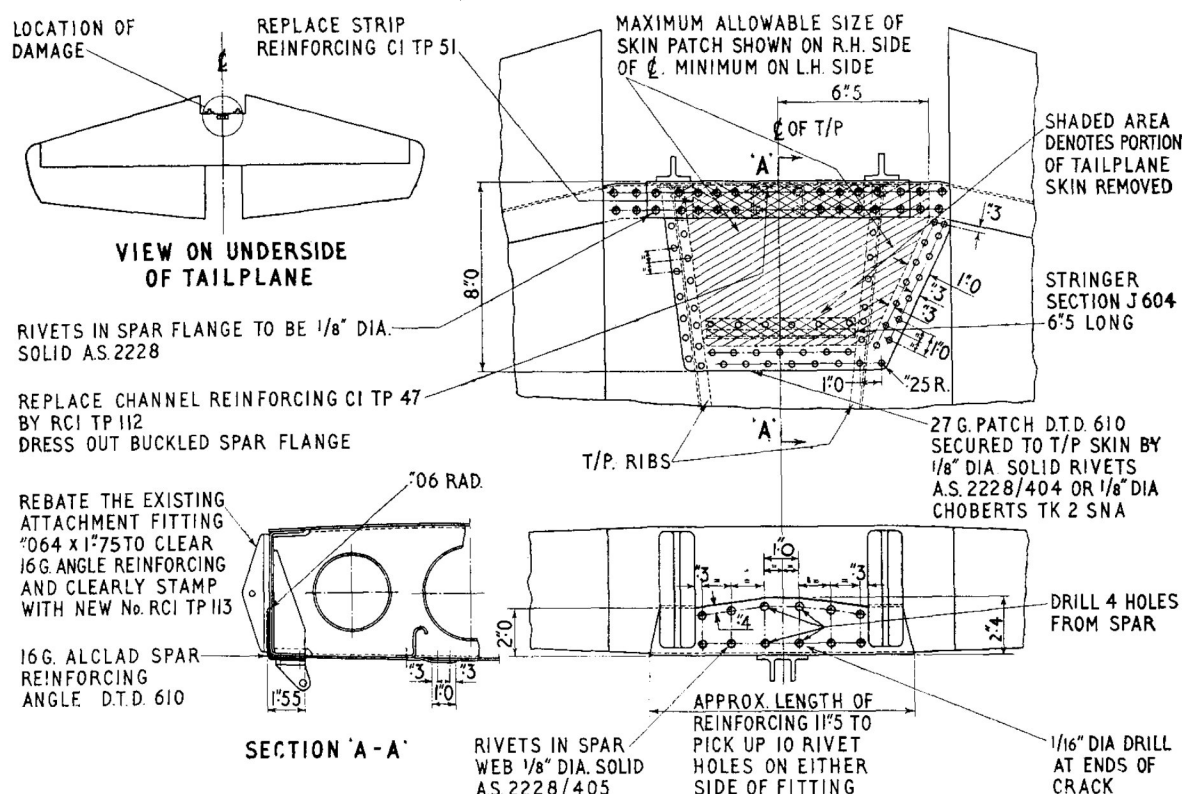
FIG. 1. METHOD OF REPAIR

As a consequence of a heavy landing or bad handling the failure of the compression member attachment to the tailplane front spar may occur.

1. The damage, totally torn skin and buckled flange of the spar, should be repaired as follows:—

- (1) Cut away skin where shown cross hatched on fig. 1.
- (2) Remove channel reinforcing from spar and unrevet 'V' brace from the ribs.
- (3) Dress out buckled flange of spar and inspect carefully for cracks or other damage; this may consist of a crack along the bend of the flange or tears at the bolt holes. Repairable damage must not exceed 2 in. on either side of the centre line of the tail-plane. All cracks must be drilled at extremities.
- (4) Remove tail-plane attachment brackets and modify the fitting as shown at the bottom left corner of fig. 1. Part number 'R.C1.TP.113' must be stamped upon the attachment fitting after this alteration.
- (5) Fit new channel reinforcement, R.C1

- (7) Repair skin with patch as illustrated. Locate stringer section J.604 and rivet to skin patch.
- (8) Make up spar reinforcing angle. Mark off rivet holes from spar and drill.

- (9) Offer up spar reinforcing angle to overlap skin patch and rivet to spar flange. Lift up skin to afford entrance for the dolly. This will not be necessary where there is an inspection hole available in top skin.

- (10) Position plates C1.TP.183 inside reinforcing channel, after drilling them for the two holding rivets as shown, so that they match up to existing 2 B.A. bolt holes. Secure each with two $\frac{1}{8}$ in. dia. rivets through channel spar and reinforcing angle, countersinking on the outside. This is a precautionary measure to facilitate easy replacement in the event of the thread stripping on a holding nut.

- (11) Drill and rivet angle to front of spar face.
- (12) Mark off additional holes in skin patch and drill and rivet, using Chobert rivets if necessary.
