REPAIR TO STRINGER ATTACHMENT BRACKETS - FORWARD FACE, REAR PRESSURE BULKHEAD, STATION 204F.

1. This repair is applicable to Vulcan B.Mk.1, Mk.1A and Mk.2 aircraft.

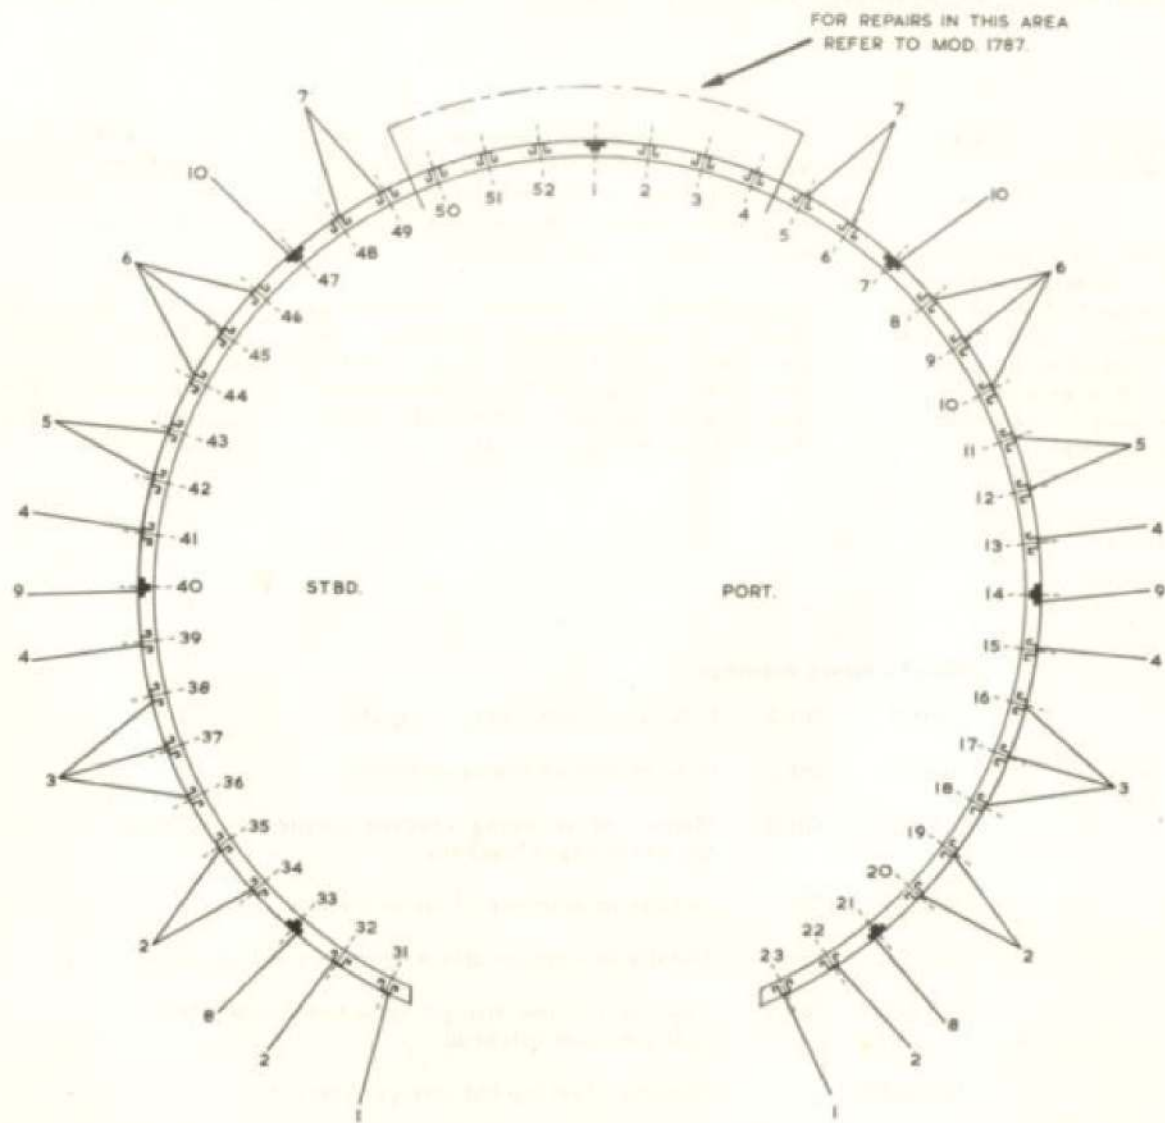
Fig.1. Rear pressure bulkhead, station 204F- forward face

2. This repair calls for the renewal of all cracked, corroded, or damaged stringer attachment brackets on the forward face of the rear pressure bulkhead at station 204F, that are outside the tolerances quoted in Repair Leaflet A.1/3. It is essential that new brackets, manufactured from aluminium alloy only, be used for renewal.

6. The original magnesium alloy stringer attachment brackets, together with their stringer positions and new aluminium alloy stringer attachment brackets are given in the Key to Fig.1 of this leaflet.
