GROUP B FUSELAGE

LIST OF CONTENTS

FUSELAGE

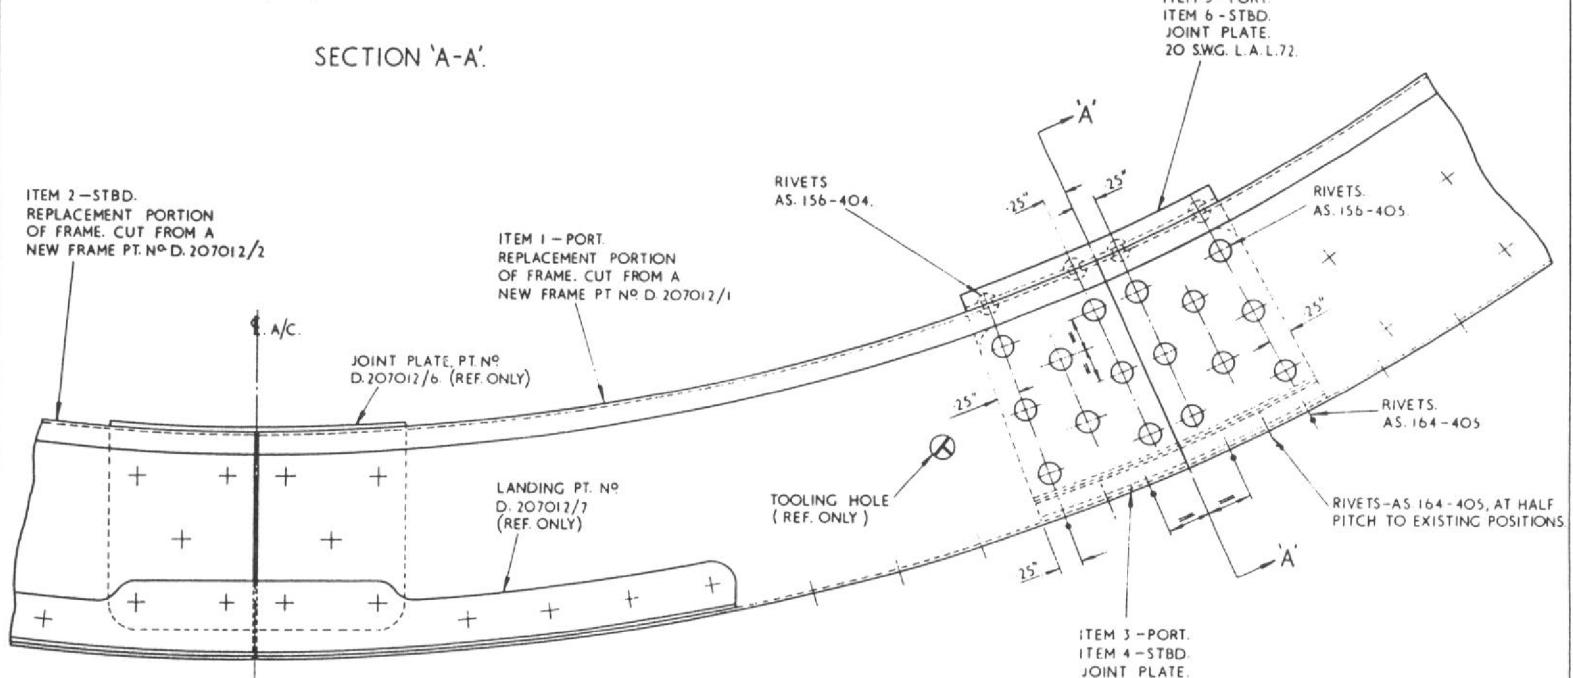
REPAIR TO BASE OF FRAME 2

1. This repair may be made in conjunction with the renewals listed in Repair Leaflet B.1/1. Reference should be made to the following repair drawing which is included with this leaflet:-

- (2) From a new frame, cut the replacement portions (items 1 and 2).
- (3) From 20 s.w.g. L.A. L.72, make the joint plates (items 3-6).
- (4) Offer up replacement portions of frame, joint plates, landing Part No. D.207012 item 7 and joint plate Part No. D.207012 item 6. Drill holes and insert the appropriate rivets.

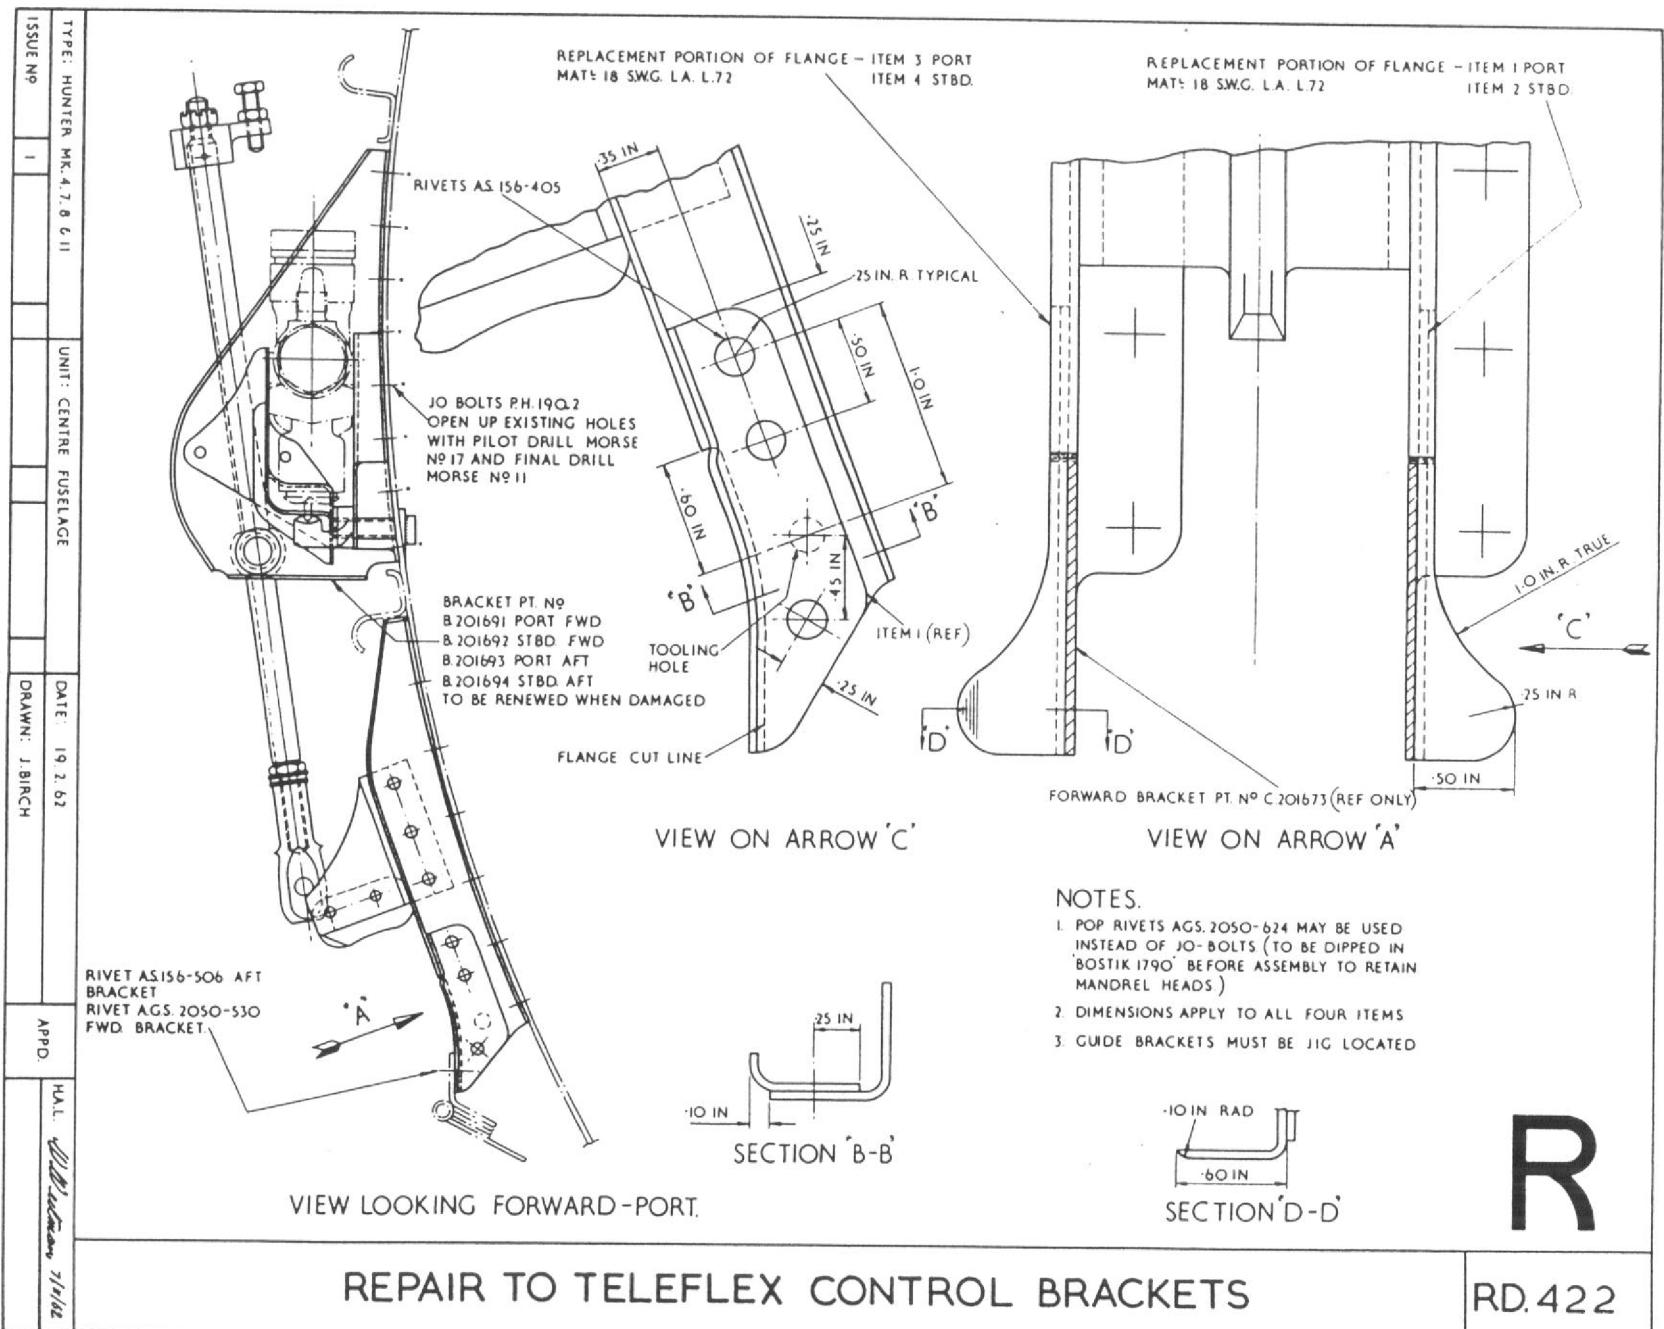
RD.422 - REPAIR TO TELEFLEX
CONTROL BRACKETS

1. Where damage has been sustained to teleflex control brackets by collision with the safety barrier, the repair or renewal may be carried out as shown in this leaflet. The lower brackets may be repaired, while the upper brackets should be renewed. The following repair drawing is included with this leaflet:-

- (1) Remove all services which will be in way of repair, discarding parts which are found to be damaged.
- (2) Drill out all rivets attaching upper brackets to fuselage.
- (3) Open up existing holes with pilot drill morse number 17 and final drill morse number 11.
- (4) Offer up new upper brackets and secure with Jo-bolts PH.190/2 or alternatively pop rivets A.G.S.2050/624 may be used.
- (5) Cut away damaged portion of lower brackets as shown on RD.422.
- (6) From 18 s.w.g. light alloy to specification L.72 manufacture replacement portion of flanges.
- (7) Offer up replacement portion of flanges, drill and rivet in position.
- (8) Insert appropriate rivets to secure lower control brackets to undercarriage wheel door hinge mounting angle.
- (9) Replace, or if necessary renew all services previously removed.

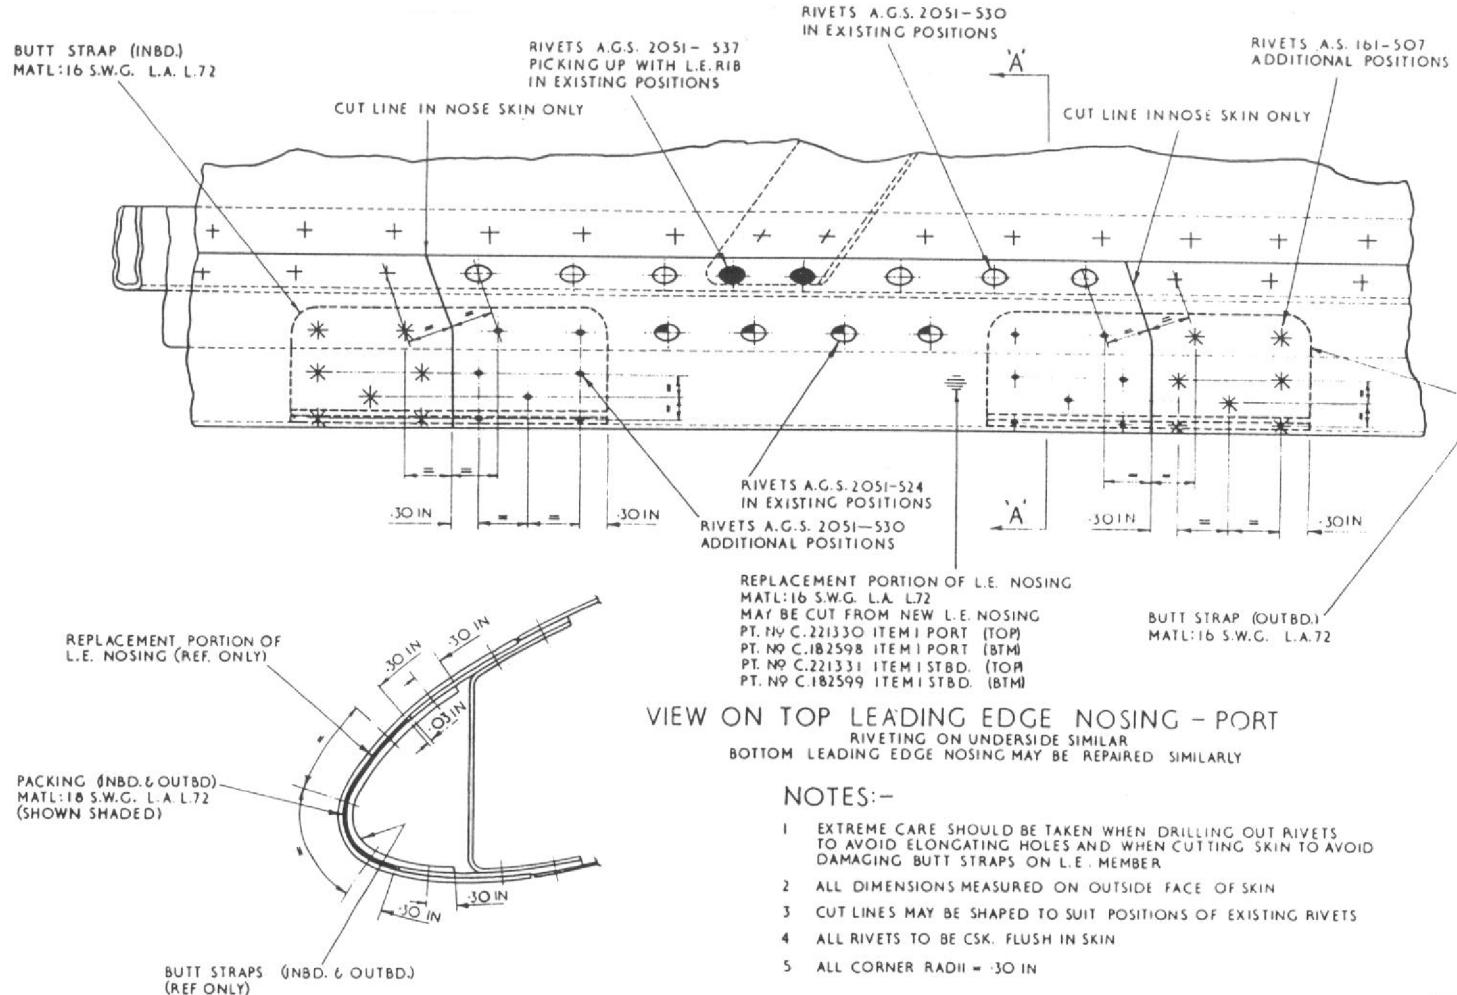
1. Where damage has occurred to the top or bottom leading edge nosing of the port or starboard stub wing they may be repaired as shown in this leaflet. The following repair drawing is included with this leaflet:-

- (1) Drill out the necessary rivets to enable the damaged portion of the nosing to be cut out.
- (2) Cut out the damaged portion of nosing as shown in RD.430, great care should be taken to ensure that no damage is caused to the existing butt straps.
- (3) Remove the remaining shank of the rivet (See note).

- (4) Manufacture outboard and inboard packings from 18 s.w.g. light alloy to specification L.72 and shape to contour.
- (5) Manufacture outboard and inboard butt straps from 16 s.w.g. to specification L.72 and shape to contour.
- (6) Offer up butt straps and packings to existing portion of leading edge nosing, drill holes and insert appropriate rivets.
- (7) From new nosing as called up on RD.430 cut replacement portion of nosing.
- (8) Offer up replacement portion of nosing drill holes and insert the appropriate rivets.

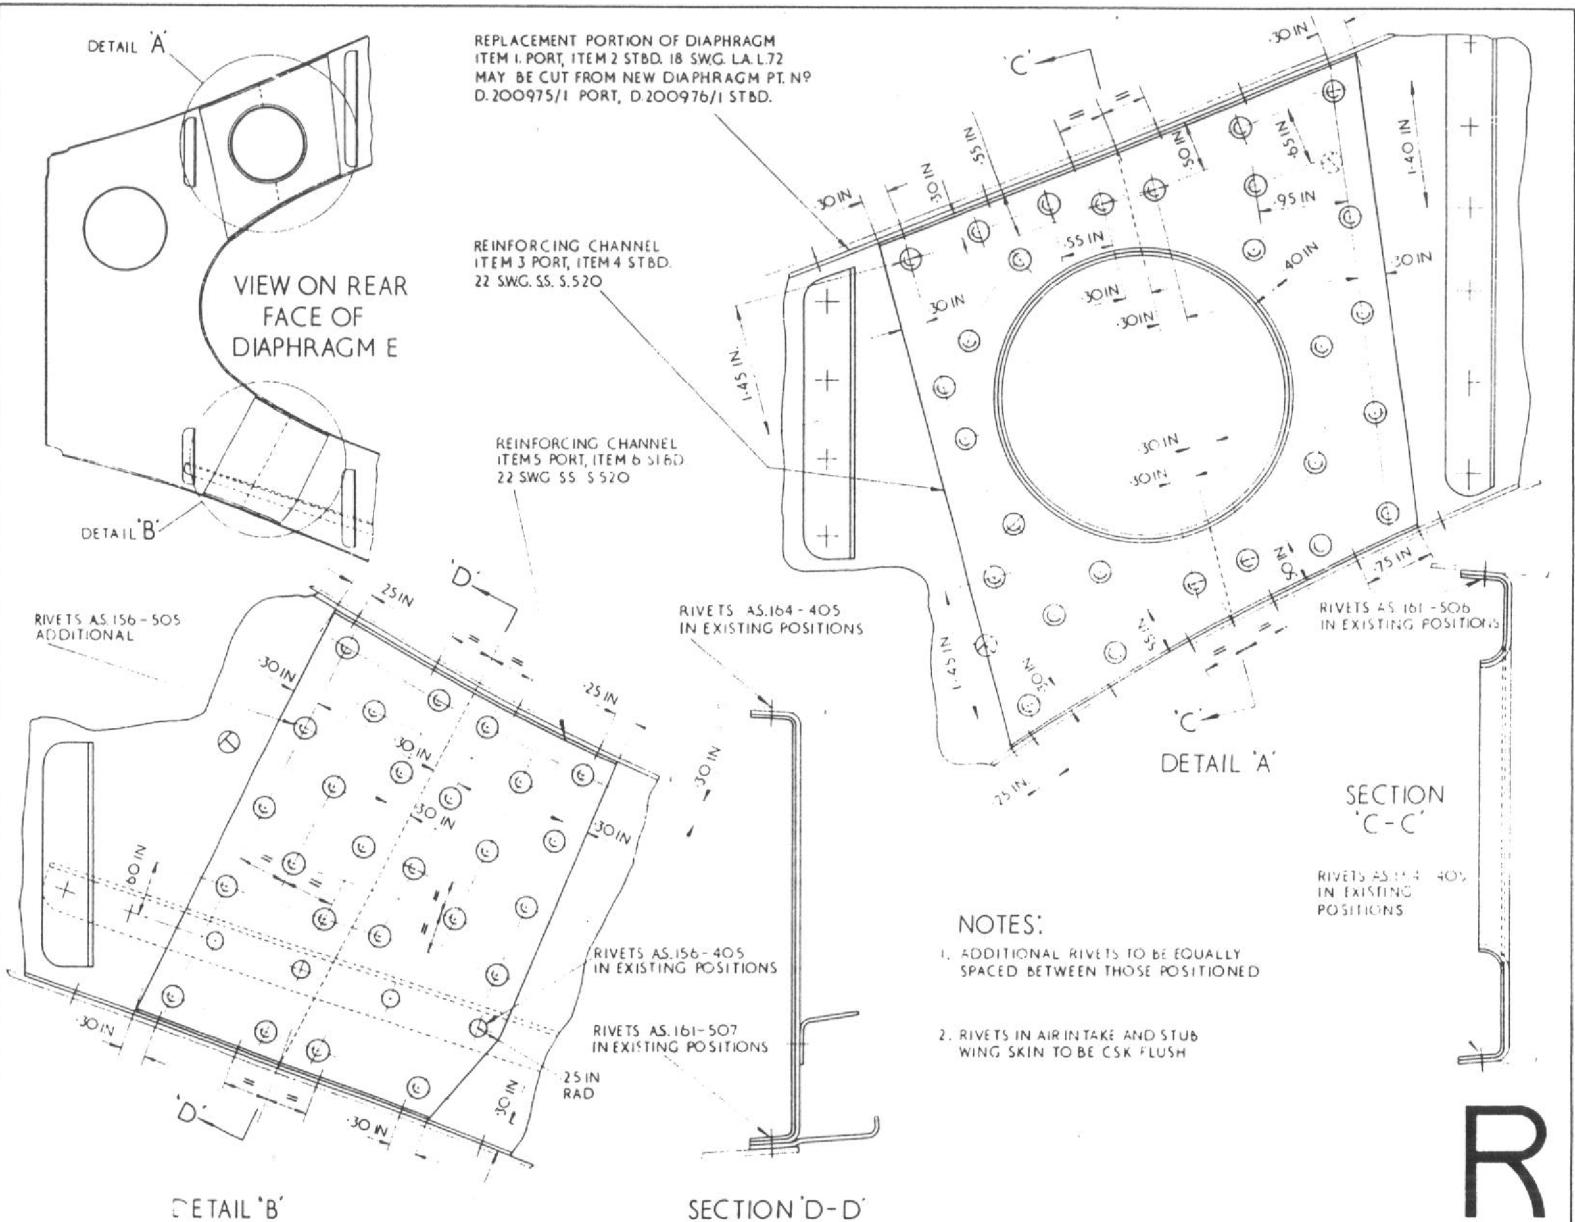
RD.424

REPAIR TO STUB WING DIAPHRAGM E

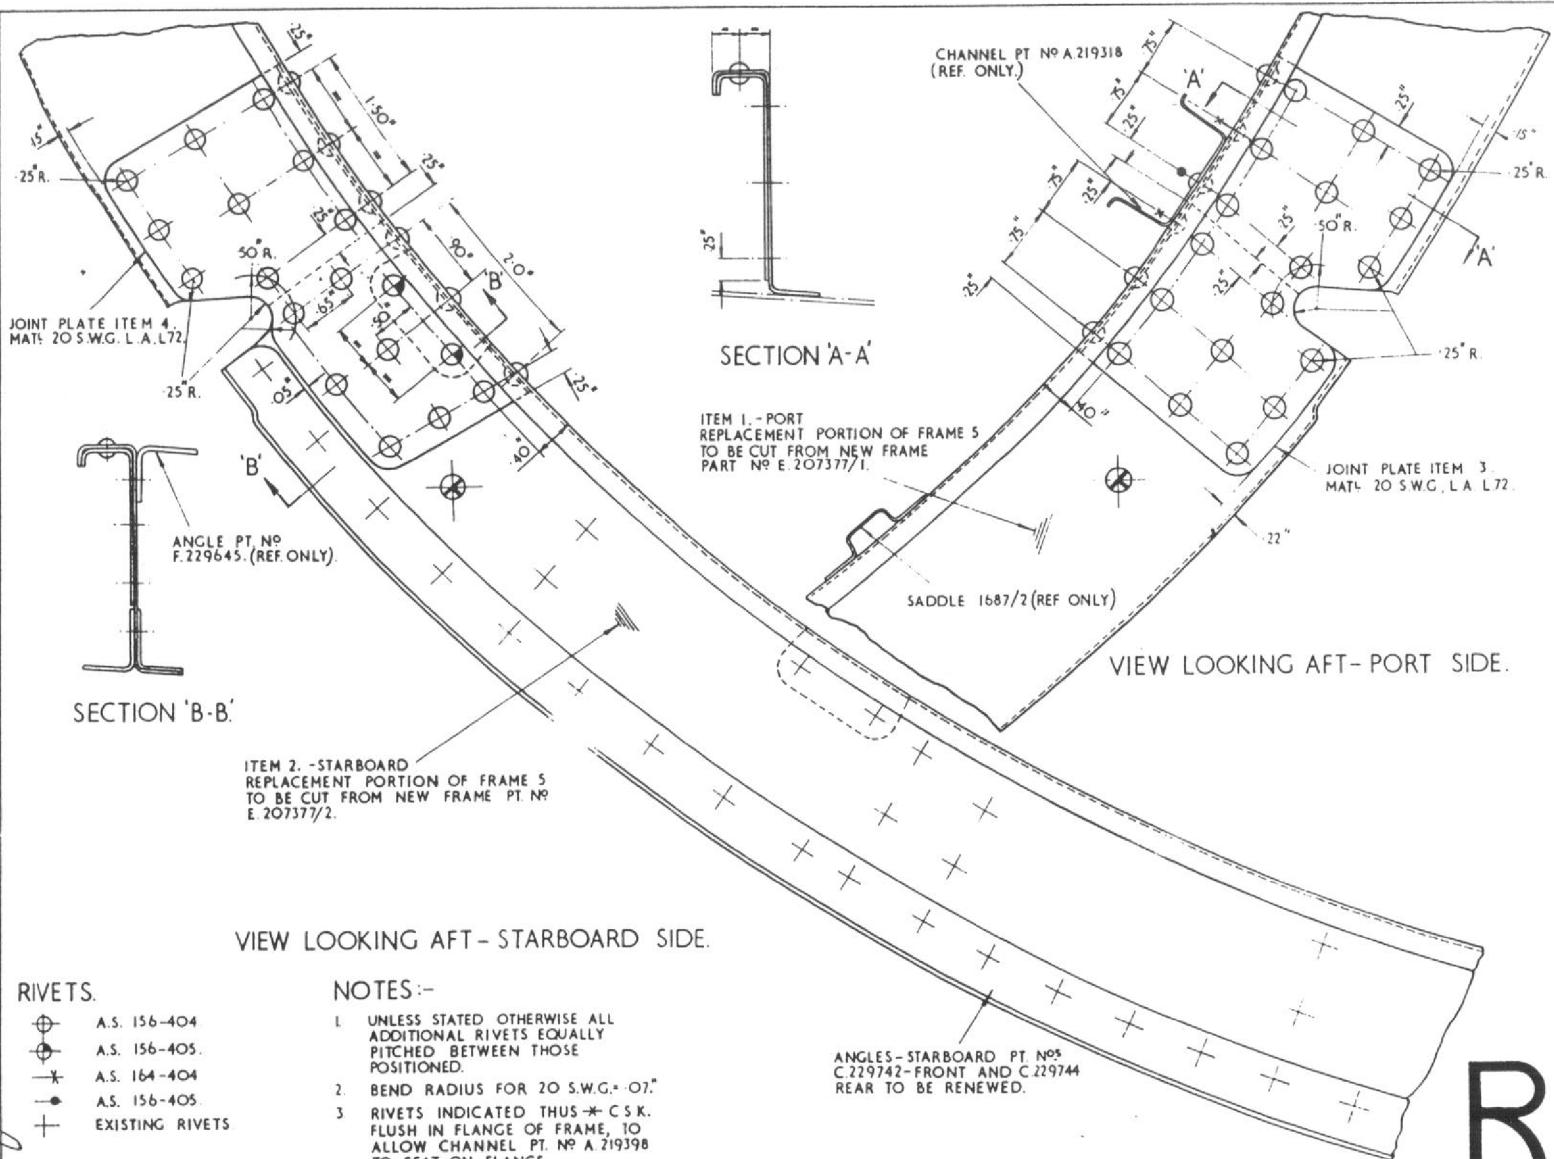
VIEW LOOKING AFT - STARBOARD SIDE.	
<p>RIVETS.</p> <ul style="list-style-type: none"> ○ A.S. 156-404 ○ A.S. 156-405 * A.S. 164-404 ● A.S. 156-405 † EXISTING RIVETS 		<p>NOTES:-</p> <ol style="list-style-type: none"> 1. UNLESS STATED OTHERWISE ALL ADDITIONAL RIVETS EQUALLY PITCHED BETWEEN THOSE POSITIONED. 2. BEND RADIUS FOR 20 S.W.G. = 07". 3. RIVETS INDICATED THUS C.S.K. FLUSH IN FLANGE OF FRAME, TO ALLOW CHANNEL PT. NO A. 219318 TO SEAT ON FLANGE <p>ANGLES - STARBOARD PT. NOS C.229742 - FRONT AND C.229744 REAR TO BE RENEWED.</p>	
REPAIR TO BOTTOM PORTION OF FRAME 5.			RD. 382

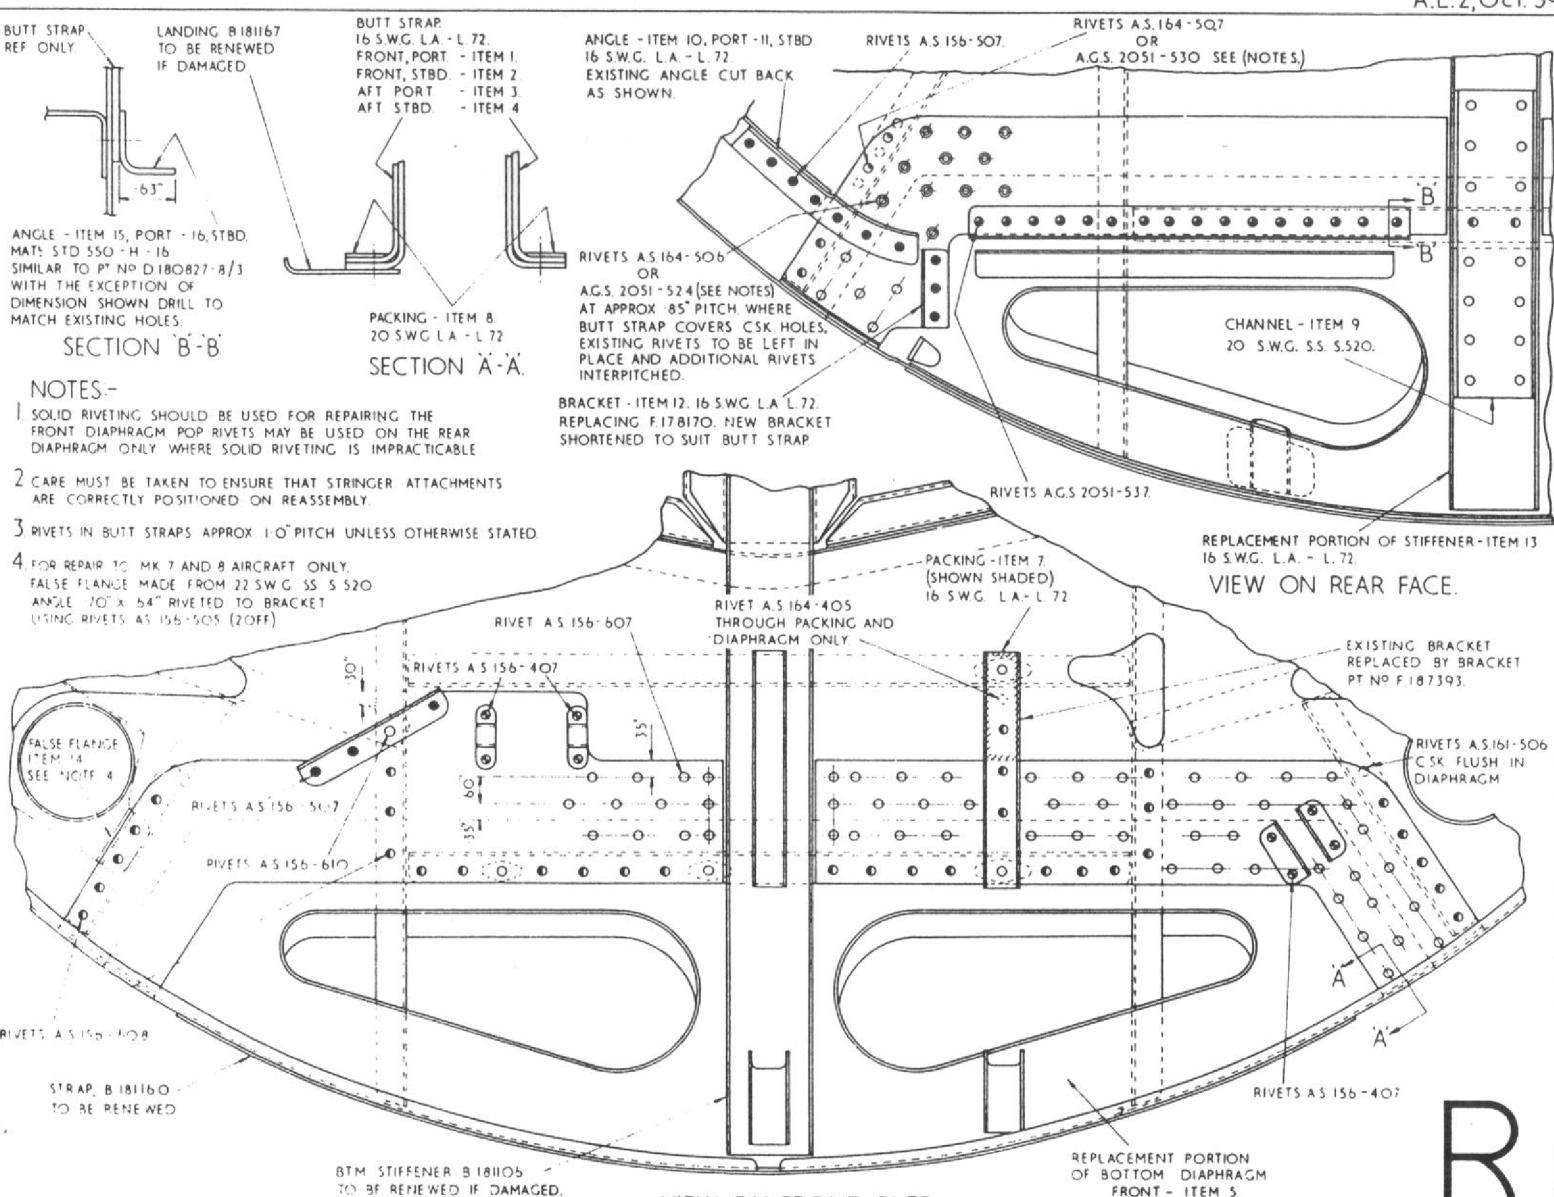
RD. 307

REPAIR TO BASE OF FRAME 19 (NOSE SPAR)

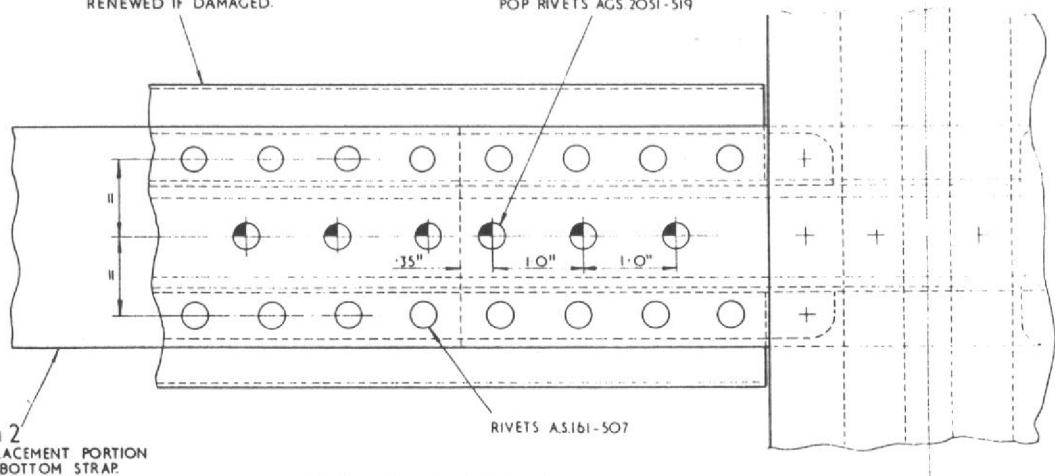
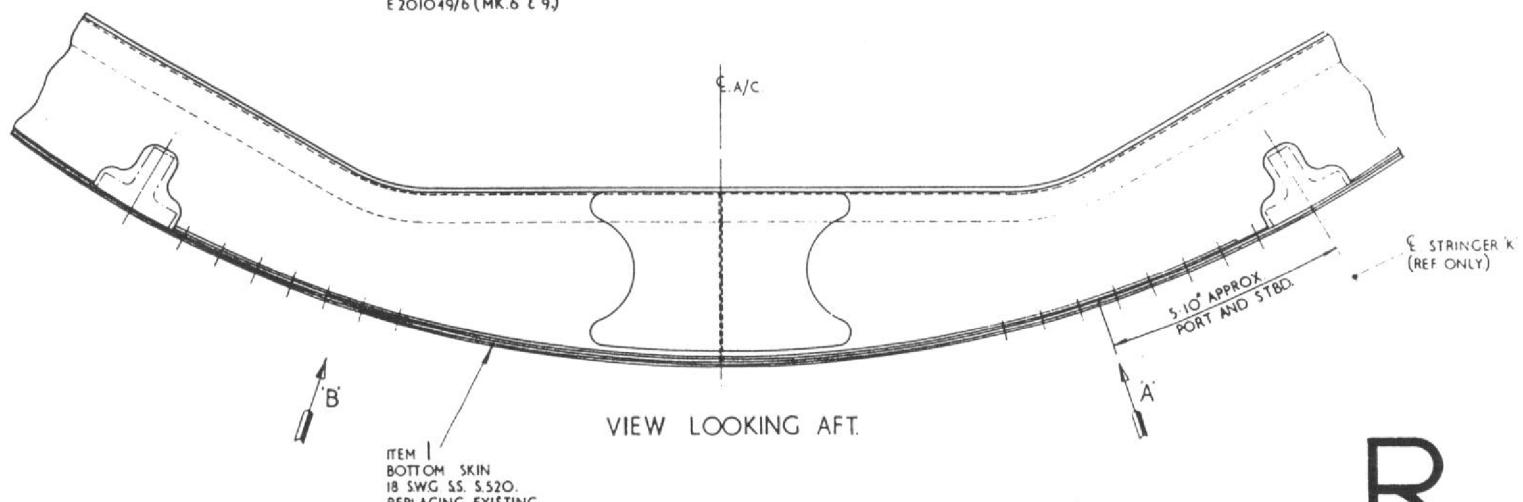
RD.368.

REPAIR TO BOTTOM STRAP AT FRAME 34.

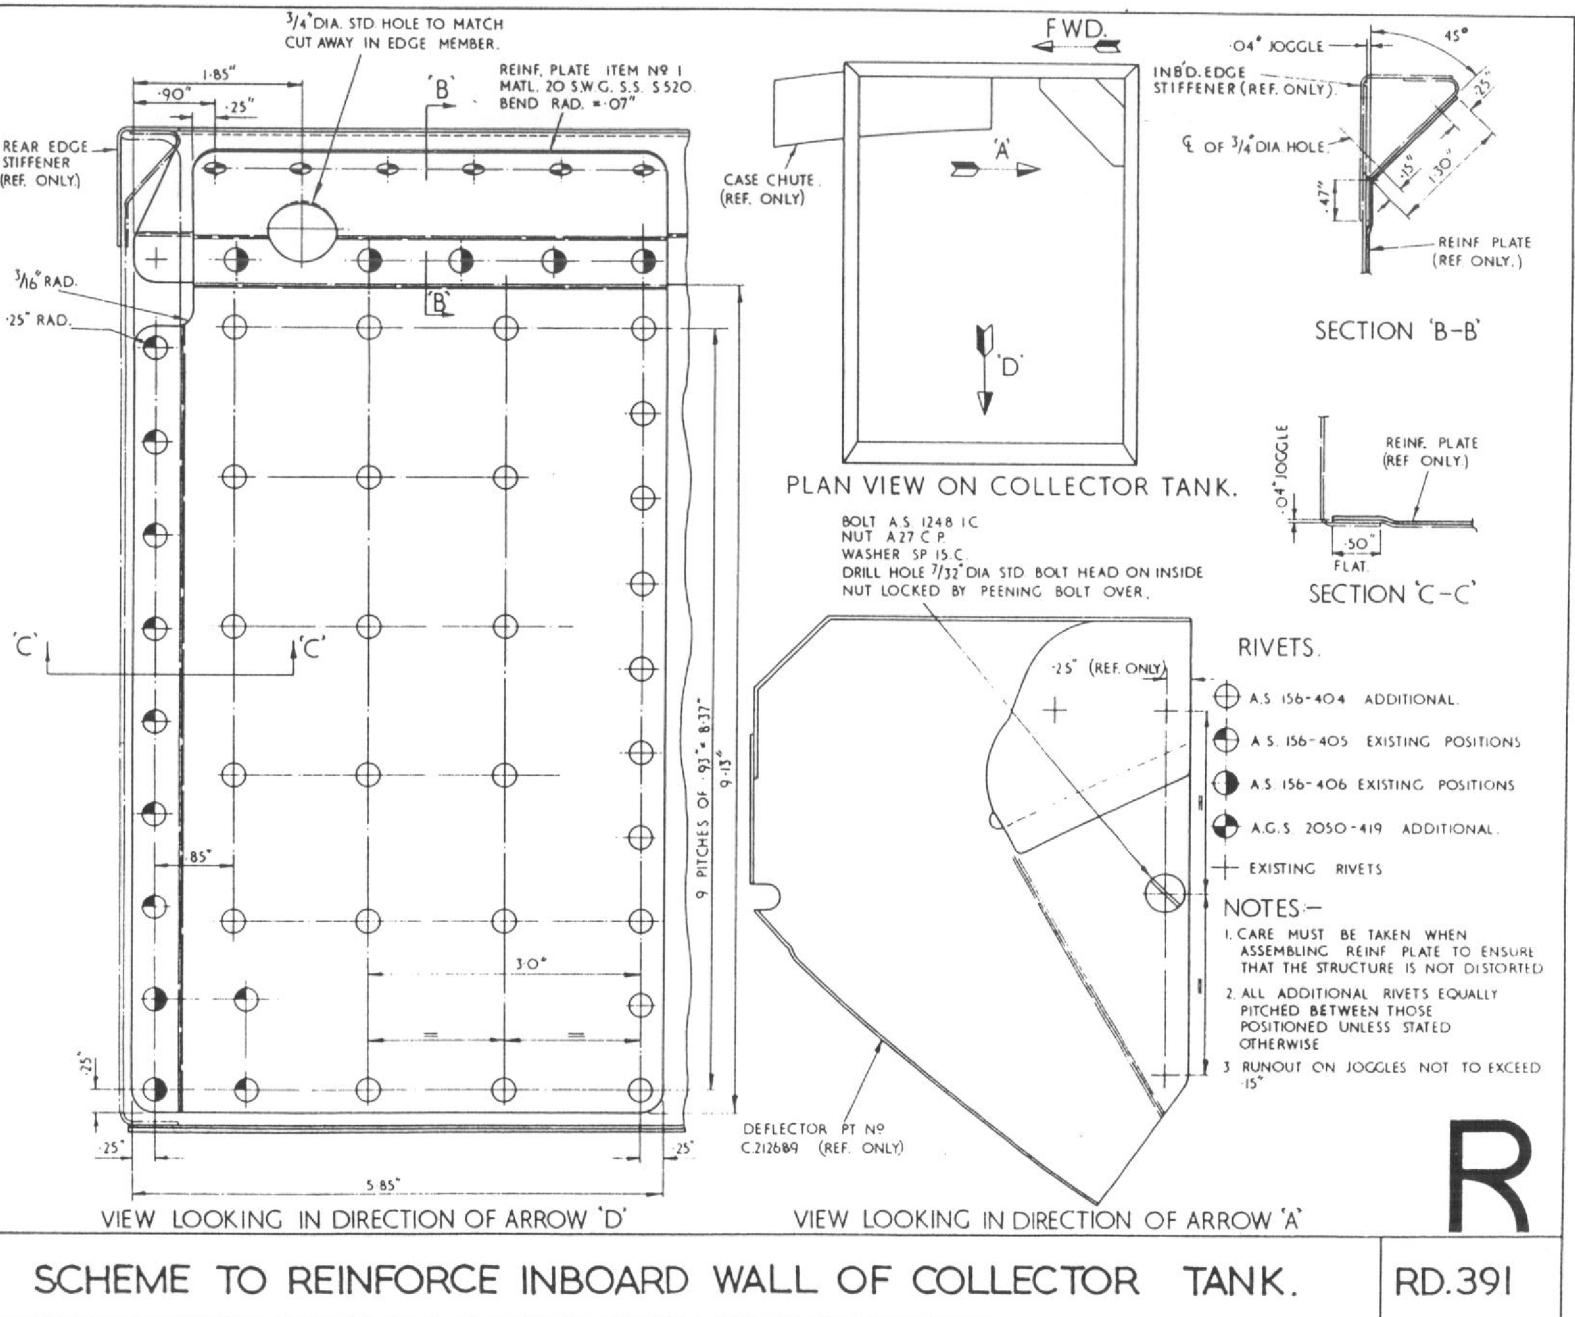
RD.391

SCHEME TO REINFORCE INBOARD WALL OF COLLECTOR TANK.

- (1) Drill out all necessary rivets in way of reinforcing plate, item No.1.
- (2) From 20 s.w.g. stainless steel S.520 manufacture reinforcing plate.
- (3) Offer up reinforcing plate; drill required holes and secure with appropriate rivets.
- (4) Drill 7/32 in. dia. std. hole in deflector and fix additional bolt as shown on RD.391.

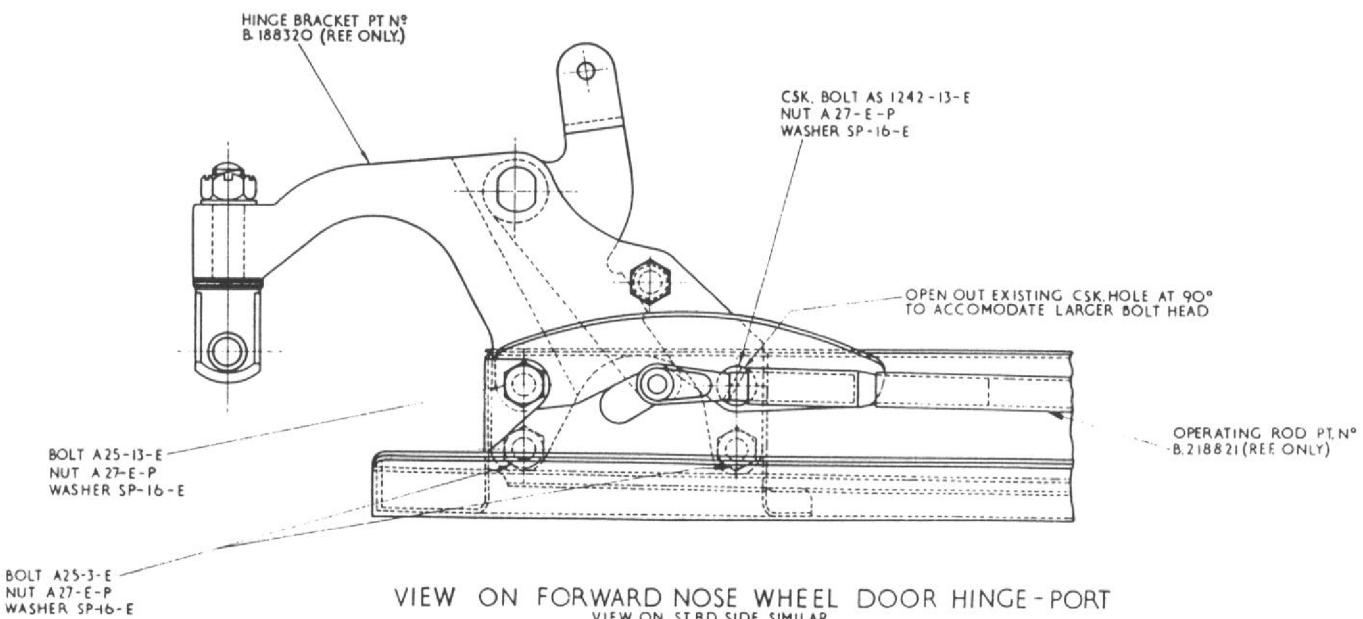
RD. 416

SCHEME TO FIT OVERSIZE BOLTS IN FWD. NOSE WHEEL DOOR

1. THE FOUR EXISTING HOLES CONCERNED TO BE REAMED OUT TO $\frac{1}{4}$ IN.DIA.HAWKER 'C' FIT
2. NUTS TO BE LOCKED IN POSITION BY PEENING OVER ENDS OF BOLTS
