Chapter Seventeen

COMPRESSOR, TURBINE, AND WHEELCASE SERVICING AND MAINTENANCE

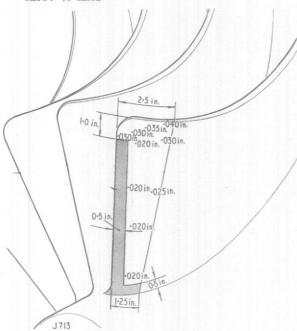
Fig. 4. Impeller damage, acceptance limits.

SHADED AREA: Smooth indentations, such as might be expected from impact with smooth rounded objects, only: maximum depth 0.030 inches. No indentations caused by irregular shaped objects permitted.

UNSHADED AREA: Indicates maximum permissible depth of indentations caused by impact with irregular shaped objects; permissible depth increases, within prescribed limits, according to position relative to leading edge and root of vane. Neither ragged nor torn edges, nor rapid unradiused changes of contour permissible.

Owing to the need for very close examination and direct measurement, acceptable damage as a whole is confined to the areas indicated in Fig. 4. There are two categories of acceptable damage, but strict attention must be paid to the limitations indicated on Fig. 4.

- 1. Smooth indentations such as might be expected from impact with smooth rounded objects.
- Indentations caused by impact with irregular shaped objects but which, when examined under a
 magnifying glass, have left neither ragged nor torn edges, nor rapid unradiused changes of
 contour.

vanes in situ cannot be permitted. Owing to the high rotative speeds, the removal of even small amounts of metal from the vane tips can cause severe out of balance, and it then becomes necessary, therefore, to determine the extent and position of the out of balance in order that a reasonably accurate state of balance can be restored by the removal of metal from a predetermined position. These operations can, obviously only be done when the engine has been dismantled completely. Furthermore, the removal of the anodic film creates a condition which is conducive to inter-crystalline corrosion. The coating of any areas after removal of the anodic film, by chemical or lacquer compounds, fails to provide effective protection over a period of running. Consequently, after any operations involving the removal of portions of the anodic film, the impeller has to be wapour blasted and anodised again.

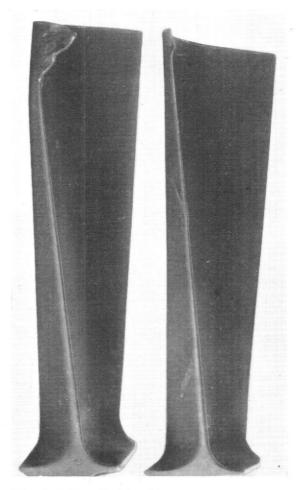
Fig. 9 (left). Turbine blade tip corner damage which is not acceptable.

Fig. 10 (right). Acceptable damage to turbine blade.

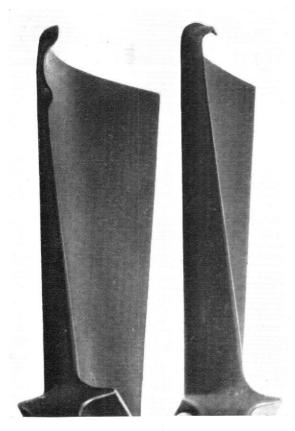
Fig. 11 (left). Acceptable damage to turbine blade.

Fig. 12 (right). Maximum turbine blade tip corner damage; sharp tip must be removed and blended smooth.

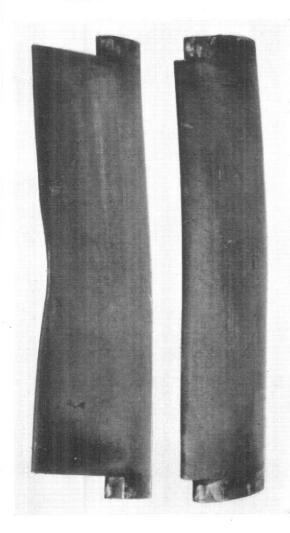
Fig. 16 (left). Maximum acceptable buckling of nozzle blade edge.

Fig. 17 (right). Maximum acceptable bowing of nozzle blade edge.

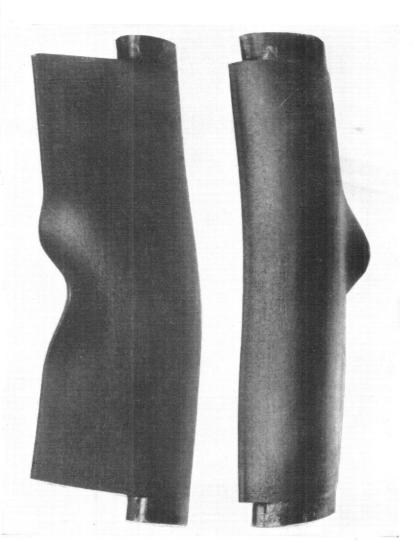
Fig. 18 (left). Buckling and bowing of nozzle blade which is not acceptable.

Fig. 19 (right). Buckling and bowing of nozzle blade which is not acceptable.

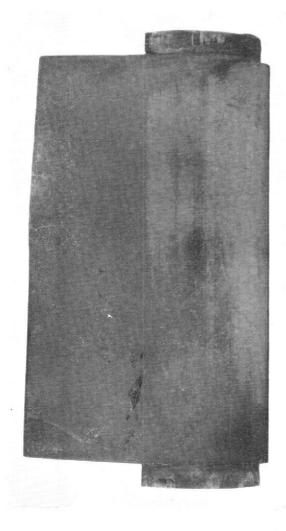
Cracks in nozzle blades. Small cracks which are just perceptible to the naked eye are acceptable as they are, and will last until the next inspection period. More pronounced cracks may be blended out in position; if necessary, remove the turbine disc, and remove the minimum amount of metal, up to a maximum depth of 0.250 inch, provided that only isolated blades are concerned. Fig. 20 shows an example of cracks in the downstream edge of a nozzle

blade which is acceptable at 50 hour inspections for continued flying, provided that the cracks can be blended out without removing metal to a depth in excess of 0.250 inch and that the adjacent blades in the assembly are undamaged; if adjacent blades are damaged the limits given on Fig. 14 must be adhered to.

Fig. 20. Cracking of nozzle blade downstream edge which is acceptable subject to the provisos given on page 7.

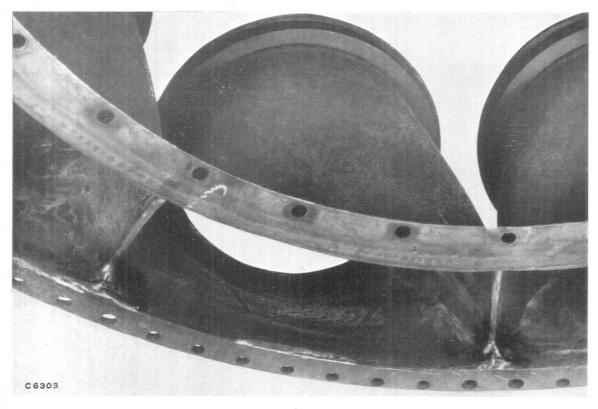
Cracks in the corners of the nozzles, occurring at the junction between the nozzles and the support rings (Fig. 32), are usually quite short and irregular in shape. Such cracks grow very slowly and may be accepted, in any number, up to an inch long, provided that they are not opening-up or tending to turn back upon themselves in such a manner that a small piece of metal might break away. Fig. 32 and 33 illustrate typical examples of cracks which may be accepted for further service. Fig. 34 shows a development of this type of defect where the crack has progressed across the support ring; where a crack has developed to this extent, the discharge nozzle assembly should be rejected.

Fig. 32. Cracks in the corners of the discharge nozzles — acceptable for further service.

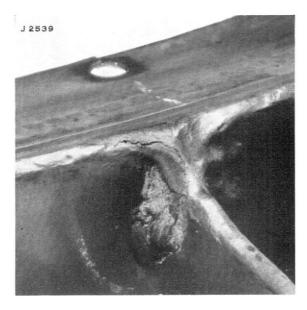
Fig. 33. Acceptable crack in the corner of the discharge nozzle.

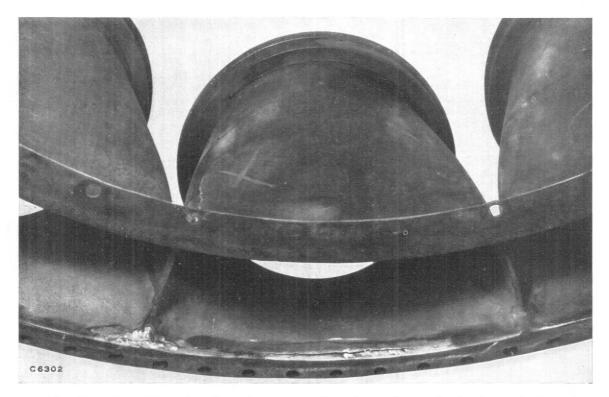
Fig. 36. Circumferential crack and crack at corner of nozzle, tending to develop into a single crack; generally, not acceptable.

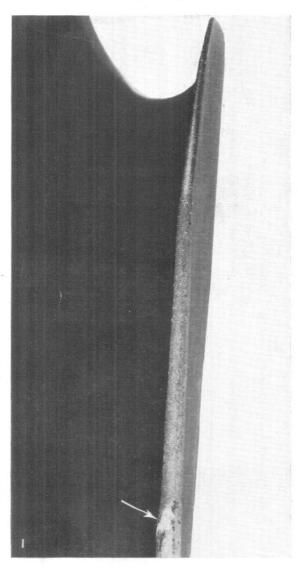
Fig. 39. Damage in the nature of a bruise resulting in little penetration (indicated by arrow), acceptable. Shows also the 'normal abrasive pitting' which has taken place along the whole of the leading edge.

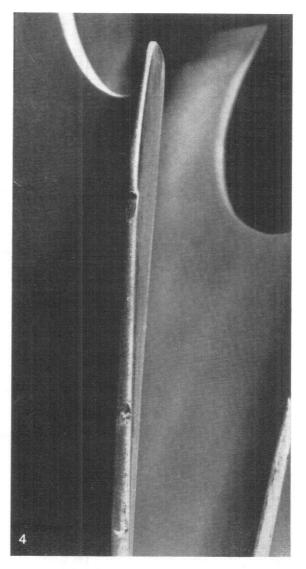
Fig. 40. Indentations of a smoothly flowing nature which need only be blended when the engine is being overhauled, acceptable.

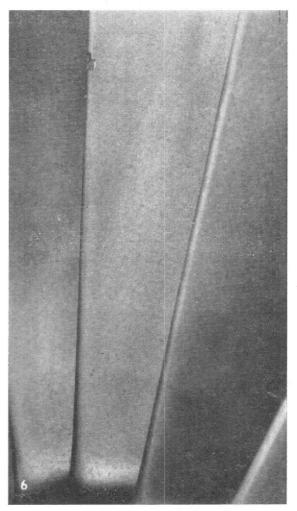
Fig. 43. Acceptable damage, only minor blending needed to remove burrs from sides of the vane; protect bared metal with lacquer.

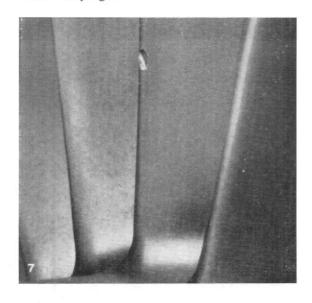
Fig. 45. Damage acceptable in an emergency only; this damage is of the same type as that illustrated in Fig. 44. Sharp edges should be removed and any bared metal covered with lacquer.

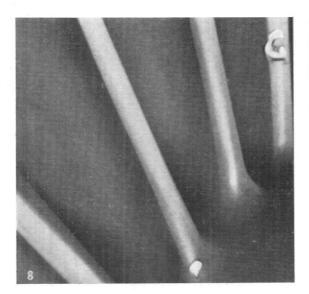
Fig. 46. Damage which is not acceptable for further running as it occurs at a point of high stress concentration and can be blended out at overhaul only; the depth of the damage illustrated is 0.030 inch.

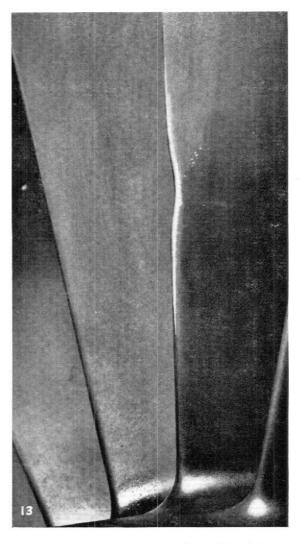
Fig. 52. Damage which has been bleanded out during overhaul; the depth of damage was the maximum permissible at this position.

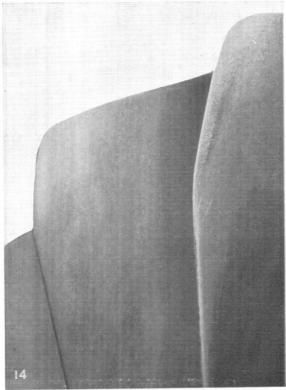
Fig. 53. Leading edges of impeller vanes cut back within the permissible limits during overhaul.

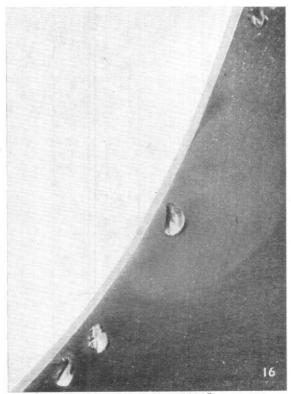
Fig. 55. Unacceptable damage on the side of an impeller vane near to its edge; can be rectified at overhaul.

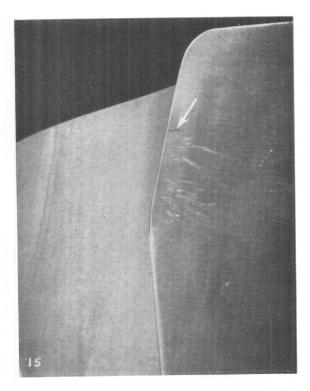
Fig. 54. What appears to be a crack or fold (indicated by arrow) in the material; subsequent X-ray examination showed this to be a slag inclusion; not acceptable either at in situ examination or at overhaul.

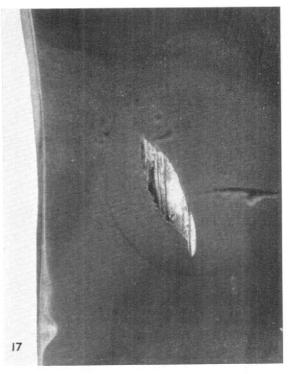
Fig. 56. Unacceptable damage on the side of an impeller vane; can be rectified at overhaul.
