#### Chapter Eighteen

# EXHAUST SYSTEM SERVICING AND MAINTENANCE

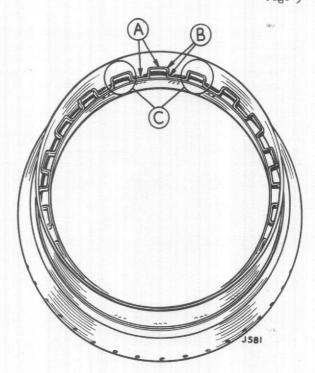
Fig. 2 Examination of propelling nozzle/ venturi cuff spacer.

Ensure that the thirty six  $\frac{1}{4}$ " B.S.F. bolts and nuts which secure the propelling nozzle to the rear of the outer cone are tight. Thoroughly examine the spacer strip (Fig.2) which connects the venturi cuff to the propelling nozzle for security of the welding and signs of cracking at the bends. Not more than six cracks can be permitted and no two adjacent 'top hat' sections must be cracked. The most common damage found on these components will be dents and distortion. Damage beyond this is usually caused by negligence.

- A. Examine spot welding for signs of failure.
- B. Examine for cracks at bends.
- C. If crack or failure is observed adjacent 'top-hat' sections must be free from cracking or failure.

The most common damage found on the propelling nozzle assembly will be dents and distortion. Damage beyond this is usually caused by negligence, Fig. 11 showing a typical instance, and this can be removed by normal sheet metal methods. The propelling nozzle stiffener (Fig. 2), or spacer strip, which is between the propelling nozzle and the venturi cuff must be thoroughly examined for cracking particularly at the welds and bends. Up to six cracks may be permitted but no two adjacent 'top-hat' sections must be cracked.

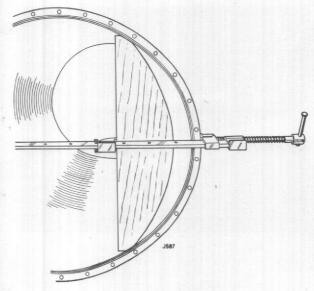
Fig. 4 Using wooden block and clamp to correct local distortion of outer cone front flange.

This consists of rotating the exhaust cone on rollers while checking the flange bolt holes with a large height gauge. Distortion and ovality are then removed by the use of a shaped wooden block and clamps as shown in Fig. 3 and 4. Ovality of the sheet metal portion must not exceed a total indicator reading of 0.200 in., and of the flange 0.050 in. (total dial indicator reading 0.100 in.). Cracks in the flange are unlikely but if discovered, cracking from the flange bolt holes to the periphery of the flange is permissible but cracks from hole to hole justify rejection of the component.

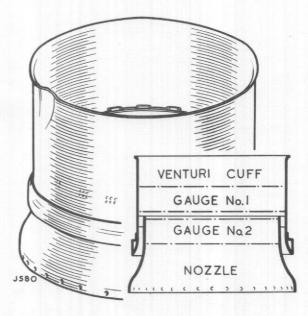
Fig. 11 Typical damage which may be found on propelling nozzle and venturi cuff, with inset showing where locally-made gauges are used when checking and correcting ovality.

Fig. 11 shows the position in which these gauges are used. Ovality can be removed by the use of wooden formers and clamps in a similar manner to that previously stated for the exhaust cone flanges.

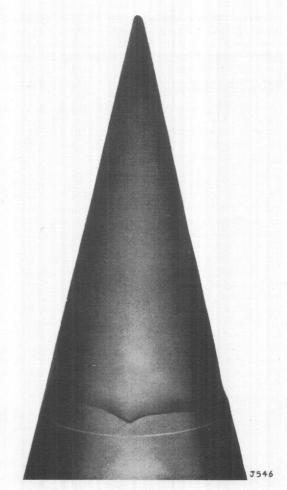
Fig. 14 Extensive cracking and buckling of inner cone apex such as this is not repairable and a new inner cone must be fitted.

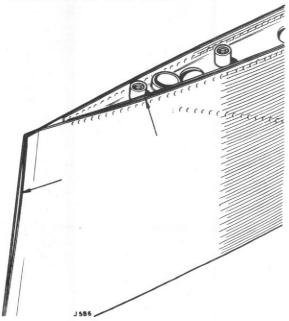
Fig. 19 Failure of seam weld at trailing edge of exhaust cone fairing and at spot welding which secure skin to formers as indicated by arrows is usually repairable.

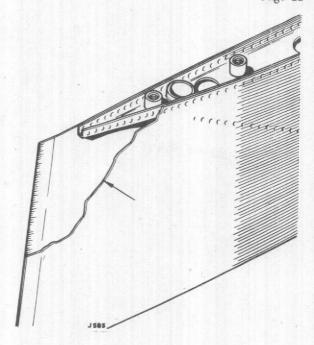
Fig. 20 Fatigue failure of exhaust cone fairing skin which is beyond repair.
