# CHAPTER 28D

## AIR-INTAKE, CENTRE HOUSING, AND WHEELCASES RENEWALS, RECONDITIONING, REPAIR, AND SALVAGE

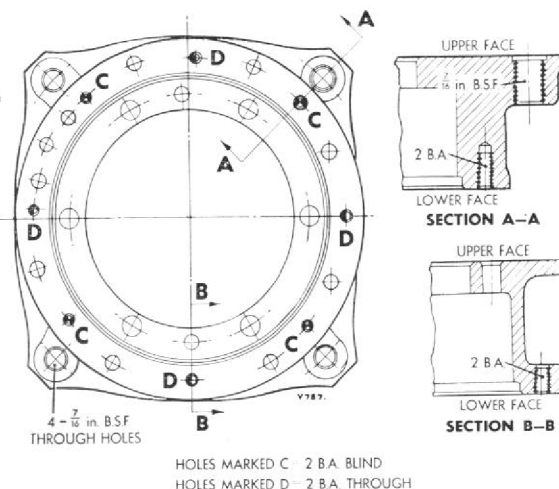
Fig. 1. Threaded holes in starter gears casing, showing blind and through 2 B.A. holes, and  $\frac{7}{16}$  inch B.S.F. holes.

Starter gears casings (Ghost 48 Mk. 1, 48 Mk. 2 or 53 Mk. 1) in which any of the 2 B.A., or  $\frac{7}{16}$  inch B.S.F., threaded holes, Fig. 1, have become damaged, may be repaired by fitting Cross wire inserts in accordance with these instructions. Reference must be made also to chapter 32, page 2, which specifies the tools required, and contains general information essential to this repair.

## REPAIR TO $\frac{7}{16}$ inch B.S.F. HOLES, FIG. 1, SECTION A-A

2. Using a  $\frac{3}{8}$  inch diameter drill, drill through the defective hole.
3. Use a  $\frac{3}{8}$  inch diameter flat-bottom drill to counterbore the hole to a depth of 0.050 inch.

4. Blow out the hole with compressed air to remove all traces of swarf, and using the appropriate taper, and plug taps, thread the hole to 0.5107 inch diameter by 18 T.P.I. (threads per inch) Whitworth thread form, and to a depth of 0.700 inch.

5. Remove any burrs from the edge of the hole, blow out the hole and, using the appropriate inserting tool, screw in wire insert Part No. N.7433 to the bottom of the thread. Break off, and remove, the notched tang of the insert.

The operations described in this paragraph are applicable to the blind 2 B.A. holes marked C in Fig. 1. Having mounted the casing on a drilling machine, proceed as follows.

1. Using a 0.1935 inch diameter (No. 10) drill, drill out the defective hole to a depth of 0.650 inch.
2. Blow out the hole with compressed air to remove all traces of swarf, and using the

appropriate taper, and plug taps, thread the hole to 0.2252 inch diameter by 31.300 T.P.I., B.A. thread form, and to a depth of 0.500 inch.

3. Using a suitable countersink, chamfer the hole to a 0.225 inch diameter, and to a 90 deg. included angle.
4. Remove any burrs from the edge of the hole, blow out the hole, and, using the appropriate inserting tool, screw in wire insert Part No. N.5040 to the bottom of the thread. Break off, and remove, the notched tang of the insert.
5. Repeat operations 1 to 4 for each damaged 2 B.A. blind hole.

The operations described in this paragraph are applicable to the through 2 B.A. holes marked D in Fig. 1. Having mounted the casing on a drilling machine, proceed as follows.

1. Using a 0.1935 inch diameter (No. 10) drill, drill through the defective hole.
2. Using the appropriate taper, and plug taps, thread the hole to 0.2252 inch diameter by 31.300 T.P.I., B.A. thread form, and to a depth of 0.400 inch.
3. Using a suitable countersink, chamfer the hole to a 0.225 inch diameter, and to a 90 deg. included angle.
4. Remove any burrs from the edge of the hole, and blow out the hole with compressed air to remove all traces of swarf. Using the appropriate inserting tool, screw in wire insert Part No. N.7417 to the bottom of the thread. Break off, and remove, the notched tang of the insert.
5. Repeat operations 1 to 4 for each damaged 2 B.A. through hole.

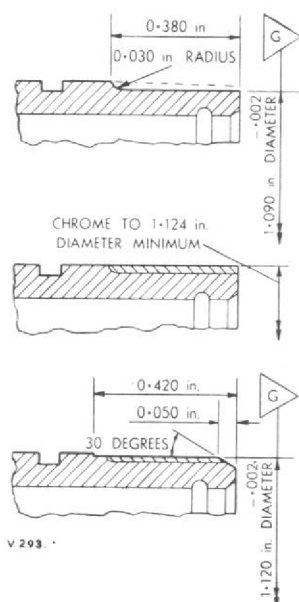
Alternator and generator gears which have developed oil leaks past the contact face of the drive shaft and the gaco oil seal, may be rectified in accordance with these instructions..

1. Grind the contact face of the drive shaft to a diameter of  $1.090 - .002$  inch and width of  $0.380$  inch, leaving a  $0.030$  inch radius in the corner.
2. Build up by chrome plating in accordance with D.H. Process Specification No. 132, to a minimum diameter of  $1.124$  inch.
3. Grind to a diameter of  $1.120 - .002$  inch and width of  $0.420$  inch; chamfer the edge to  $0.050$  inch at  $30$  deg.
4. Etch T.R.350 adjacent to the existing part number and make an entry in the appropriate record book of the engine.

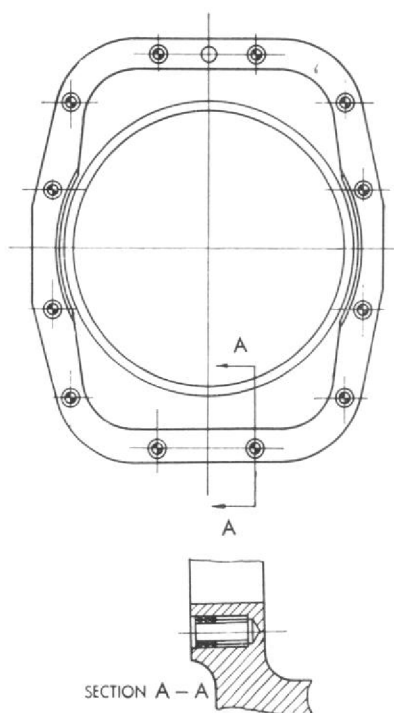
Air-intakes in which any of the  $\frac{1}{4}$  in. B.S.F. threaded holes (shown

in the illustration) have become damaged may be rectified in accordance with these instructions.

1. Drill the damaged hole to a diameter of  $0.2570$  inch (letter F drill) by  $0.650$  inch deep.
2. Thread the hole to a diameter of  $0.3012$  inch by 26 T.P.I. Whitworth thread form to a depth of  $0.600$  inch. The effective diameter is to be  $0.2766 + .0020$  inch, and the minor diameter  $0.2520 + .0117$  inch. Counterbore the hole to a diameter of  $\frac{5}{16}$  inch by  $0.050$  inch deep.
3. Screw in wire insert Part No. N.4972 and break off and remove the tang.
4. Fit existing stud if serviceable, or, a new stud if unserviceable.
5. Lightly stamp T.R.284 adjacent to the existing part number and make an entry in the appropriate record book of the engine.

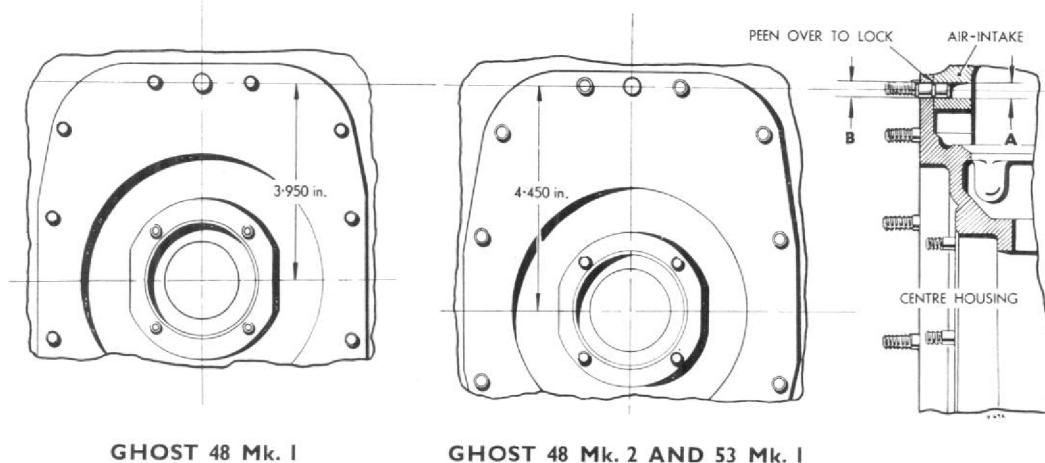
Fig. 2. Centre-housing dowel in air-intake.

Any air-intake (Ghost 48 Mk. 1, 48 Mk. 2, or 53 Mk. 1) in which the centre-housing dowel has become loose or damaged may be repaired by fitting an oversize dowel. This repair may also be employed to rectify damage to the dowel hole in the centre housing.

13. Using a tap wrench and the appropriate reamer, of those listed in the table, hand ream the dowel hole to the smallest diameter 'A' which will rectify the damage.

18. Lightly stamp T.R.123 and the appropriate suffix, as indicated in table, adjacent to the existing part number on the air-intake and on the centre housing. Make the appropriate entry in the engine log book.

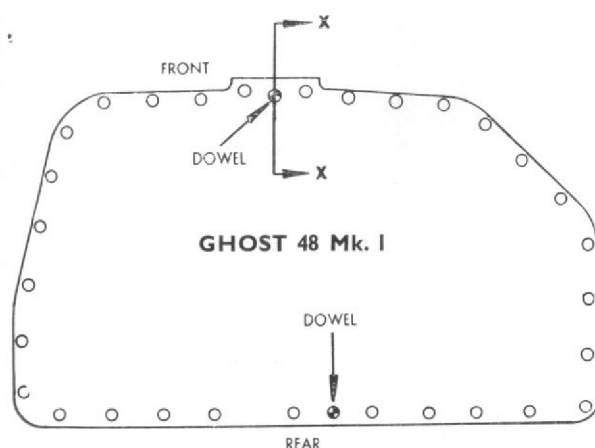
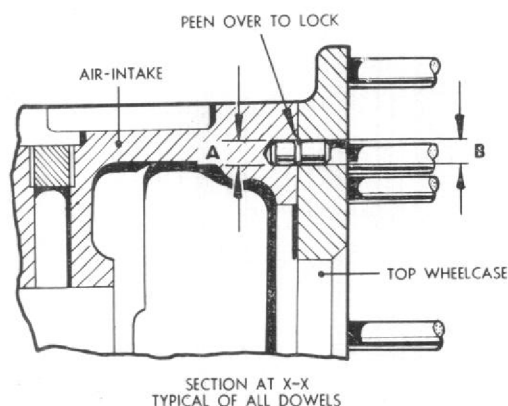
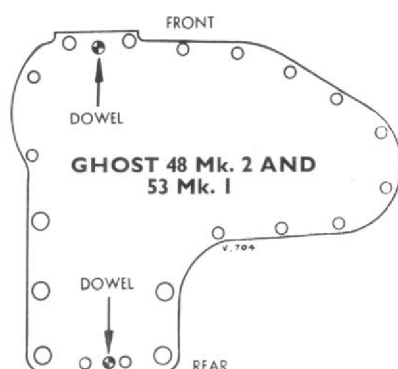
Fig. 6. Top wheelcase dowels in air-intake.

Any air-intake (Ghost 48 Mk. 1, 48 Mk. 2, or 53 Mk. 1) in which the top-wheelcase dowels have become loose or damaged may be repaired by fitting oversize dowels. This repair may also be employed to rectify damage to the dowel holes in the top wheelcase.

1. Using a standard tap wrench and the appropriate reamer, of those listed in the table below, Fig. 6, hand ream to the bottom of the dowel hole in the air-intake, selecting the smallest diameter 'A' which will rectify the damage.
2. Blow out the hole to remove all traces of swarf and check the diameter of the hole using the John Bull Intercheck small bore gauge in conjunction with the setting ring specified in the table.
3. Ghost 48 Mk. 1. Remove the locating mandrel. Remove the top wheelcase, together with the reaming jig, from the air-intake.

6. Lightly stamp T.R.124 and the appropriate suffix, as indicated in table, adjacent to the existing part number on the air-intake, and on the top wheelcase. Make the appropriate entry in the engine log book.

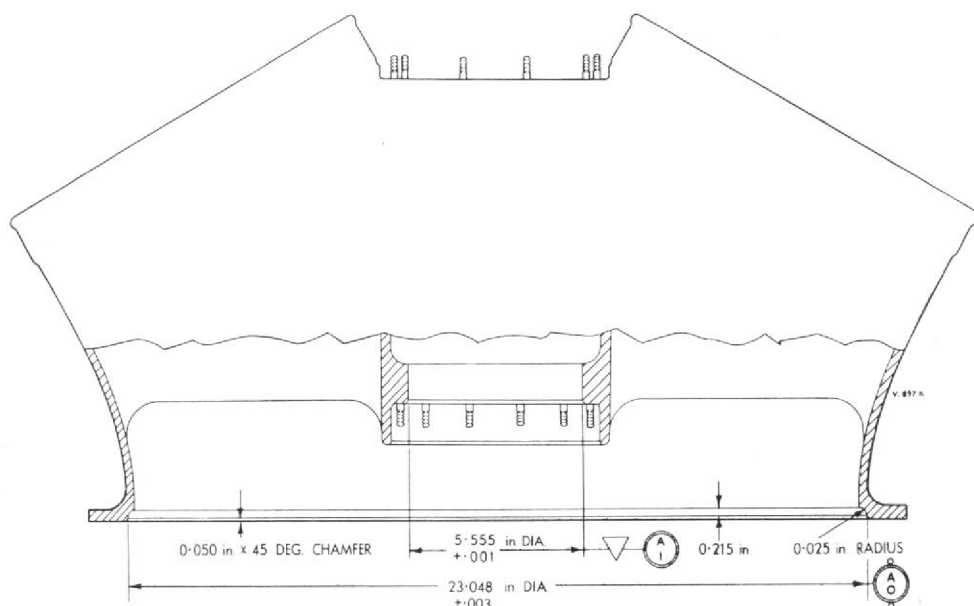
T.R.213. Air-intake, bearing housing bore.

If the number T.R.213 is found on a Ghost 48 Mk. 1, 48 Mk. 2, or 53 Mk. 1, air-intake, adjacent to the existing part number, this indicates that the front bearing housing bore has been machined to 0.005 in. oversize.

Where sufficiently skilled personnel and adequate workshop facilities are available, this repair can be employed as a means of rectifying damage to the bearing housing bore in an air-intake, provided that this repair has not been applied previously.

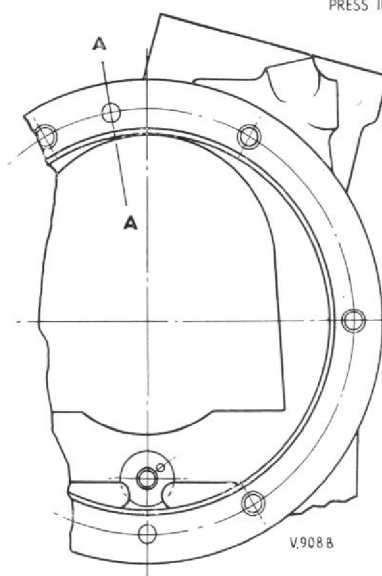
T.R.364. Air compressor housing, oil hole.

If the number T.R.364 is found on a Ghost 48 Mk. 1 air compressor housing, adjacent to the existing part number, this indicates that the top oil gallery has been lined with a tube, Part No. 603562.

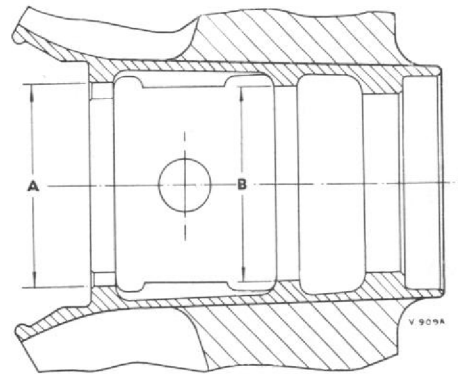
## Oversize centre-housing bore in air-intake.

If the number T.R.260 is found on a Ghost 48 Mk. 1 air-intake, adjacent to the existing part number, this indicates that the centre-housing bore has been machined oversize.

The degree of oversize is indicated by the suffix 1, 2, or 3 following the T.R. number. Such air-intakes may only be assembled in conjunction with the appropriate oversize centre-housing, see table and drawing.
