Chapter 28F

CENTRE CASING AND NOZZLE RING RENEWALS, RECONDITIONING, REPAIR, AND SALVAGE

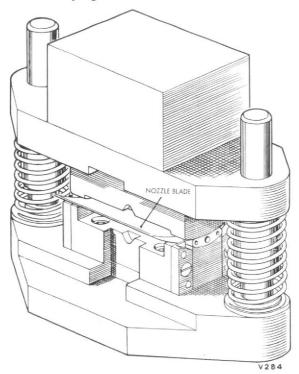
Fig. 3. Nozzle blade in tool T.78208; reforming damaged lugs.

When each damaged blade has been removed, the blades which remain in the outer ring segment should be cleaned up, within the limits specified in T.R.152 (page 9), with a smooth file and emery cloth, and the inner extremity of the lug on each of these blades should be examined. To secure the blades in the inner and outer rings, the blade lugs are peened after assembly, and if, after removal from the inner ring, the spread of metal at the extremity of a blade lug is sufficient to prevent easy reassembly into the inner ring, that blade must be removed from the outer ring segment, as described above, and both its lugs reformed by pressing as described at the top of the next column. The working pressure-which must be found by experience-is governed by the condition of the blade; the pressure required to correct a badly dis-torted blade will be in the region of 25-30 tons.

- (1) Position the blade in tool T.78208 (Fig. 3).
- Position the tool under a hydraulic press and press the blade.

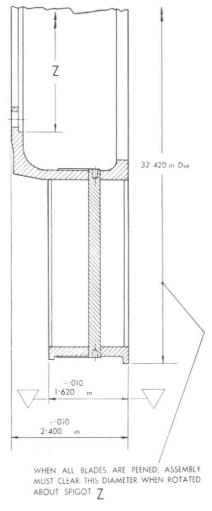
Fig. 4. Machining dimensions for outer ring segment.

New outer ring segments are supplied approximately $\frac{11}{64}$ in. oversize on the width. Therefore if one or more new outer ring segments have been fitted, the new segments must be machined, after the nozzle blades and rings have been peened, to bring the overall width of the complete assembly

- (1) Set up the complete blade and ring assembly on a suitable grinding machine.
- (2) Set the spigot "Z" to run true and check that the outside diameter of the rear flange of the outer ring is within the limits specified in Fig. 4.
- (3) Grind the front and rear faces of each new outer ring segment to bring them into the same plane as the original segments and within the

limits indicated in Fig. 4. In some instances it may be difficult to grind the new segments without removing metal from the original segments. When this occurs, continue grinding only until the wheel just marks the original segments and complete the facing of the new segments by careful hand filing.

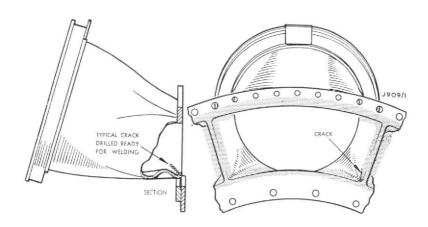
Fig. 6. (Right) possible location of cracks in discharge nozzle indicated by shading; (left) example of crack prepared for welding.

Cracking of the welded joints in the area shown dotted in Fig. 6, may be repaired irrespective of length, but cracks in the bore of each entry duct—an example is shown in Fig. 6—may be repaired only provided that no crack exceeds 1.500 in. in length. All cracks must be argon-arc welded using filler rod to Specification D.T.D.549.

- Remove metal along each crack by drilling
 ₁₆ in. diameter holes to the depth, and length,
 necessary to remove the original outline of the
 crack. Clean off any oil or grease, and, using

- a rotary wire brush, thoroughly clean in and around the crack until bright metal is exposed. Using the recommended filler rod, argon-arc weld the crack.

- 6. File, or grind, the welds in the bore of each entry duct until they are flush with the skin; similarly, blend the welds which protrude above the flanges until they are flush with the surrounding face.

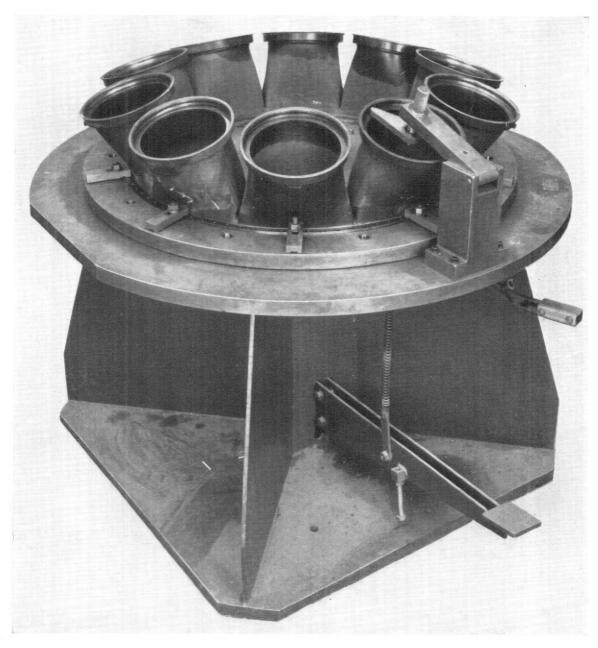
Fig. 10. Discharge nozzle assembly mounted on checking fixture T.79434.

discharge nozzle entry duct, and check with feeler gauges that ovality of the nozzle does not exceed 0.015 in. Ovality can be corrected by judicious use of a steel drift, or with a circular expanding tool. If, however, use of the checking pointer indicates that the complete port has moved in relation to the centre line of the assembly, this movement can be corrected by using adjusting tool T.79427. When using this tool, the bar should be given a short, sharp pull, as a steadily increasing pull will result in the port springing back when the tool is

- 8. Transfer the discharge nozzle assembly to checking fixture T.79434, Fig. 10, and secure it in position by tightening the ten locking plates over the outer flange. Swing the arm of the checking pointer over and into the adjacent

released. To repeat this check in each of the remaining nozzles, swing clear the checking pointer, operate the hand locking-bar, and depress the foot pedal to permit the discharge nozzle assembly to be rotated and the next entry duct to be locked in position.

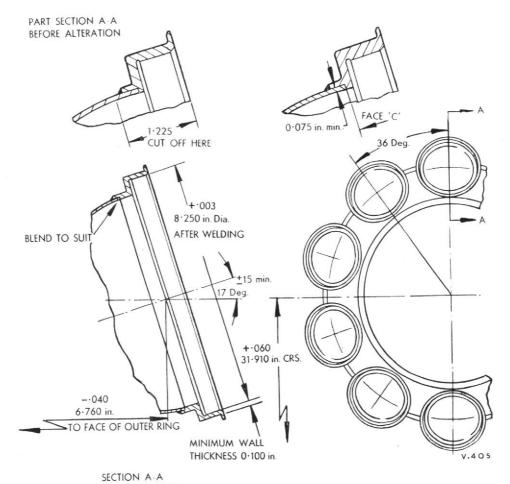
T.R.341. Discharge nozzle joint rings.

If the number T.R.341 is found on a discharge nozzle assembly, adjacent to the normal part number, this indicates that an incorrectly machined joint ring has been replaced either by a new standard joint ring Part No. 93990, or by a special modified joint ring Part No. 603425. This in no way affects the interchangeability of the component nor does it affect its dismantling, inspection, repair, or reassembly.

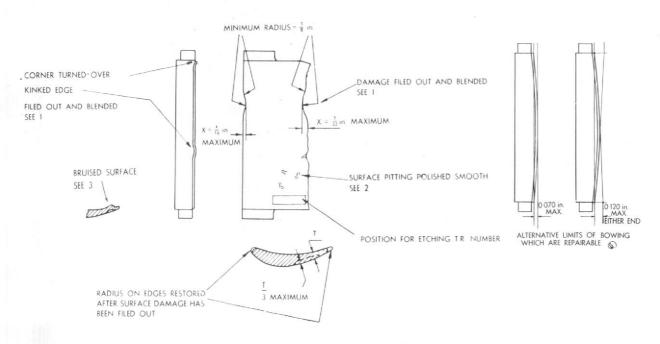
T.R. 152. Limits of repair to nozzle blades.

- 1. DOWNSTREAM (TRAILING) EDGE KINKED. The damage must be completely filed out and the edge blended smooth and radiused; see sketch indicating maximum amount that may be filed out. If any doubt exists concerning damage that is slight, it must be rectified similarly. The complete downstream edge may, if necessary, be filed back to the permitted depth of 3/2 inch, provided that any damage to adjacent blades is of a minor character.

- SURFACE PITTING. Damage of a depth equal to one-third the local thickness may be tolerated, provided that any ragged edges are smoothed off to conform to the general profile.

- 3. BRUISING. If the surface is bruised to the extent of raising a hump on the opposite side of the blade, the bruise must be filed and polished smooth. In many cases this damage is quite smooth and difficult to rectify in situ, in such a case it is preferable to leave it as it is.

- UPSTREAM (LEADING) EDGE. Damage on this edge is comparatively rare, due to the

- robust section of the blade. Pitting and bruising must be filed out and polished and the radius restored. The complete upstream edge may, if necessary, be filed back to the maximum permissible depth of $\frac{1}{10}$ inch, provided that the peening of the blade is not disturbed, and that damage to adjacent blades is not extensive.
- DOWNSTREAM (TRAILING) EDGE BOWED. Where the amount of bowing does not exceed either of the limits shown, it is permissible to straighten the blade.
- 6. CRACKS IN BLADES. Cracks in the upstream and downstream edges may be removed by filing, provided that the limits stipulated in Note 1 and 4, and indicated in the sketch are not exceeded. If a cracked blade requires metal to be removed beyond these limits, it must be replaced by a new blade.

Blades which require blending, or straightening, beyond the limits specified must be replaced by new blades.

All repairs must be polished free of file marks and scratches, and blades which have been repaired in accordance with these instructions must have T.R.152 lightly etched in the position indicated by the sketch.
