Chapter Thirty

COMBUSTION CHAMBERS, RENEWALS, RECONDITIONING, REPAIR AND SALVAGE

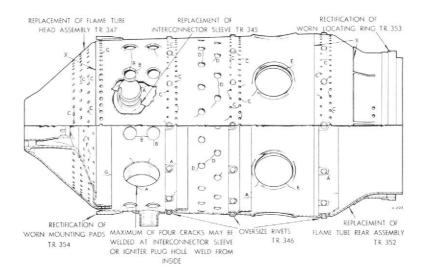
nearest adjacent air hole or rivet hole at B, C and D, and also three air holes at C-but in this instance, only on the same row of holes-may be repaired.

Unless extensive buckling has taken place, and excluding the inner row of holes in the flare, single cracks between any two adjacent air holes at position F may be repaired. Cracks in the inner row of holes are not acceptable for repair. Cracks at G may be repaired as required, provided that the permissible limit for this location is not exceeded.

Failure or cracking of the welded joints at X may be repaired as required, but where the part concerned has become almost detached, relative concentricity must be maintained during welding, by means of a welding jig.

Fig. 2. Diagram showing possible position of various cracks in flame tube and head, which are repairable subject to the limits specified in the diagram and the text.

Cracking of the flame tube and head at the points indicated in Fig. 2 may be repaired by argon-arc welding, subject to the cracks not exceeding the limits specified below (refer also to Fig. 2).

The argon-arc welding process with filler rod NC 82 must be used for repairing cracks at any of the points specified in Fig. 2.

Commencing approximately $\frac{1}{4}$ in, before the drilled end of the crack and finishing on the periphery of the hole, argon-arc weld the crack with filler rod NC 82. An interconnecting crack may be welded from either end.

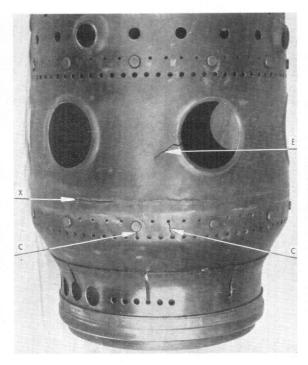
Fig. 3. Example of typical cracks at points C, E and X which are repairable.

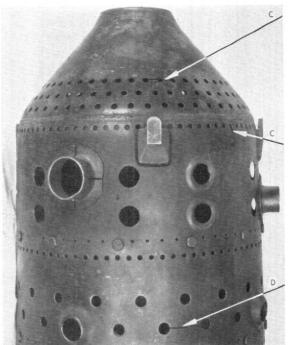
Fig. 4. Example of typical cracks at points C and D which are repairable.

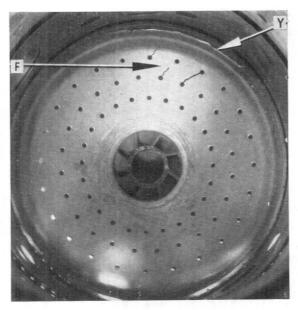
Fig. 5. View through rear end of flame tube showing cracks in the flare.

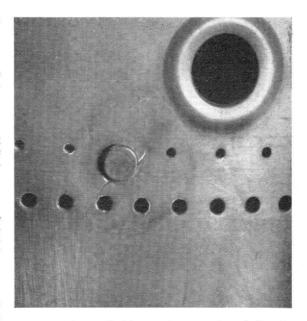
An example of a repairable crack at point B is illustrated in Fig. 7. Fig. 8 illustrates a repairable crack at a rivet hole point C.

Fig. 8. A repairable crack at a rivet hole; inaccessible for repair unless the rivets and cooling skirt are removed.

If a rivet hole in the flame tube or a cooling skirt is cracked, drill and chip off the heads of the twelve rivets and remove the cooling skirt concerned, leaving it inside the flame tube.

Grind welded cracks at any of the rivet holes only sufficiently to prevent fouling when re-riveting a cooling skirt to the flame tube.

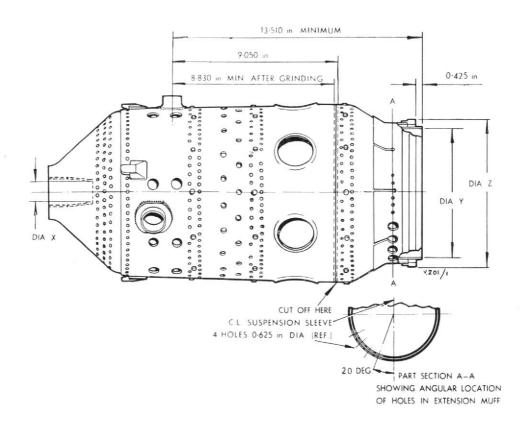
COMBUSTION CHAMBER, FLAME TUBE AND HEAD ASSEMBLY, FITTING NEW REAR SECTION T.R.352 issue 4—Mod. 978

Where the rear section of a flame tube has become cracked or damaged beyond the limits of repair, a complete new section consisting of rear section Part No. 95083 and extension muff and ring Part No. 95085, may be fitted in accordance with these instructions.

- Grind the end face of the flame tube to remove the existing weld to the dimensions shown. The finished face after grinding must be square to the horizontal centre-line of the flame tube.
- Fit new rear section Part No. 95083 to the flame tube to the dimension shown, and argonarc fillet weld all round.
- Fit new extension muff and ring Part No. 95085 to rear section to the dimension shown (refer also to section A-A), and seamweld right round between the key-hole slots.
- Check that diameter Z is within 0.010 in. total clock reading when the flame tube and head assembly is rotated about diameters X and Y.
- Etch T.R.352 adjacent to the existing part number and make an entry in the appropriate record book of the engine.

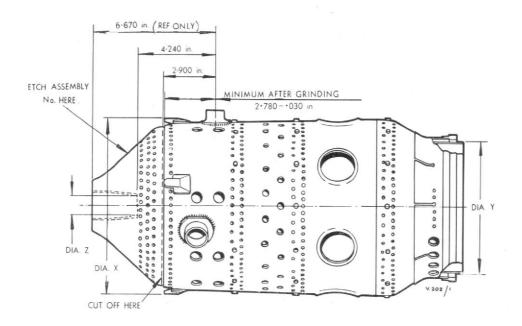
COMBUSTION CHAMBER, FLAME TUBE AND HEAD ASSEMBLY, FITTING NEW HEAD T.R.347 issue 3—Mod. 978

Flame tube heads which are cracked or damaged beyond the repairable limits of T.R.344, may be rectified by fitting a replacement head Part No. 95077 in accordance with these instructions.

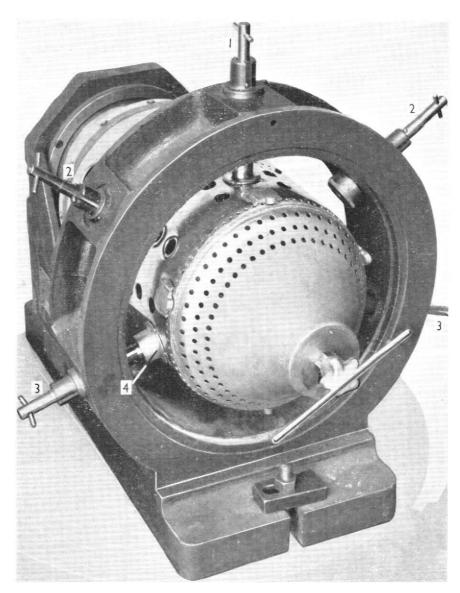
Flame tube and head assemblies on which the material thickness of an interconnector sleeve has been reduced by wear at any point around the sides to less than 0.030 inch, may be rectified by fitting a new interconnector sleeve Part No. 600651 in accordance with these instructions.

Fig. 12. Flame tube and head assembled to welding fixture, and replacement interconnector sleeve tack-welded in position.

Grind off the damaged interconnector sleeve, and clean the flame tube and new interconnector ready for welding.

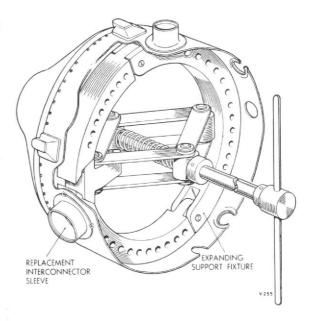
Fig. 14. Method of providing support inside the flame tube when welding the interconnector sleeve in position.
