Chapter Thirty-one

# EXHAUST SYSTEM

## RENEWALS, RECONDITIONING, REPAIR AND SALVAGE

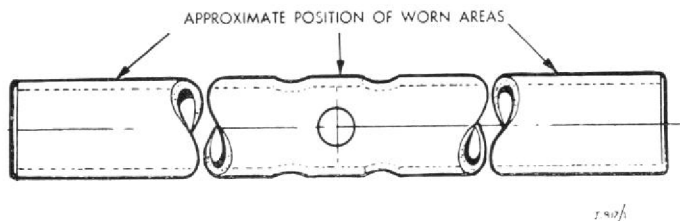
Any exhaust cone support tube (Ghost 48 Mk. 1, 48 Mk. 2 or 53 Mk. 1) which, as a result of fretting and indentation at the approximate positions shown in Fig. 1, has become damaged beyond the maximum permissible depth of 0.010 inch, may be repaired by re-building the worn diameters by the argon-arc welding process.

Fig. 1. Location of indentation and fretting of front support tube.

1. Remove any oil or grease from the tube, and using a rotary wire brush, thoroughly clean the worn diameters ready for welding.
2. Using the argon-arc welding process with filler rod to specification D.T.D.549, or stabilized D.T.D.571, and working lengthwise along the

tube, build up a small area (approximately one-sixteenth of the circumference) at each worn position; shown as area 1 in the welding sequence diagram, Fig. 2.

3. Similarly build up small areas at diametrically opposite positions on the tube; shown as area 2 in the welding sequence diagram.
4. Refer to the welding sequence diagram, and, taking each area in numerical order, continue to build up the worn positions until the whole of each damaged diameter has been rectified.
5. The tube must be perfectly straight before the application of the next operation, and any distortion which exists as a result of the welding must be corrected. This is carried out by supporting the tube across two blocks of wood, and correcting the distortion by applying blows

6. Carefully grind the deposited filler rod to restore the diameter of the tube, and, on the front support tube only, the 0.375 inch diameter of the air holes.

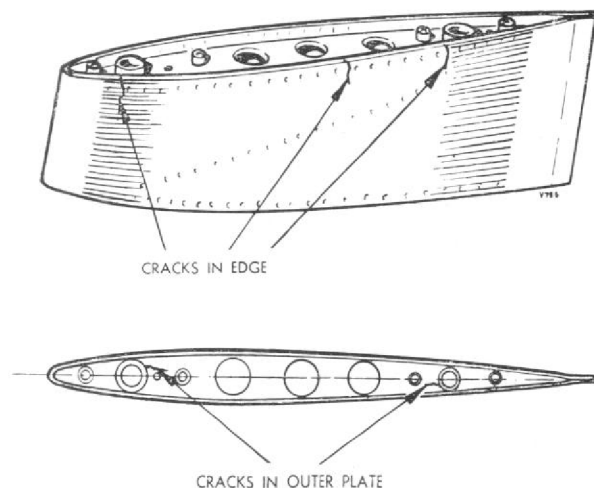
Fig. 3. Location of repairable cracks in exhaust cone fairing.

Any exhaust cone fairing (Ghost 48 Mk. 1, 48 Mk. 2 or 53 Mk. 1) in which cracks exist in its edges, or in its outer plates, at the approximate positions indicated in Fig. 3, may be repaired by the argon-arc welding process, provided that no crack exceeds 1.000 inch in length.

1. Remove any oil or grease, and using a rotary wire brush, thoroughly clean in and around the crack until bright metal is exposed.
2. Weld the crack by the argon-arc process, using filler rod to specification D.T.D.549.
3. Grind and polish the weld to produce a smooth finish, ensuring that the fusion point of the weld is not removed.
4. If this is the first time that this repair has been applied, lightly etch T.R.241 adjacent to the existing part number on the fairing. Make the appropriate entry in the engine log book.

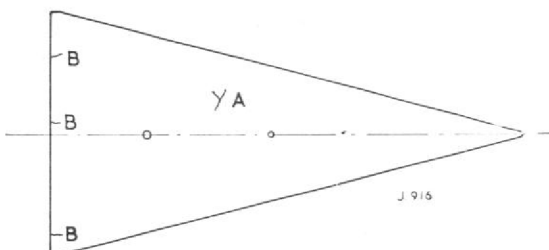
Inner cones cracked in approximately the positions indicated by 'A' and 'B' on Fig. 4 may be repaired by argon-arc welding, provided that the cracks do not exceed 5.000 inches in length at positions indicated by 'A' and 1.250 inches in length at positions at 'B'; see Fig. 4.

Fig. 4. Possible positions of repairable cracks in inner cone indicated by letters A and B.

Clean off any grease or oil, and using a rotary wire brush, thoroughly clean in and around the crack on both sides, until bright metal is exposed.

Weld the crack by the argon-arc process, using filler rod NC.82 (supplied by H. Wiggin & Co.). On completion, the weld may be cleaned by wire brushing, to facilitate inspection.

Lightly etch T.R.226 adjacent to the part number of the inner cone, and make an entry in the appropriate record book of the engine.

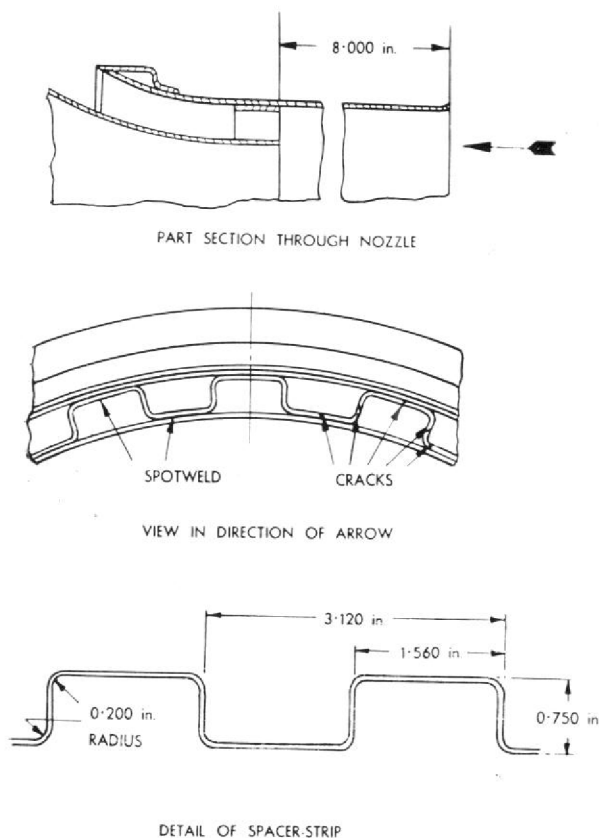
Any propelling nozzle, pre-mod. 740 (fixed) (Ghost 48 Mk. 1 or 48 Mk. 2), in which the spacer-strip has become cracked at any of the positions indicated in Fig. 5, overleaf, may be repaired by fitting a complete new spacer-strip.

Fig. 5. Location of cracks in spacer-strip; positions for spot-welding replacement sections, and dimensions for making replacement sections.

1. Cut out the complete spacer-strip and, where necessary, grind off any portions of the strip which remain attached to the parallel nozzle (venturi cuff) and to the propelling nozzle.
2. Thoroughly clean the surfaces to which the new spacer-strip is to be welded.

3. Refer to the table below, and select the spacer-strip appropriate to the assembly part number. Take four sections of the selected strip, and ensure that the surfaces to be welded are thoroughly clean. If a replacement strip is not available, suitable sections may be made up from local resources by using 18 S.W.G. steel sheet 0.900 inch wide, to Specification D.T.D.571, formed to the dimensions shown in Fig. 5.

4. Locate the four sections of the strip in position, so that the serrations are in contact with material that has not been subjected previously

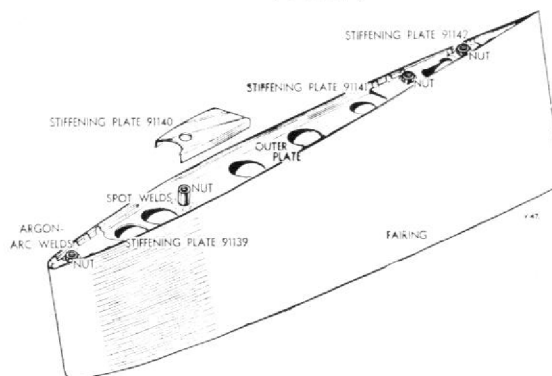
Fig. 7. Fairing with one of the stiffening plates removed to show the spot welds which secure the nut to the outer plate.

Fairings rejected as a result of damage to any of the outer plate nuts indicated in Fig. 7, may be salvaged by removing the damaged nut and its stiffening plate and argon-arc welding a replacement nut and stiffening plate in position.

Using a suitable power-driven grinder, carefully grind off the beads of argon-arc welding securing the damaged nut to the stiffening plate and also the stiffening plate to the edges of the fairing. Remove the stiffening plate.

Prepare the surrounding area of the vacated hole for welding, by cleaning off any oil or grease, followed by wire brushing until bright metal is exposed. Prepare the replacement nut and stiffening plate similarly.

Insert the nut through the hole from the inside and secure in position with a suitable clip or clamp. Using the argon-arc process and a filler rod to specification D.T.D.549, deposit a bead of filler rod into each drilled hole. Place the appropriate replacement stiffening plate into position and secure by tack welding at half inch intervals along both sides. Tack weld the protruding portion of the nut to the stiffening plate at four equal points. Ensure that the filler rod beads do not encroach on to the edges of the fairing, and where necessary, blend by careful grinding. Clean the finished weld by wire brushing.

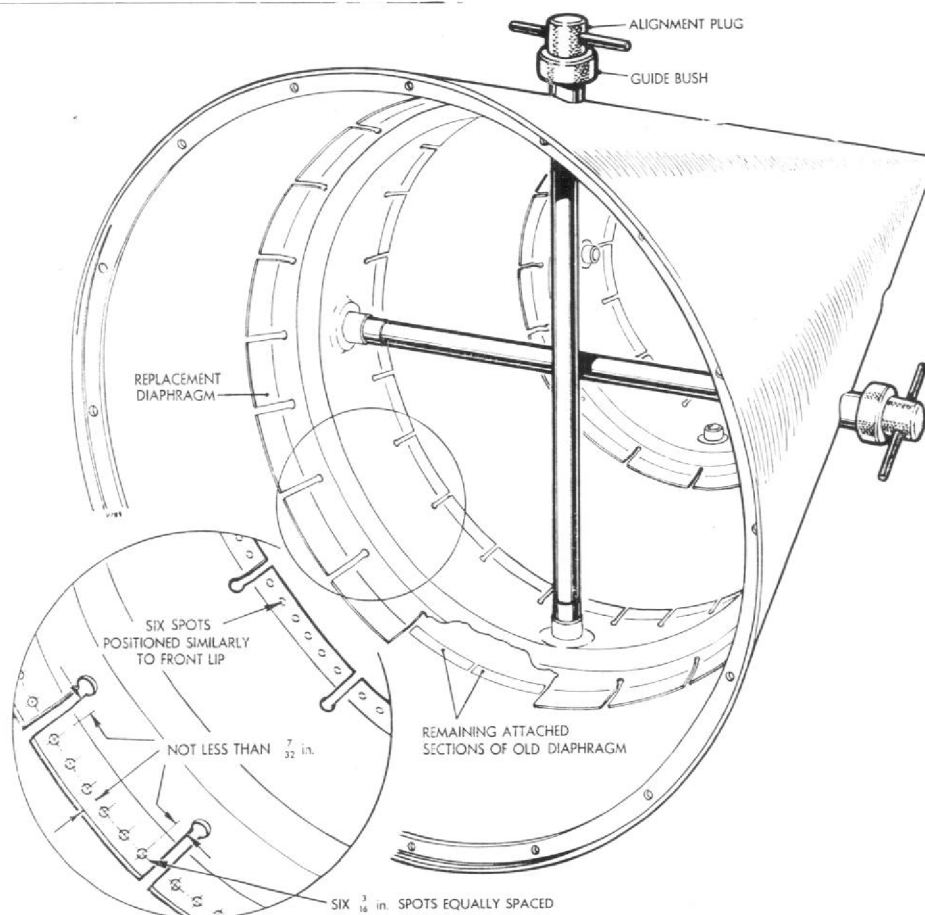
Fig. 8. Replacement front diaphragm positioned in inner cone.

Any inner exhaust cone (Ghost 48 Mk. 1, 48 Mk. 2 or 53 Mk. 1) in which the front diaphragm has broken away, leaving part of the diaphragm

1. Using oxy-acetylene welding equipment with the blowpipe adjusted to give an oxidizing flame, or using argon-arc welding equipment, detach the diaphragm from the inner cone by

remains which might foul the new diaphragm when it is located in position for welding. As in the previous operation, damage to the skin of the cone must be avoided by exercising extreme care.

3. Remove the remains of any metal which, as a result of the cutting operation, may be adhering to the cone.
4. Remove any oil or grease from the welding surfaces of replacement diaphragm, Part No. 93881, and of the inner cone, and thoroughly clean these surfaces by wire brushing.

5. Locate the replacement diaphragm in position in the cone, so that the four bosses on the diaphragm are aligned with the four holes in the cone.
6. Insert guide bush T.78804 through each of the four holes in the cone until it abuts with the diaphragm.

9. Clean off any welding flash which may protrude from under the flanges.
10. If this is the first time that this repair has been applied, lightly etch T.R.242 adjacent to the existing part number on the cone. Make the appropriate entry in the engine log book.

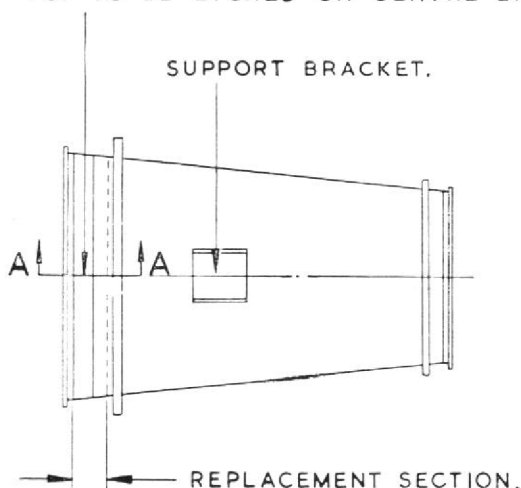
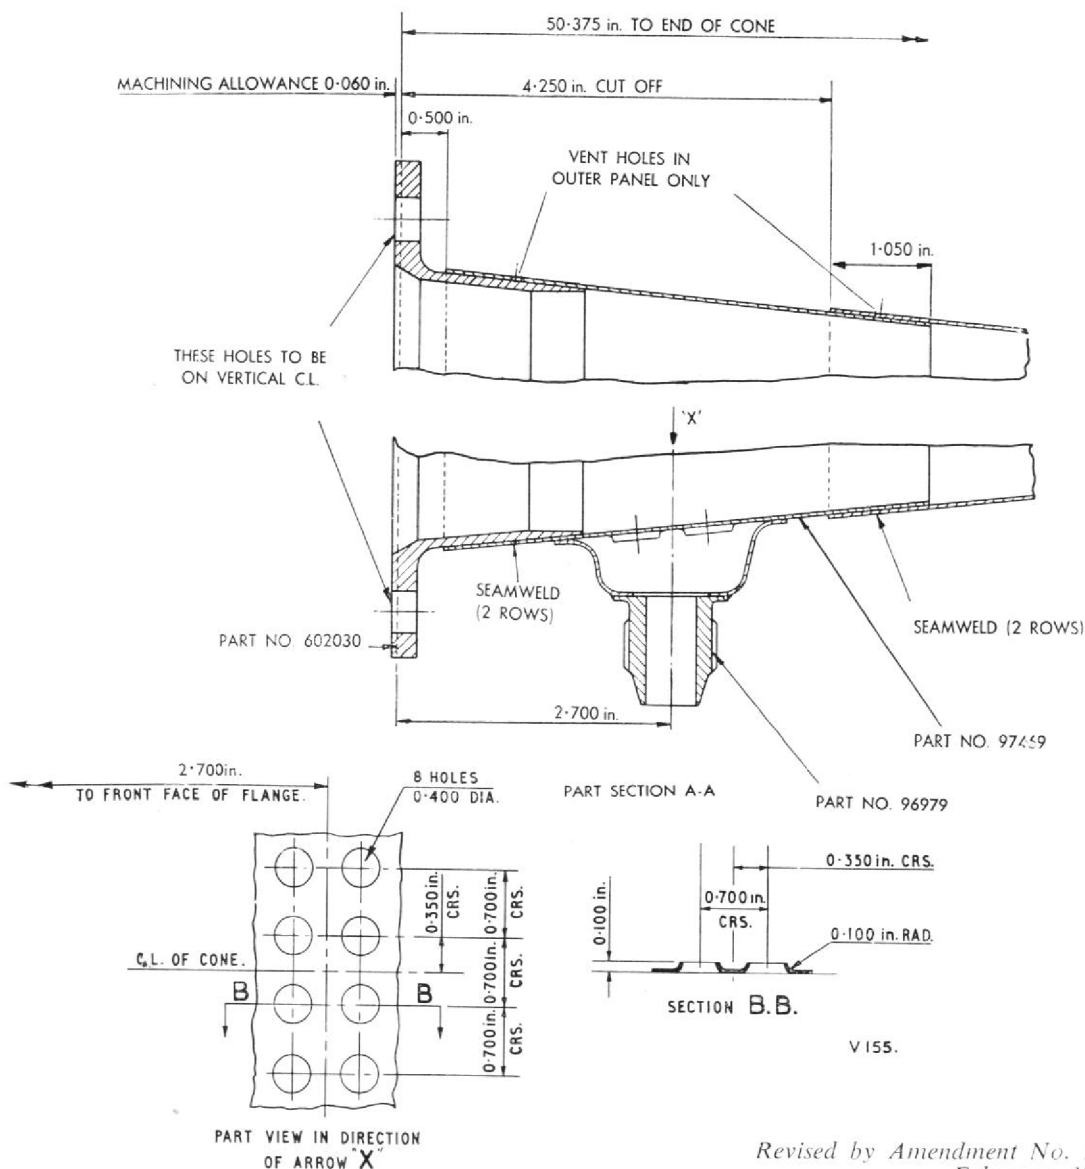
V.146.

Outer exhaust cones which have developed cracks or other damage in the front flange, may be rectified by fitting a replacement front flange section in accordance with these instructions.

1. Cut off the front section of the cone to the dimension shown.
2. Clean the surfaces to be welded. Prior to seamwelding, drill  $\frac{1}{16}$  inch diameter vent holes central to the seamweld, approximately 1.500 inch on either side of all longitudinal joints.
3. Seamweld replacement front section Part No. 97469 to the cone at the position indicated.
4. Mark off and drill drain holes.
5. Seamweld new front flange in position.

6. Finish machine front flange.
7. Drill thirty holes  $\frac{1}{8}$  inch diameter spaced equally on 33.200 inch pitch circle diameter in the front flange.
8. Seamweld drain trough in position.
9. Etch T.R.298 adjacent to the existing part number and make an entry in the appropriate record book of the engine.

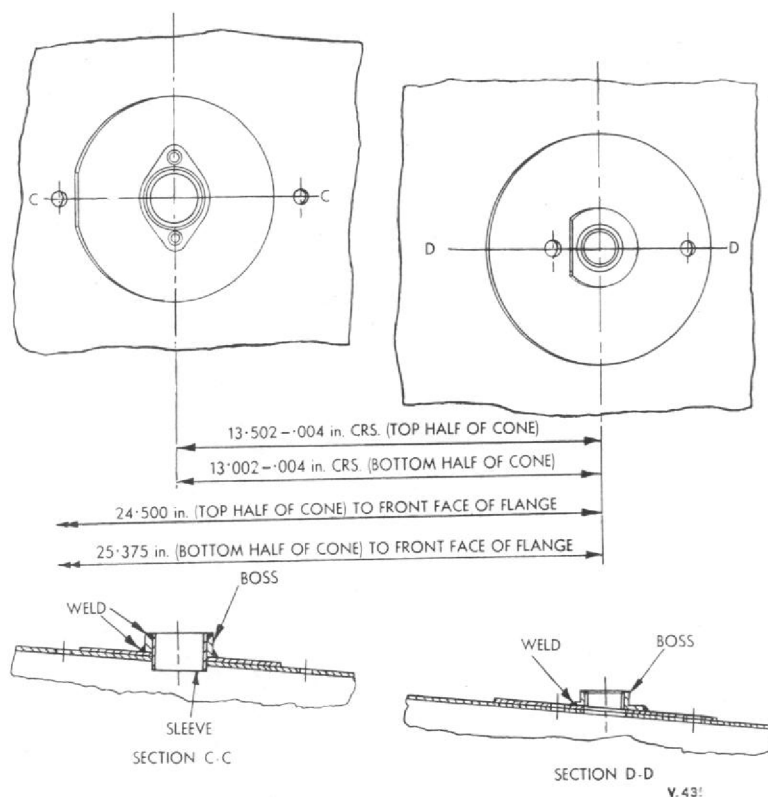
Inner exhaust cones which are excessively cracked, or damaged at the stiffening ring or threaded holes, may be rectified by fitting a replacement front flange section in accordance with these instructions. It should be noted that single cracks running inwards from any holes (up to a maximum of four) on the existing stiffening ring may be repaired by cleaning out and welding the cracks by the argon-arc process, re-threading the hole and machining the flange faces clean.

5. Seamweld the replacement front section to the inner cone as shown. Using a suitable tool, remove any welding flash.
6. Mark off and form the parallel section at the front end of the inner cone.

7. Trim the edge of the inner cone and clean the argon-arc welded joints in preparation for welding the butt joints of the replacement front section. (This, and operation 8, is only necessary when the replacement front section has been supplied in two parts.)

11. Seamweld the stiffening ring to the inner cone. Stitchweld the seam where missed by the seamwelding machine, on both the replacement front section and stiffening ring. Using a suitable tool, remove any welding flash from all seamweld joints.

12. Dress the skin of the replacement front section over the stiffening ring, as shown, using rollers T.78693.
13. Etch T.R.297 adjacent to the existing part number and make an entry in the appropriate record book of the engine.

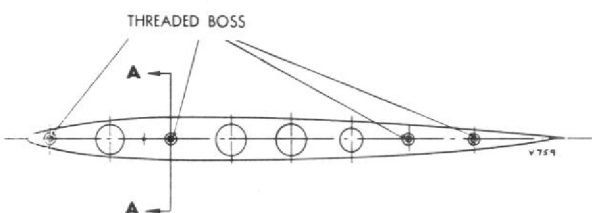
Exhaust cone fairings (Ghost 48 Mk. 1, 48 Mk. 2 or 53 Mk. 1) in which the threads in any of the bosses, Fig. 9, have become damaged, may be repaired by fitting Cross wire inserts in accordance with these instructions. Reference must be made also to chapter 32, page 2, which specifies the tools required, and contains general information essential to this repair.

Fig. 9. Threaded bosses in exhaust cone fairing. For section A-A see Fig. 10 and 11.

1. Using a 0.257 inch diameter (letter F) drill, drill through the defective hole.

2. Using a tap wrench with the appropriate taper, and plug taps, thread through the hole to 0.3012 inch diameter by 26 T.P.I. Whitworth form.
3. Remove any burrs from the edge of the hole, blow out the hole with compressed air, and using the appropriate inserting tool, screw in wire insert, Part No. N.4972, Fig. 10. Break off, and remove, the notched tang of the insert.

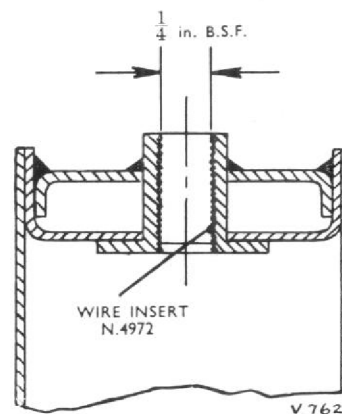
Fig. 10. Section A-A pre-mod. 187, showing wire insert fitted to boss.

4. Use a John Bull Intercheck small bore gauge in conjunction with the appropriate mandrel, and ring screw gauge, to check the thread of the insert.
5. Repeat operations 1 to 4 for each damaged hole.
6. If this is the first time that this repair has been applied, lightly etch T.R.381A adjacent to the

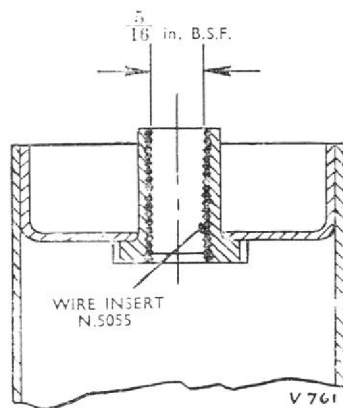
Fig. 11. Section A-A mod. 187, showing wire insert fitted to boss.

1. Using a 0.323 inch diameter (letter P) drill, drill through the defective hole.
2. Using a tap wrench with the appropriate taper, and plug taps, thread through the hole to 0.3727 inch diameter by 22 T.P.I. Whitworth form.
3. Remove any burrs from the edge of the hole, blow out the hole with compressed air, and

4. Use a John Bull Intercheck small bore gauge in conjunction with the appropriate mandrel, and ring screw gauge, to check the thread of the insert.
5. Repeat operations 1 to 4 for each damaged hole.
6. If this is the first time that this repair has been applied, lightly etch T.R.381B adjacent to the existing part number on the fairing. Make the appropriate entry in the engine log book.

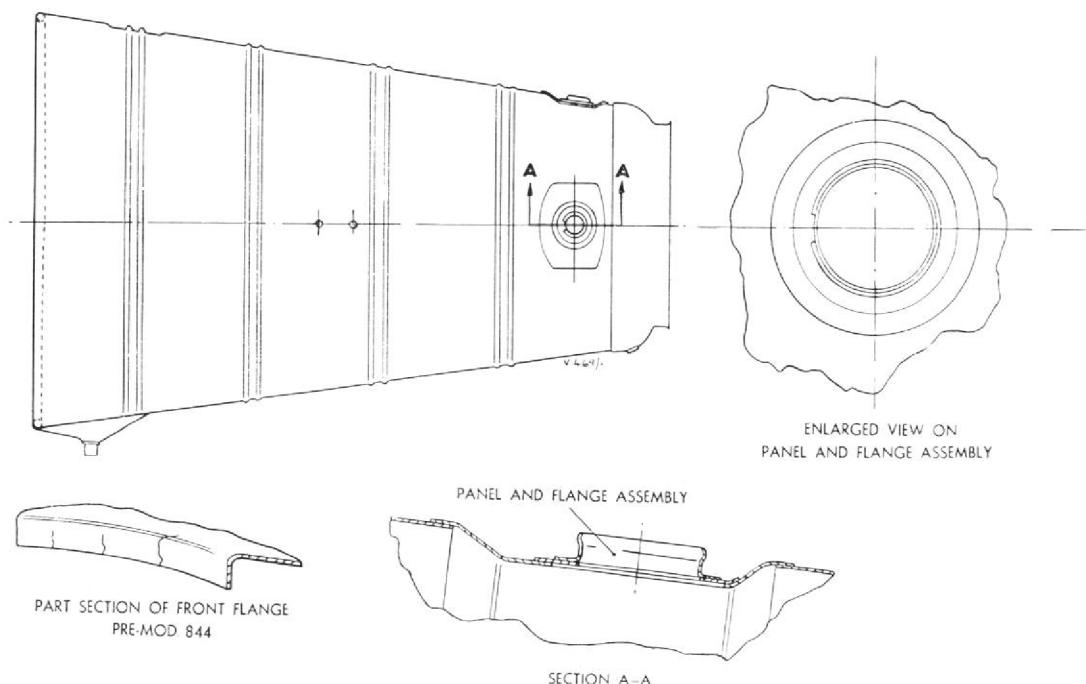
Any fireguard assembly (Ghost 48 Mk. 1, 48 Mk. 2, or 53 Mk. 1) in which cracks, not exceeding 1.000 inch in length, have occurred in the skin, or in which any one, or more, of the thermocouple flanges has become damaged, may be repaired in accordance with these instructions. Furthermore, fireguard assemblies, pre-mod. 844, in which cracks, not exceeding 0.500 inch in length, have occurred in the front flange, Fig. 12, may be repaired by applying the appropriate section of these instructions.

Fig. 12. View of the fireguard showing thermocouple flanges and location of cracks in front flange.

1. Remove any oil or grease, and using a rotary wire brush, thoroughly clean in and around the crack until bright metal is exposed.
2. Weld the crack by the argon-arc process, using filler rod to Specification D.T.D.489, or stabilized D.T.D.571.
3. Clean up after welding.

1. Cut out the damaged flange, ensuring that the resulting hole in the seating panel is left smooth and clean, and does not exceed 3.600 inches diameter.
2. Select the appropriate panel and flange assembly, from those listed below, according to the position in which it is to be fitted.

3. Remove any oil or grease, and using a rotary wire brush, thoroughly clean the surfaces of the fireguard, and of the replacement assembly, which are to be welded.
4. Position the replacement assembly central to the hole in the fireguard, ensuring that the slot in the flange is facing the front (large) end of the fireguard, refer to Fig. 12.
5. Electrically stitch weld all round the circumference of the panel of the assembly.

1. Remove any oil or grease, and using a rotary wire brush, thoroughly clean in and around the crack until bright metal is exposed.
2. Weld the crack by the argon-arc process, using filler rod to Specifications D.T.D.489, or stabilized D.T.D.571.
3. Grind and polish the weld to produce a smooth finish.
4. If this is the first time that this repair has been applied, lightly etch T.R.379A adjacent to the existing part number on the fireguard. Make the appropriate entry in the engine log book.

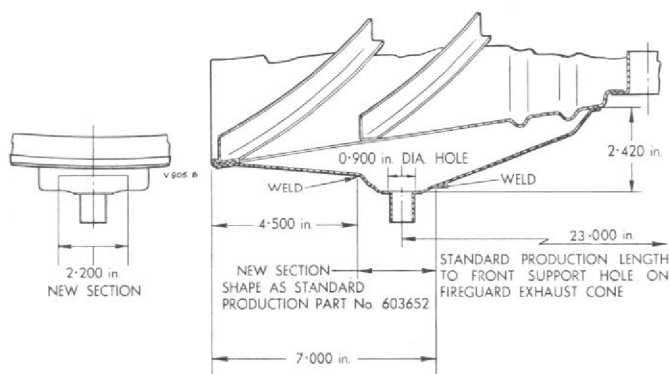
T.R.375. Fireguard drain trough.

If the number T.R.375 is found on a Ghost 48 Mk. 1 or 48 Mk. 2 fireguard, adjacent to the existing part number, this indicates that the position of the drain trough has been altered to accord with production standard.
