Chapter Forty-eight

## THE LODGE SURFACE DISCHARGE IGNITER PLUGS

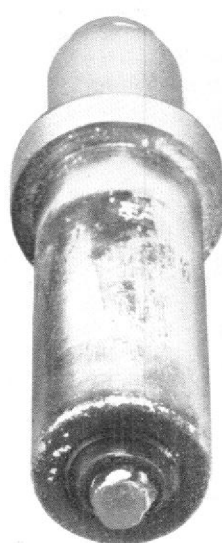
Fig. 4 (6 left). Centre electrode burnt and R.I pellet flaking—reject.

- (a) Centre electrode burnt or eroded to such an extent that the R.1 pellet is left unsupported over more than 15% of the circumference of the electrode tip—Fig. 4 and 5 are examples.
- (b) Radial cracks in the R.1 pellet or severe erosion such as that illustrated in Fig. 6 and 7.
- (c) Any signs of the centre electrode having fused or 'melted' around the periphery of the tip—Fig. 8.
- (d) Any signs of the centre electrode 'lifting' and, therefore, ceasing to maintain pressure on the R.1 pellet.

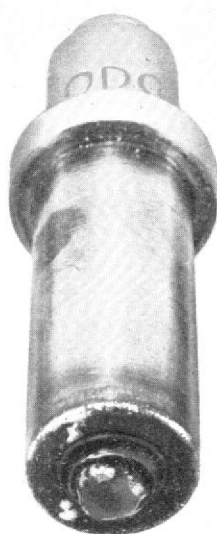
17

Fig. 5 (17 right). Centre electrode badly burnt and fused, R.I pellet flaking—reject.

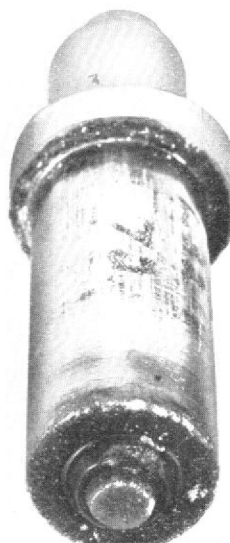
2

Fig. 6 (2 left). R.I pellet satisfactory but centre electrode burnt—reject.

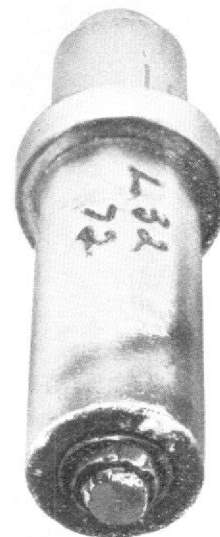
Fig. 7 (7 right). Centre electrode burnt but R.I pellet satisfactory—reject.

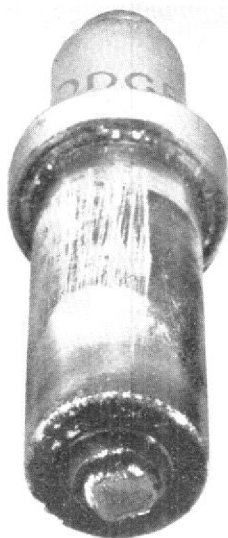
4

Fig. 8 (4 left). R.I pellet satisfactory but centre electrode burnt—reject.

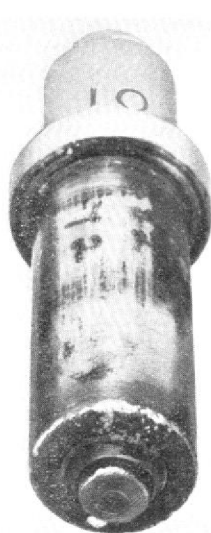
13

Fig. 9 (13 right). Centre electrode satisfactory but slight flaking of R.I pellet—serviceable.

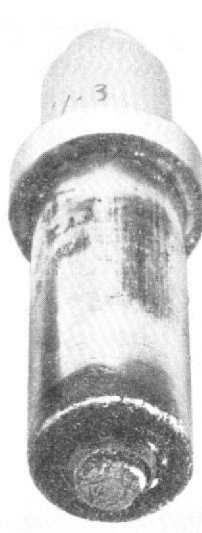
14

Fig. 10 (14 left). Slight burning of centre electrode and slight flaking of R.I pellet—serviceable.

Igniter plugs where there is normal slight erosion of both the centre electrode tip and of the R.1 pellet, or slight *surface* flaking of the R.1 pellet, such as those illustrated in Fig. 9, 10 and 11 can be regarded as serviceable.

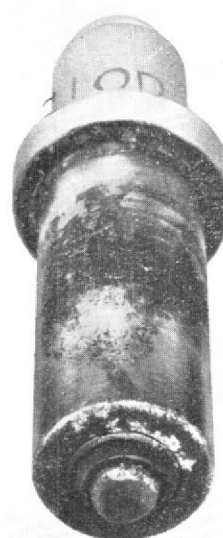
16

Fig. 11 (16 right). Slight burning of centre electrode and slight flaking of R.I pellet—serviceable.

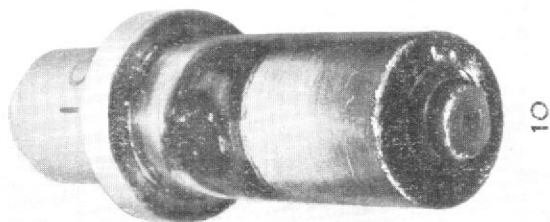
Fig. 12 (10). Both R.1 pellet and centre electrode satisfactory—serviceable.

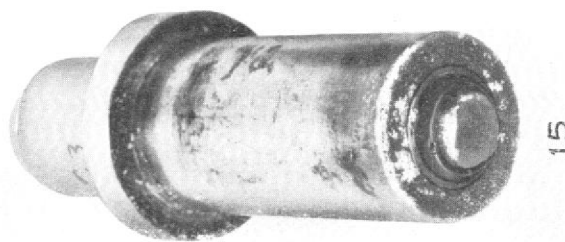
Fig. 13 (15). Slight burning of centre electrode but R.1 pellet satisfactory—serviceable.

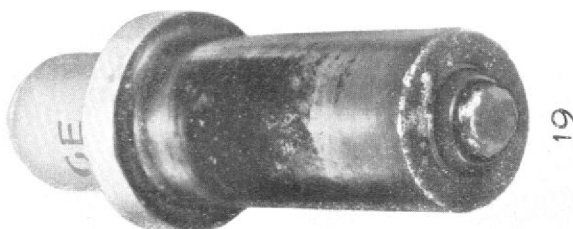
Fig. 14 (19). Slight burning of centre electrode but R.1 pellet satisfactory—serviceable.

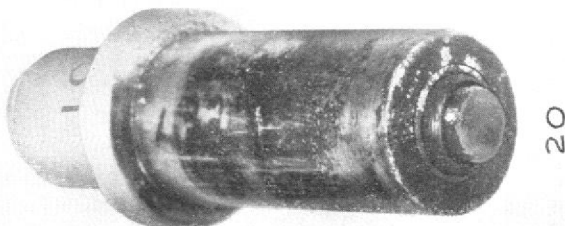
Fig. 15 (20). Slight burning of centre electrode and slight flaking of R.1 pellet serviceable.

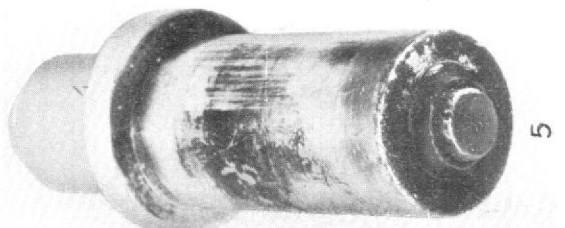
Fig. 16 (5). Very slight flaking of R.1 pellet and slight burning of centre electrode—almost a borderline case, serviceable subject to inspection every 50 hours.

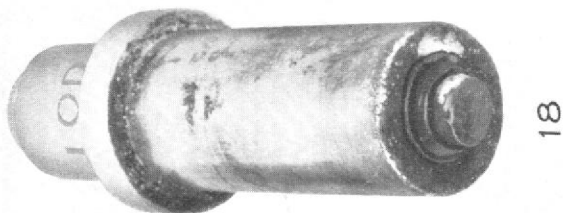
Fig. 17 (18). Centre electrode burnt and R.1 pellet flaking—reject.
