## TAIL PLANE

### Repair of damage affecting the spar flange and bottom skin of the tail plane

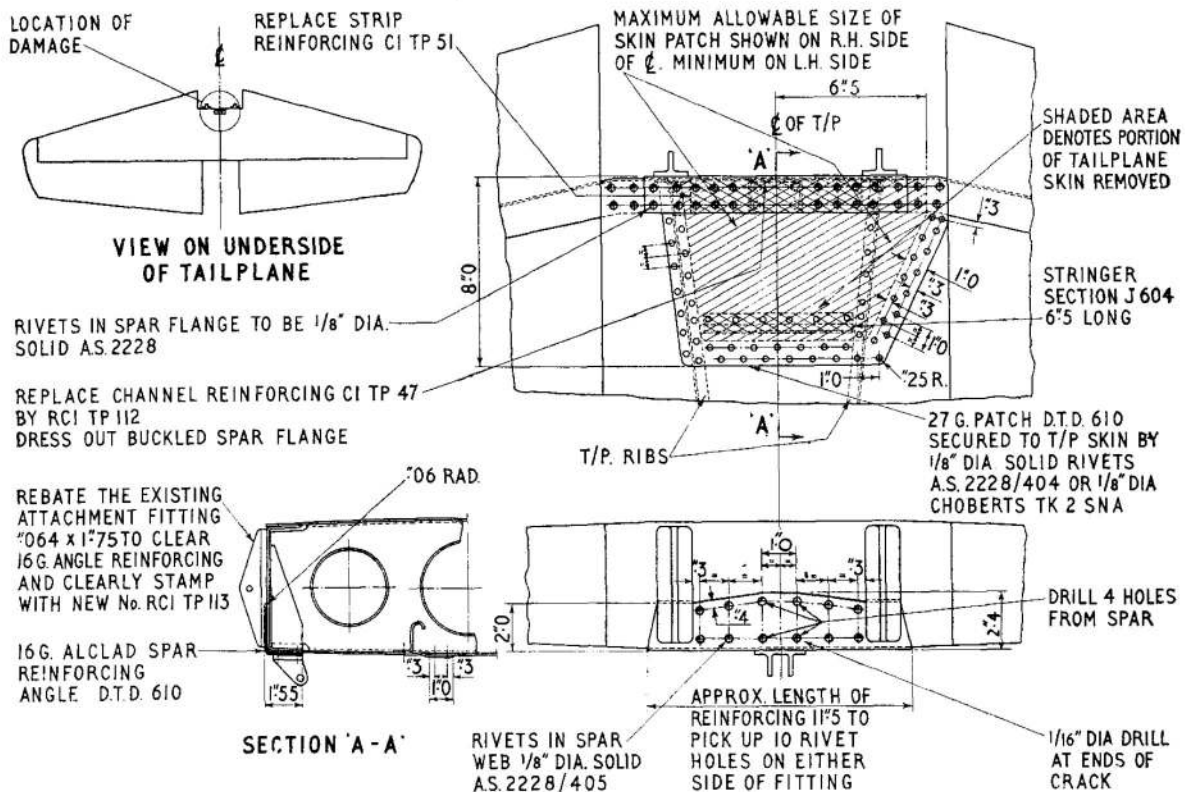
**FIG. 1. METHOD OF REPAIR**

As a consequence of a heavy landing or bad handling the failure of the compression member attachment to the tailplane front spar may occur.

1. The damage, totally torn skin and buckled flange of the spar, should be repaired as follows:—

- (1) Cut away skin where shown cross hatched on fig. 1.
- (2) Remove channel reinforcing from spar and unrevet 'V' brace from the ribs.
- (3) Dress out buckled flange of spar and inspect carefully for cracks or other damage; this may consist of a crack along the bend of the flange or tears at the bolt holes. Repairable damage must not exceed 2 in. on either side of the centre line of the tail-plane. All cracks must be drilled at extremities.
- (4) Remove tail-plane attachment brackets and modify the fitting as shown at the bottom left corner of fig. 1. Part number 'R.C1.TP.113' must be stamped upon the attachment fitting after this alteration.
- (5) Fit new channel reinforcement, R.C1

- (7) Repair skin with patch as illustrated. Locate stringer section J.604 and rivet to skin patch.
- (8) Make up spar reinforcing angle. Mark off rivet holes from spar and drill.

- (9) Offer up spar reinforcing angle to overlap skin patch and rivet to spar flange. Lift up skin to afford entrance for the dolly. This will not be necessary where there is an inspection hole available in top skin.
- (10) Position plates C1.TP.183 inside reinforcing channel, after drilling them for the two holding rivets as shown, so that they match up to existing 2 B.A. bolt holes. Secure each with two  $\frac{1}{8}$  in. dia. rivets through channel spar and reinforcing angle, countersinking on the

- (11) Drill and rivet angle to front of spar face.
- (12) Mark off additional holes in skin patch and drill and rivet, using Chobert rivets if necessary.
- (13) Refit tailplane attachment brackets now numbered R.C1.TP113 and also fit tail wheel compression strut fitting C1.TP.107.
