GROUP B FUSELAGE

FUSELAGE

NOSE WHEEL COLLAPSE

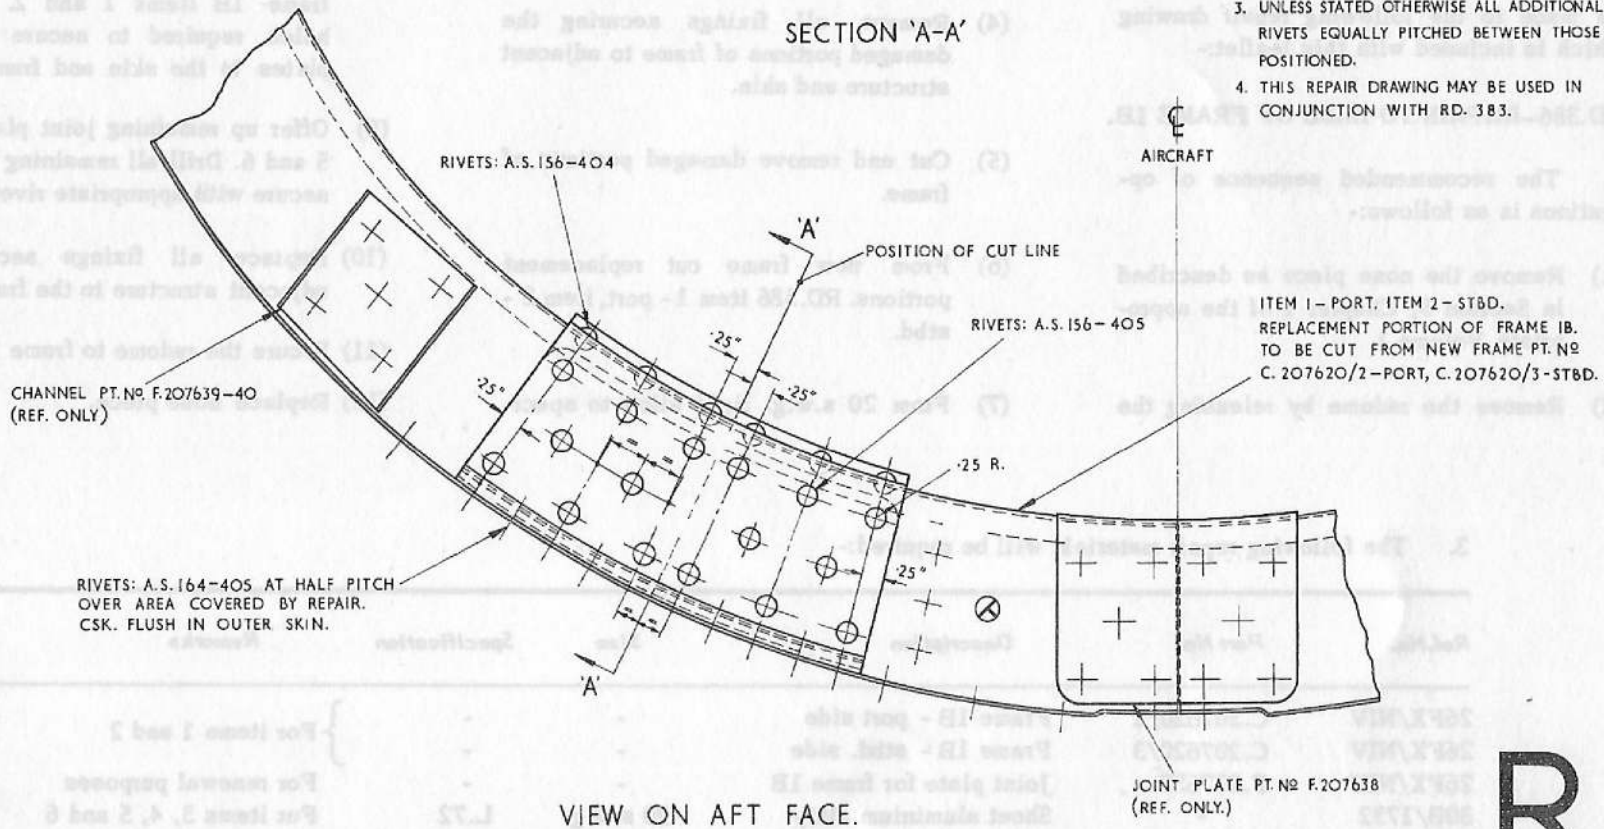
1. Where damage has occurred to the nose piece the frames as well as the skin may be damaged. This leaflet deals with the repair of frame 1B. Reference should be made to the following repair drawing which is included with this leaflet:-

- (3) Mark out the position of the cut line.
- (4) Remove all fixings securing the damaged portions of frame to adjacent structure and skin.
- (5) Cut and remove damaged portions of frame.
- (6) From new frame cut replacement portions. RD.386 item 1 - port, item 2 - stbd.
- (7) From 20 s.w.g. light alloy to speci-

- (8) Offer up joint plates items 3 and 4 together with replacement portions of frame 1B items 1 and 2. Drill the holes required to secure the joint plates to the skin and frame flange.
- (9) Offer up remaining joint plates items 5 and 6. Drill all remaining holes and secure with appropriate rivets.
- (10) Replace all fixings securing the adjacent structure to the frame.
- (11) Secure the radome to frame 1A.
- (12) Replace nose piece.

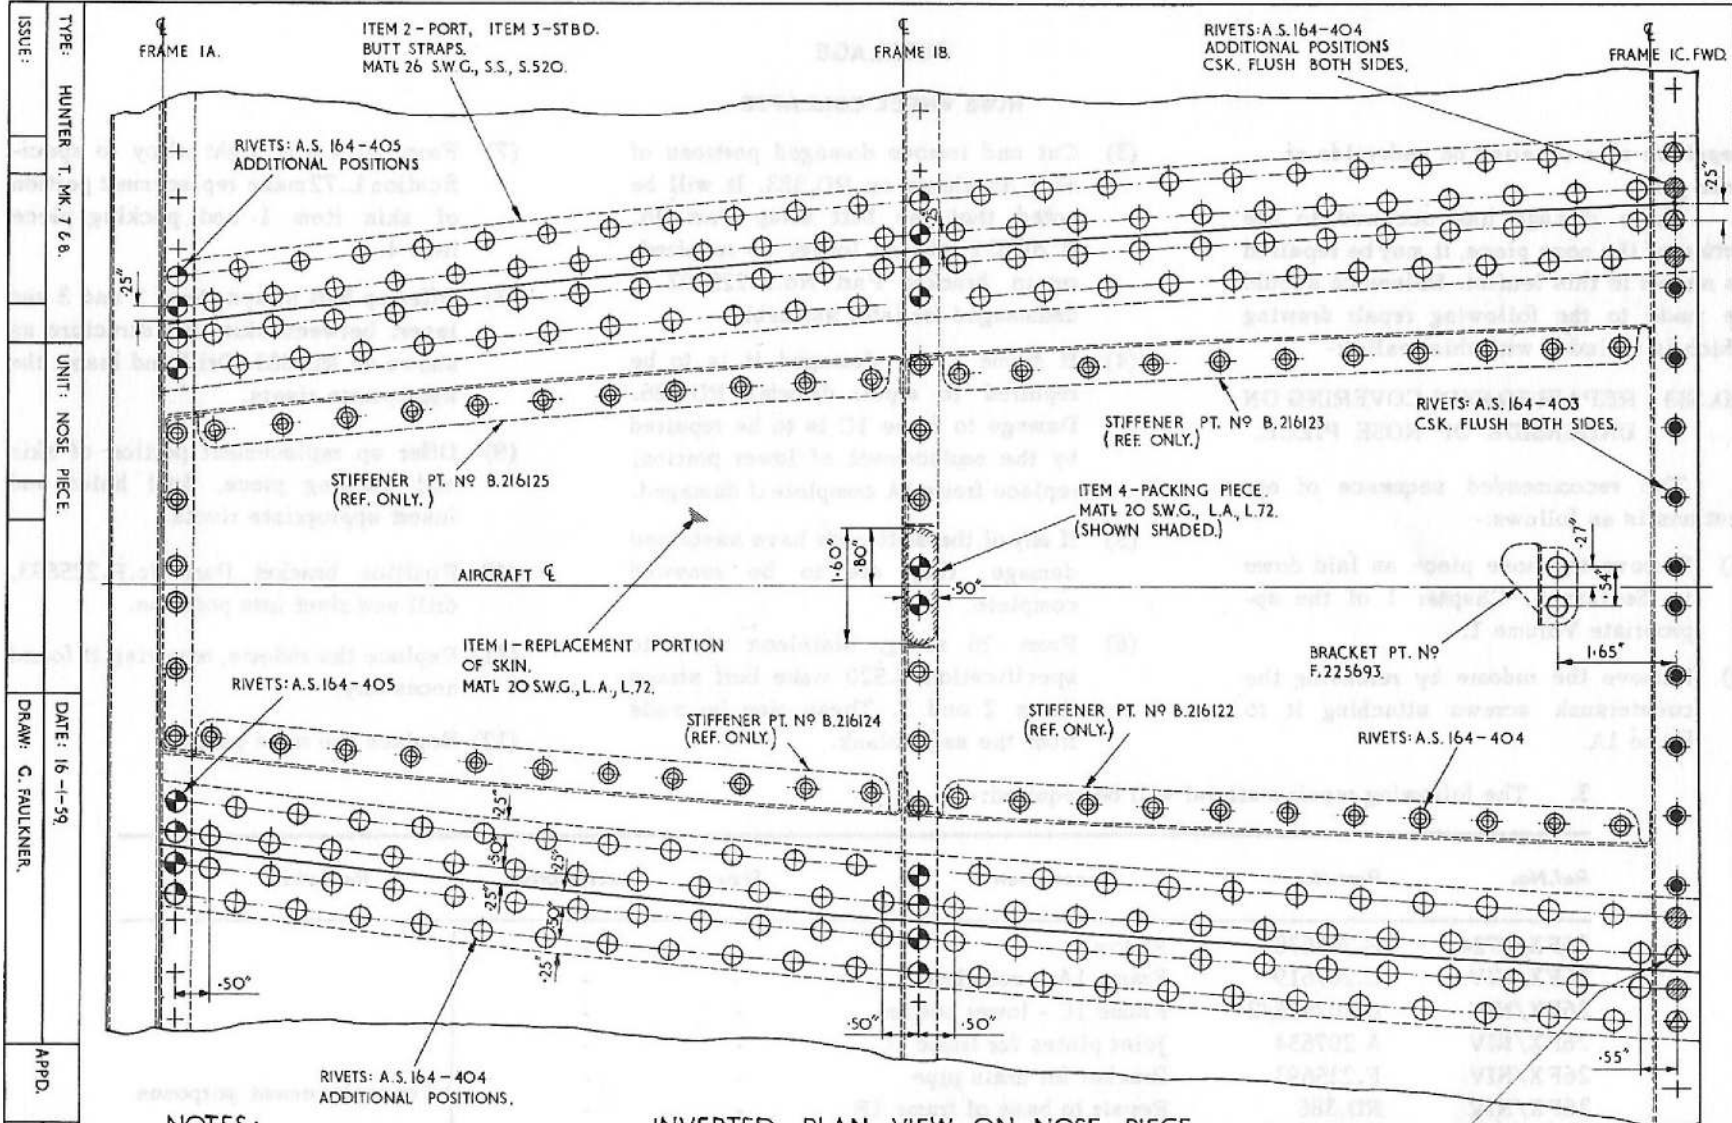
REPAIR TO SKIN COVERING ON UNDERSIDE OF NOSE PIECE.

1. Where damage has occurred to the bottom of the nose piece, it may be repaired as shown in this leaflet. Reference should be made to the following repair drawing which is included with this leaflet:-

- (3) Cut and remove damaged portions of skin as shown on RD.383. It will be noted that the butt strap Part No. B.207631 will no longer be required, retain bracket Part No.F.225693 if undamaged for later assembly.
- (4) If frame 1B is damaged it is to be repaired to repair drawing RD.386. Damage to frame 1C is to be repaired by the replacement of lower portion, replace frame 1A complete if damaged.
- (5) If any of the stiffeners have sustained damage they are to be renewed complete.
- (6) From 26 s.w.g. stainless steel to specification S.520 make butt straps items 2 and 3. These may be made from the same blank.

- (7) From 20 s.w.g. light alloy to specification L.72 make replacement portion of skin item 1 and packing piece item 4.
- (8) Offer up butt straps items 2 and 3 and insert between skin and structure as shown on RD.383. Drill and insert the appropriate rivets.
- (9) Offer up replacement portion of skin and packing piece, drill holes and insert appropriate rivets.
- (10) Position bracket Part No.F.225693, drill and rivet into position.
- (11) Replace the radome, renewing if found necessary.
- (12) Replace the nose piece.

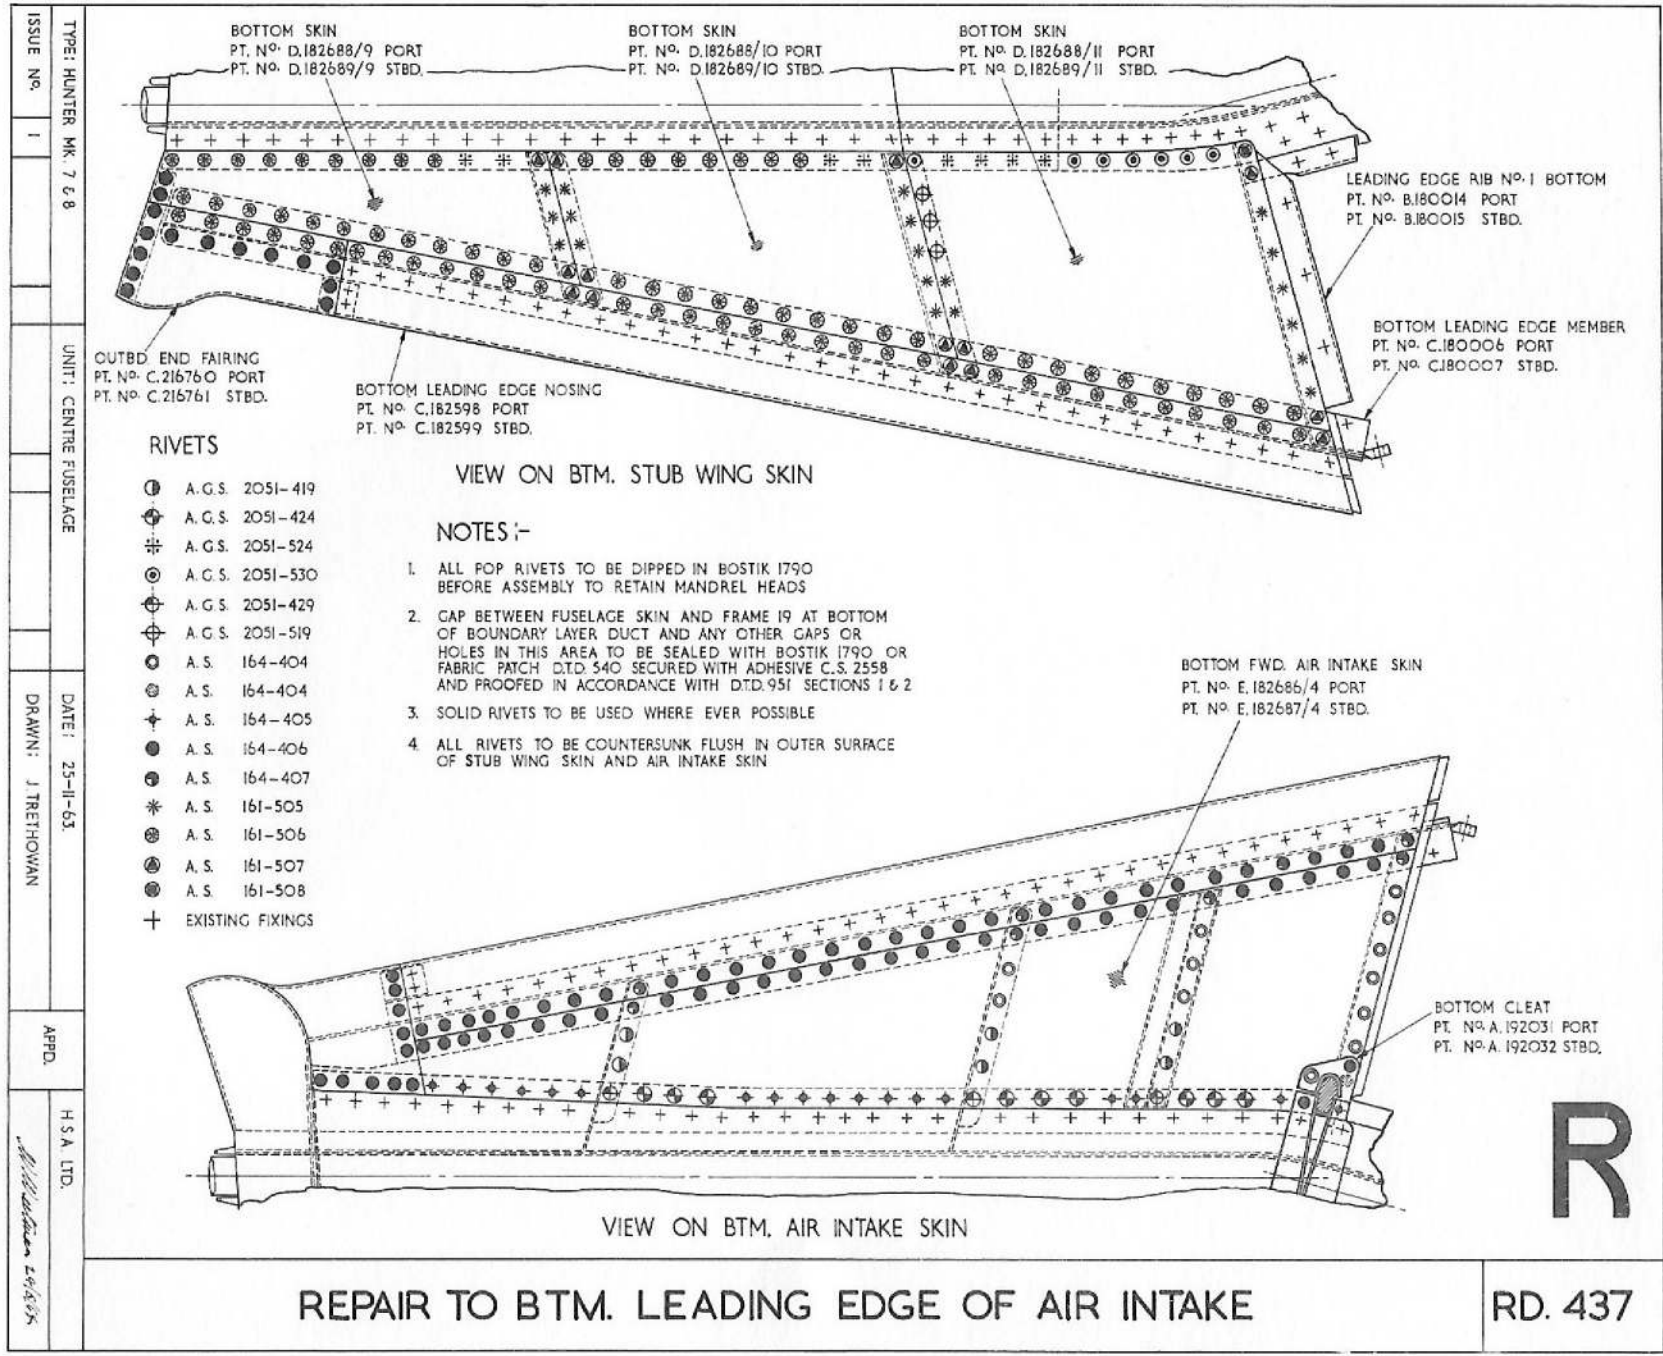
REPAIR TO BTM. LEADING EDGE OF AIR INTAKE

Repair to bottom leading edge of air intake.
