Chapter Fifty-two

# ROTAX HIGH ENERGY IGNITION UNITS

Type NB.25/2

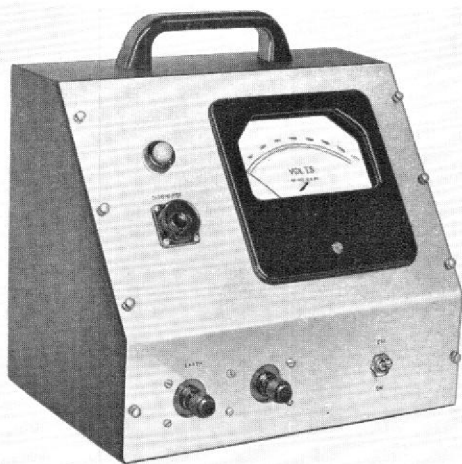
Fig. 5. Typical peak valve voltmeter.

The peak valve voltmeter, Fig. 5, may be built up from the components, as shown in the circuit diagram, Fig. 6.

Set the input voltage to 28 and switch on the supply; then, using the peak valve voltmeter, measure the voltage across the  $6\ \mu\text{F}$ . capacitor and the case. This should be within the limits of 1.9 to 2.1 kV.

With the unit removed from the altitude box, operate it with the surface discharge plug lead disconnected from the H.T. outlet socket; then using the peak valve voltmeter, measure the voltage between the 6  $\mu$ F. capacitor and earth. This should not exceed 2.5 kV.
