CHAP. 4 AIRFRAME S.P. 404 A.L. 1 SHEET 1 OF 2	SERVICING PROCEDURE F53 T55	BAC F53 & T55 (SA) 5A3A Section 1 2nd Edition
Main Undercarriage Side-stay Brackets - Cracking		AFSC 43151 53450 53470
Safety and Servicing Notes are to be complied with throughout the work detailed on this card.		TIME EST
SPECIAL TOOLS AND EQUIPMENT Nil.		ASSOCIATED PROCEDURES
<u>43151</u>		
1. EXAMINATION		
1.1 Main undercarriage side-stay brackets (Part No. EB1-20-1629 or Part No. EB1-20-1630, at joint to Rib 11B).	Examine, particularly for cracks (See Fig.1).	
<u>53450</u>		
NOTE: Item 2 is applicable only where cracks are found in side-stay brackets.		
2. RECTIFICATION		
2.1 Defective brackets.	Repair as necessary.	
<u>53470 (INSPECTOR)</u>		
3. INSPECTION STAGE		
3.1 Inspect.	Item 2, if applicable.	
Continued Overleaf

BAC F53 & T55 (SA)
5A3A Section 1
2nd Edition

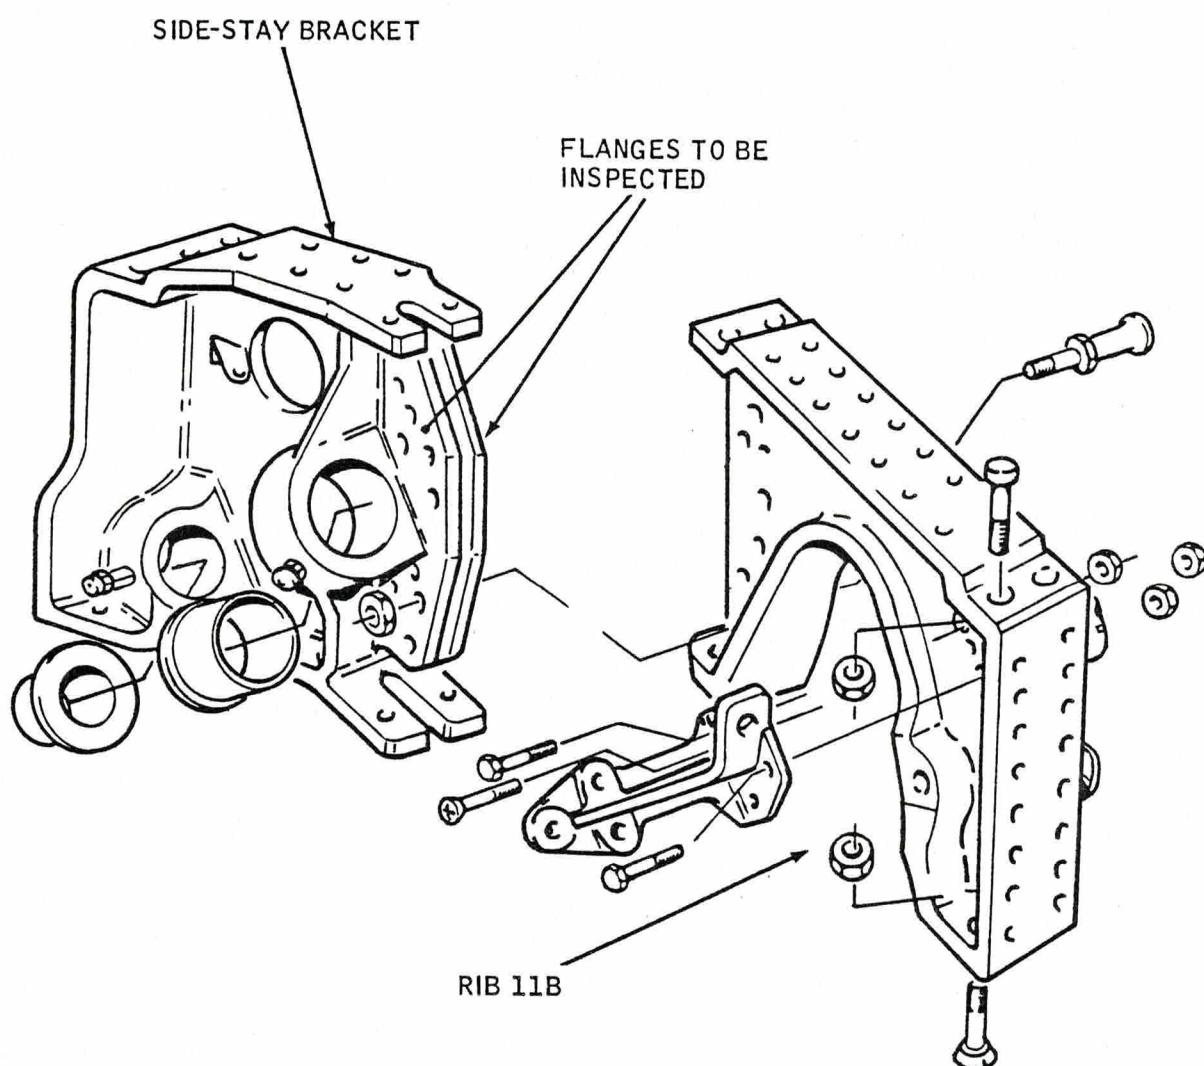
FIGURE 1

MAIN UNDERCARRIAGE SIDE-STAY BRACKET
