SI/Hunter/128

29 January 1976

A SI/HUNTER/128 B
FUSELAGE: HOOD JETTISON MECHANISM RELEASE UNIT: INOPERATIVE

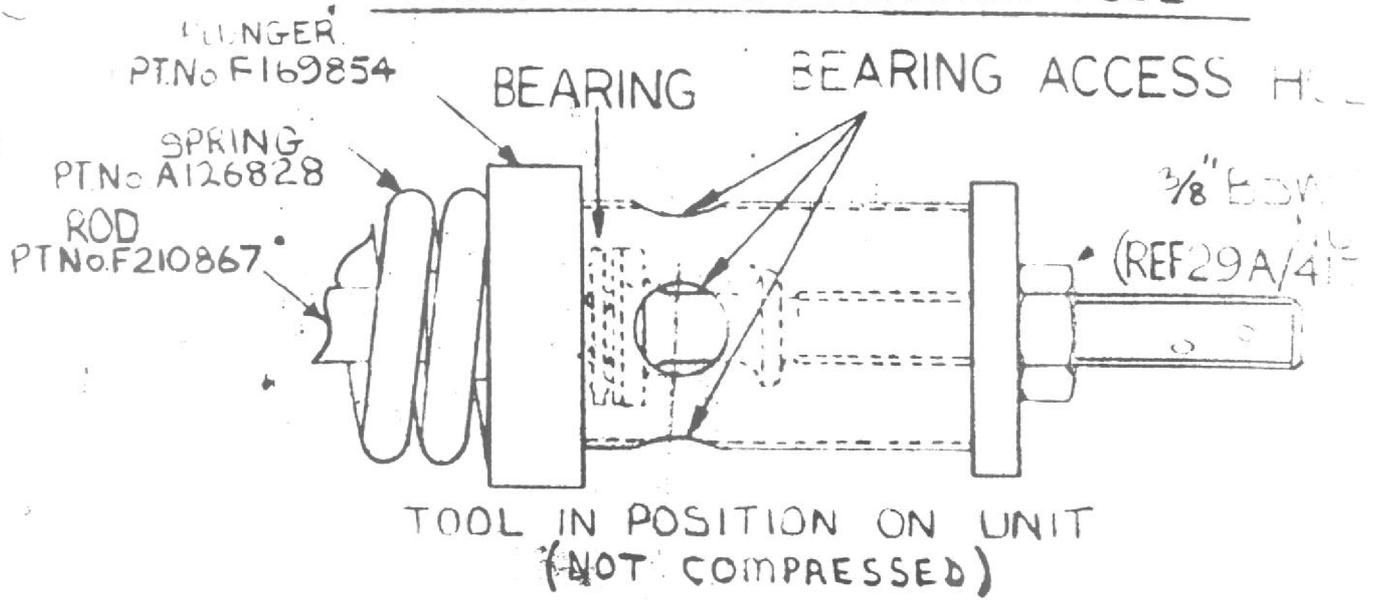
FIG.1. SPRING COMPRESSION TOOL

- (9) Refer to Fig 1 attached and manufacture the Distance Piece from 16 SWG Mild Steel Tube (Ref 30A/9610334) and the Washer from 3 SWG Steel Plate (Ref 30A/2708) or $1\frac{1}{2}$ inch Mild Steel Bar (Ref 30C/9610743).

- (10) Assemble the distance piece and washer to the operating lever end of the rod as shown in Fig 1 and using a $\frac{3}{8}$ inch BSW Steel Nut (Ref 29A/4179166) assembled to the threaded portion of the rod, compress the spring approximately 0.4 inch to allow lubrication of the $\frac{3}{8}$ inch Thrust Bearing (Ref 2A/9500491) through the four $\frac{1}{2}$ inch diameter holes in the distance piece.

- (27) Refer to the attached sketch and manufacture the Distance Piece from 16 SWG Mild Steel Tube (Ref 30A/9610334) and the Washer from 3 SWG Steel Plate (Ref 30A/2708).

- (28) Assemble the distance piece and washer to the operating lever end of the rod as shown in Fig 1 and using a $\frac{3}{8}$ inch BSW Steel Nut (Ref 29A/4179166) assembled to the threaded portion of the rod compress the spring approximately 0.4 inch to allow lubrication of the $\frac{3}{8}$ inch Thrust Bearing (Ref 2A/9500491) through the four $\frac{1}{2}$ inch diameter holes in the distance piece.

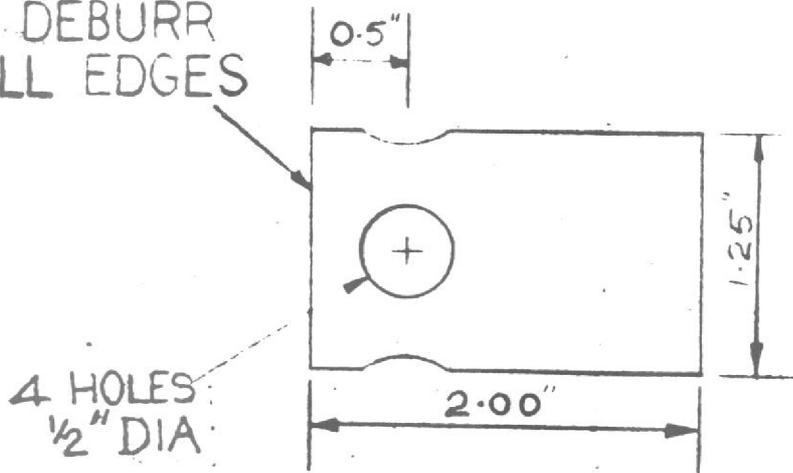
DISTANCE PIECE

DEBURR
ALL EDGES

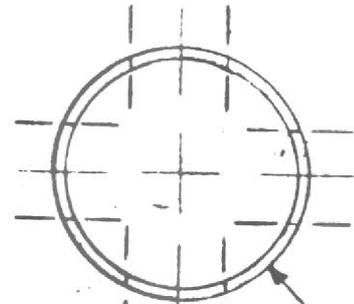
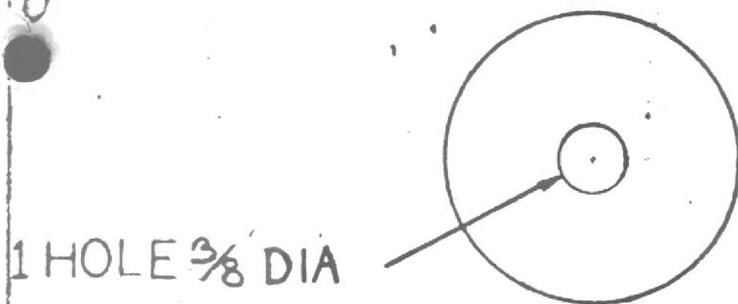
WASHER

MANUFACTURE FROM 1 1/2" DIA
MILD STEEL BAR (REF 30C 9610743)

OR 3 SWG STEEL PLATE
(REF 30A/2708)
