A
ROLLS - ROYCE

MAINTENANCE OF THE
AVON 1
TURBO JET AERO-ENGINE

Oil System Servicing

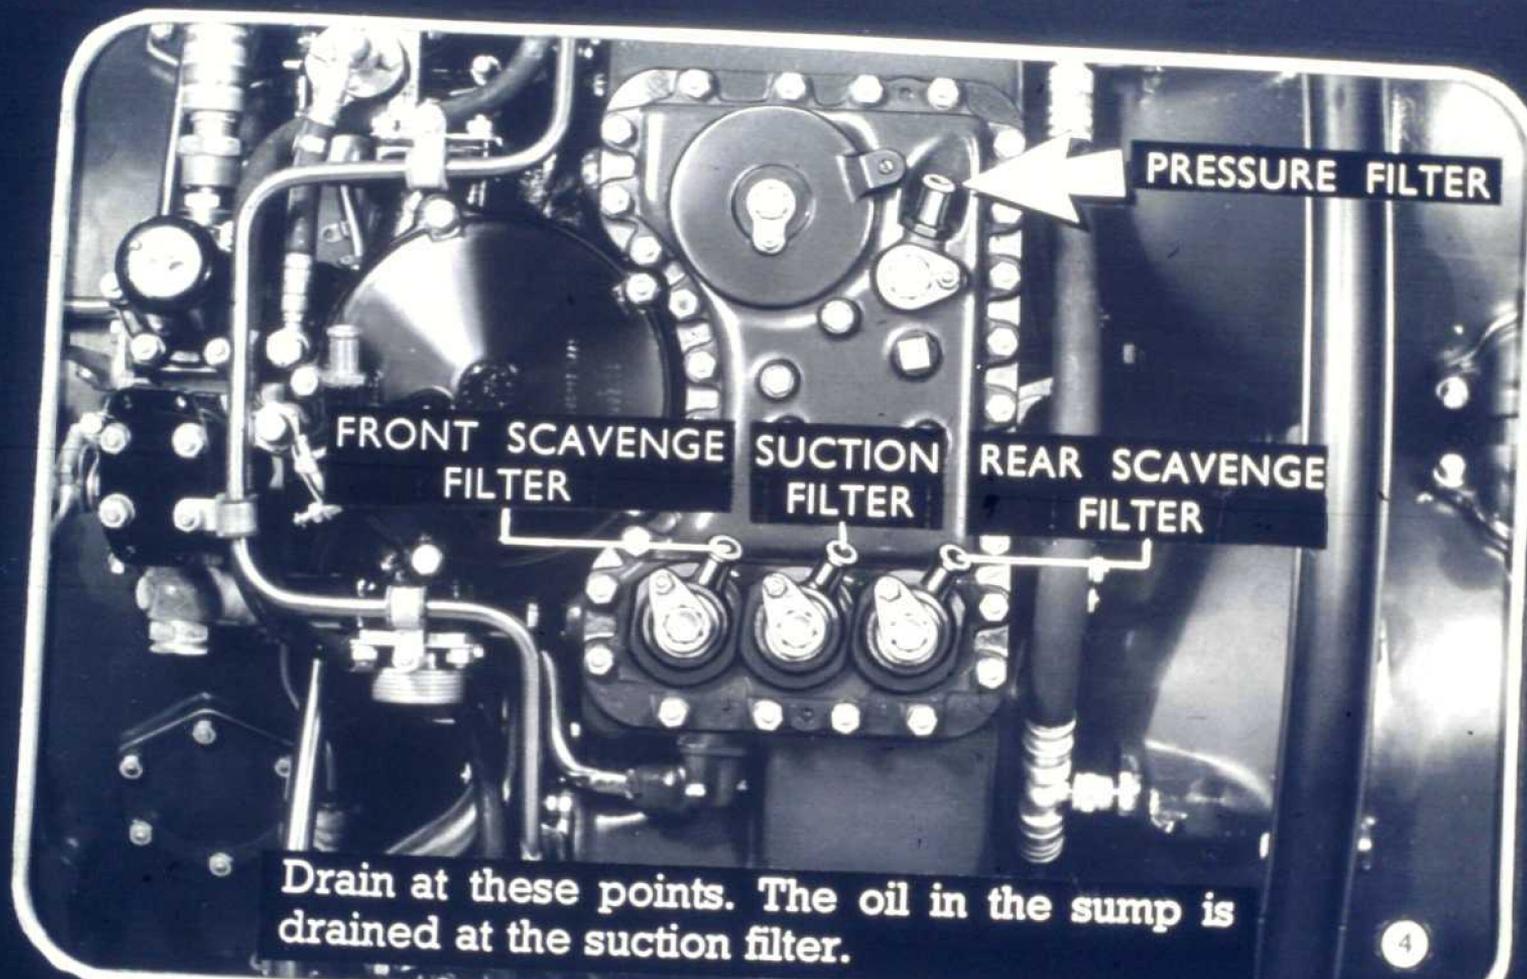
PRESSURE FILTER

**FRONT SCAVENGE
FILTER**

**SUCTION
FILTER**

**REAR SCAVENGE
FILTER**

Drain at these points. The oil in the sump is drained at the suction filter.

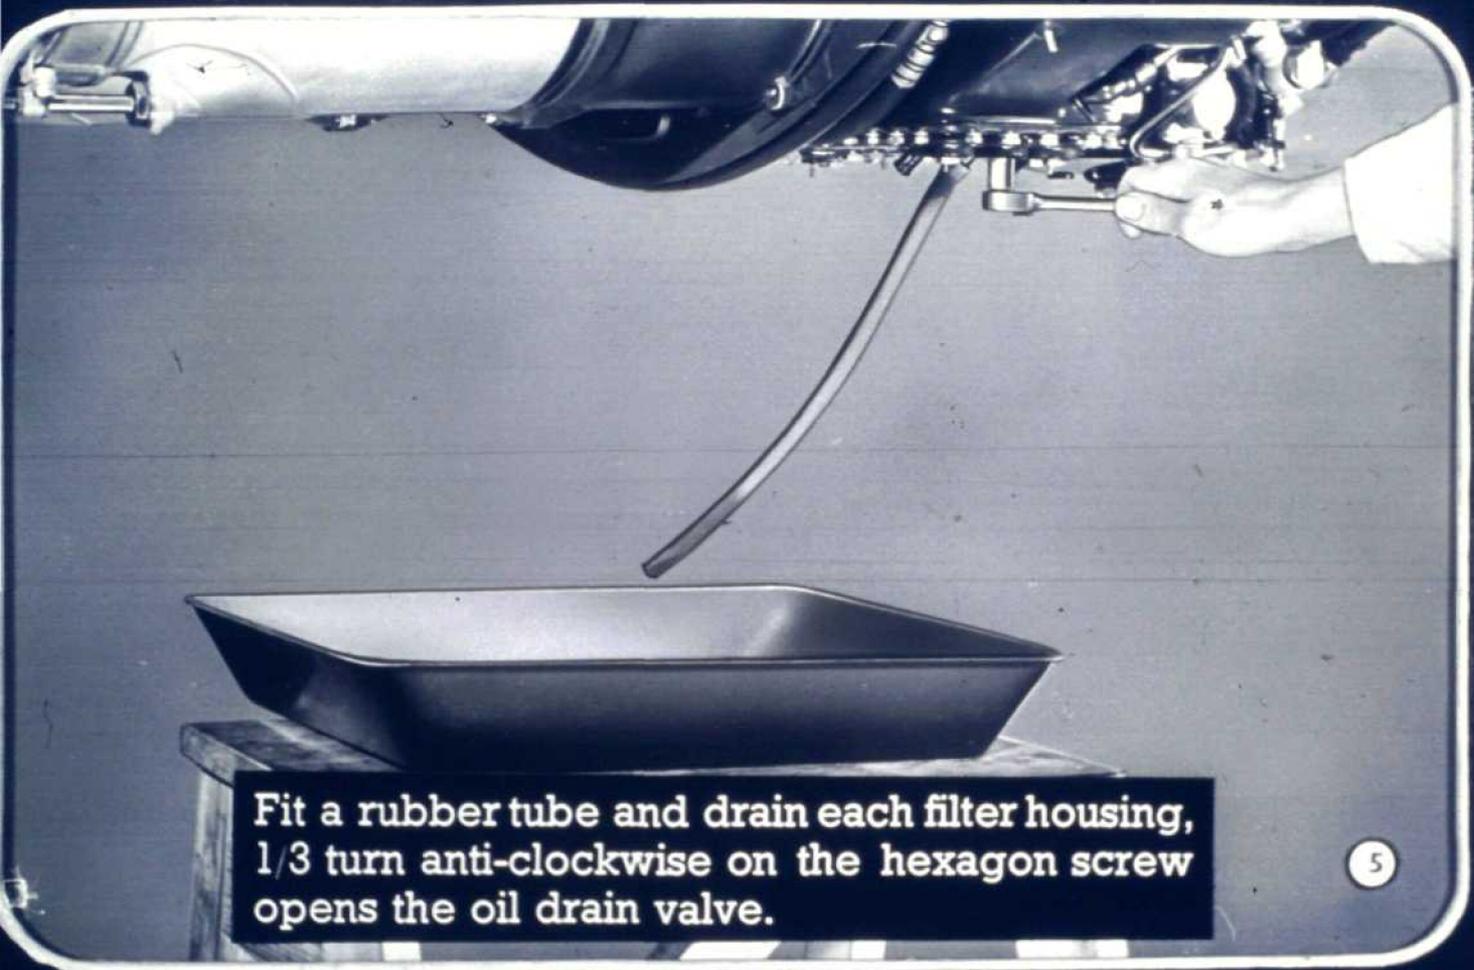
Fit a rubber tube and drain each filter housing, 1/3 turn anti-clockwise on the hexagon screw opens the oil drain valve.

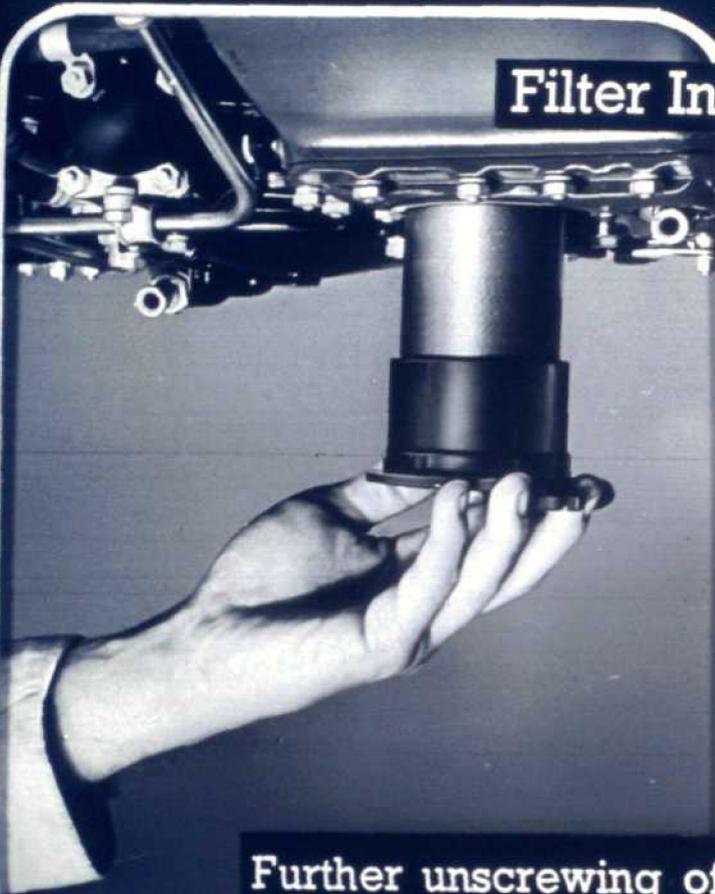
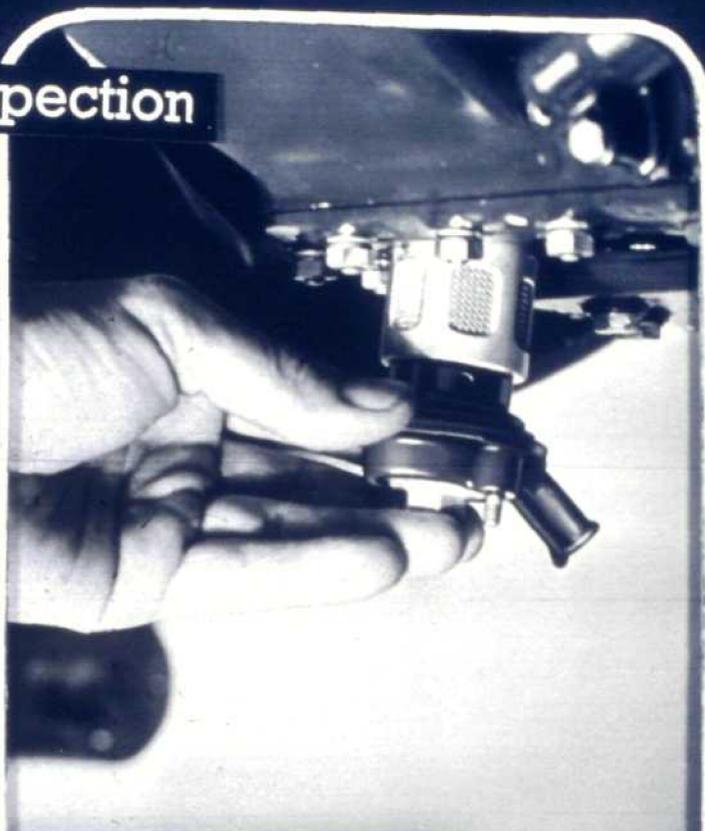
Further unscrewing of the hexagons extracts the filters and caps. Remove all filters.

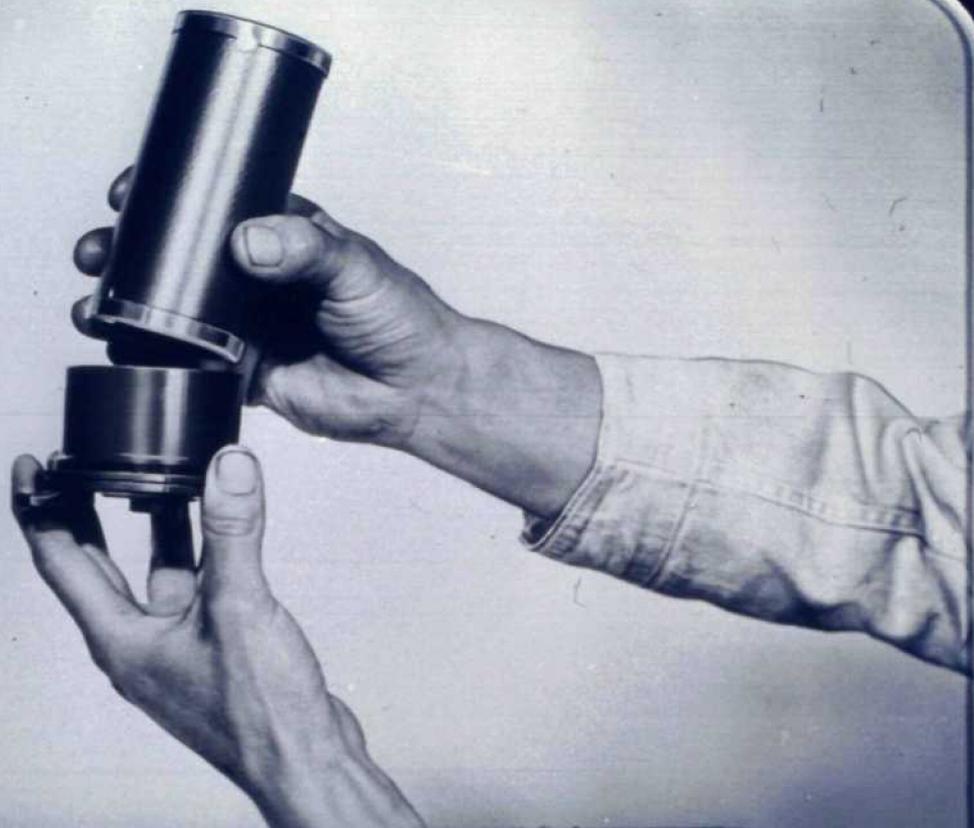
Extract the pressure filter from the filter cap.

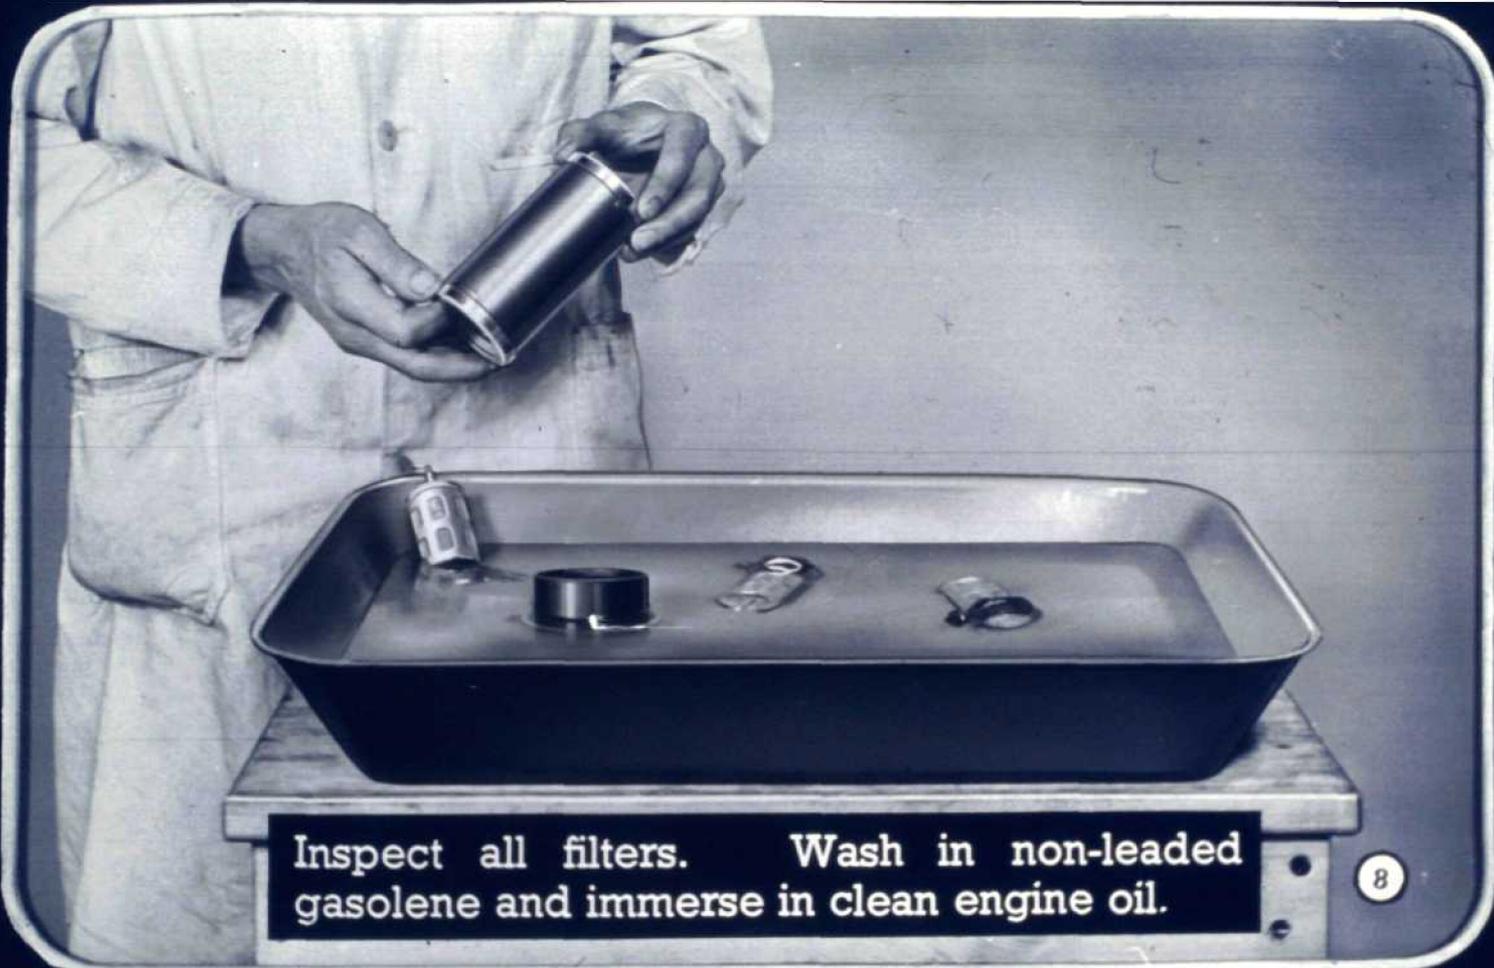
Inspect all filters. Wash in non-leaded gasoline and immerse in clean engine oil.

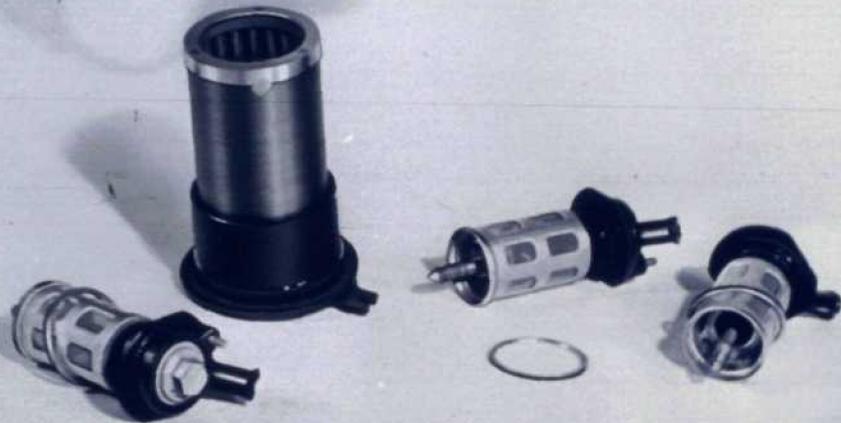
Examine the filter sealing washers and renew if damaged.

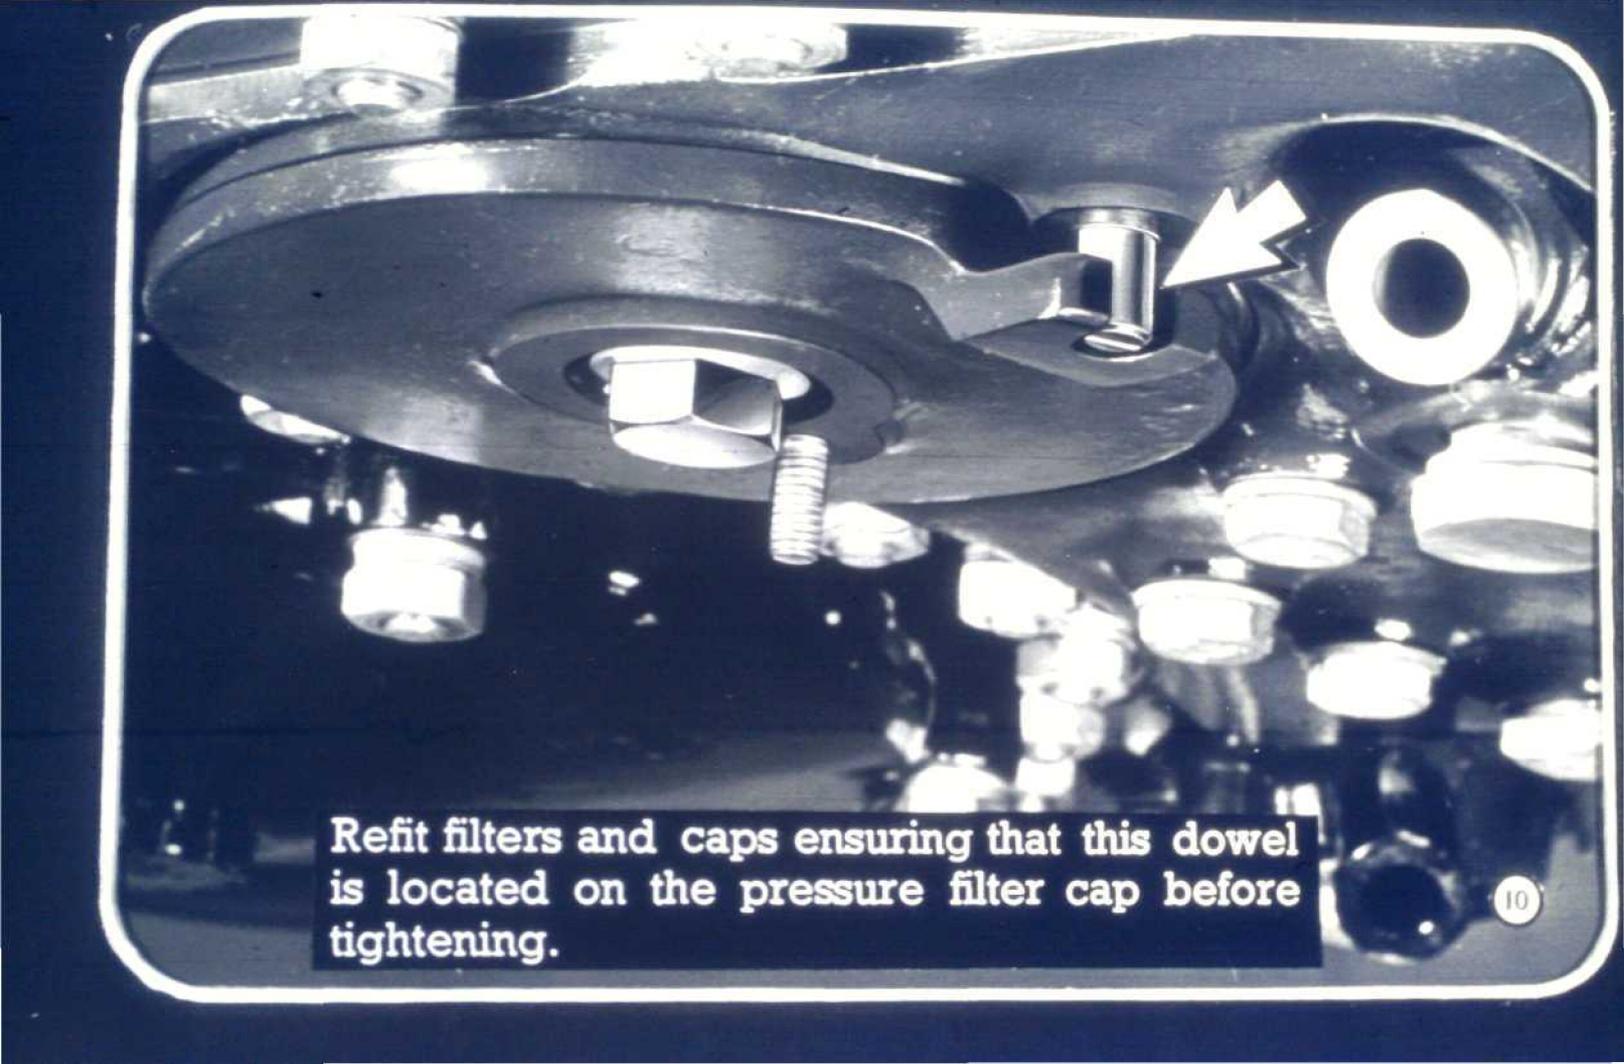
Refit filters and caps ensuring that this dowel is located on the pressure filter cap before tightening.

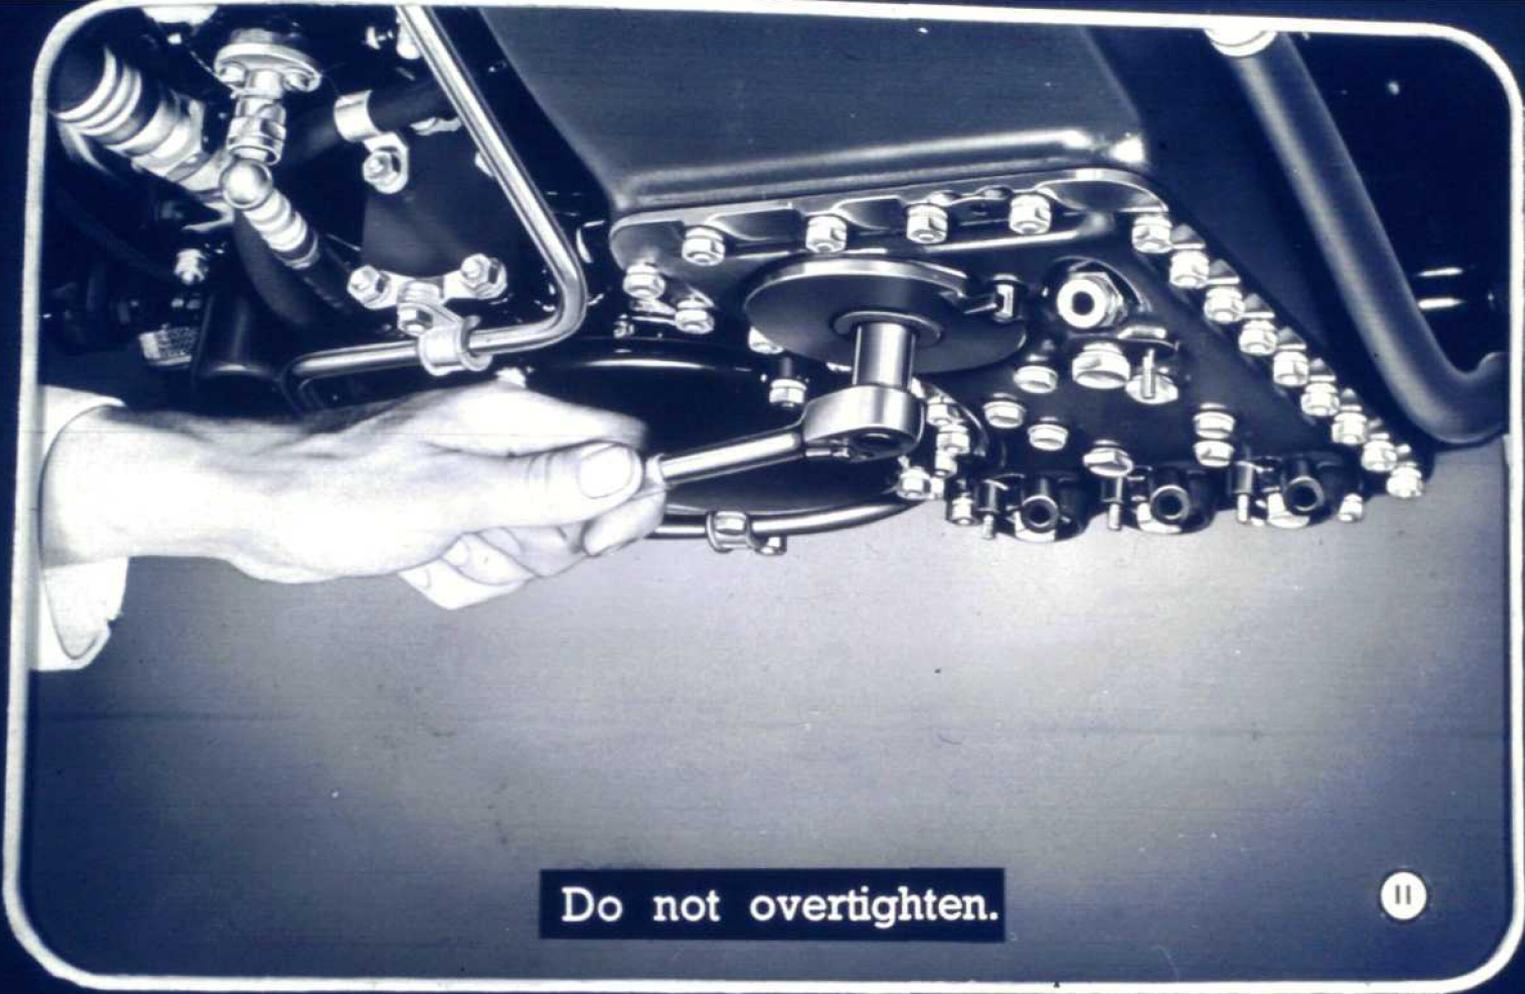
Do not overtighten.

Fit lockplates to the cap nuts and drain plug.
The pressure filter and drain plug lockplates
have distance pieces.

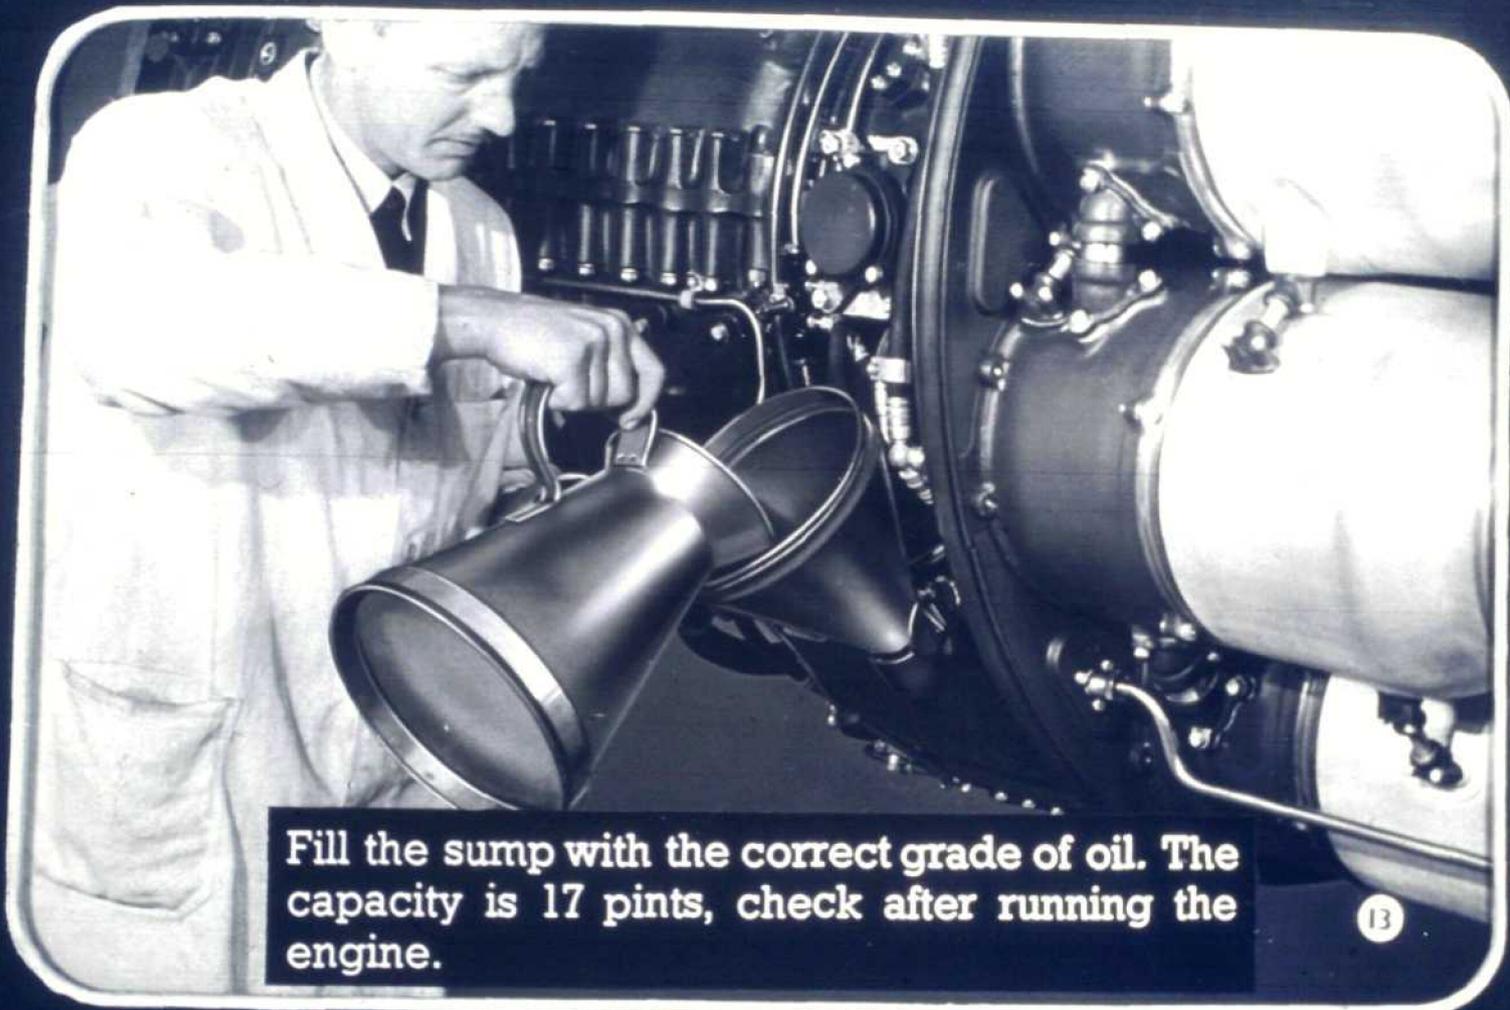
Fill the sump with the correct grade of oil. The capacity is 17 pints, check after running the engine.

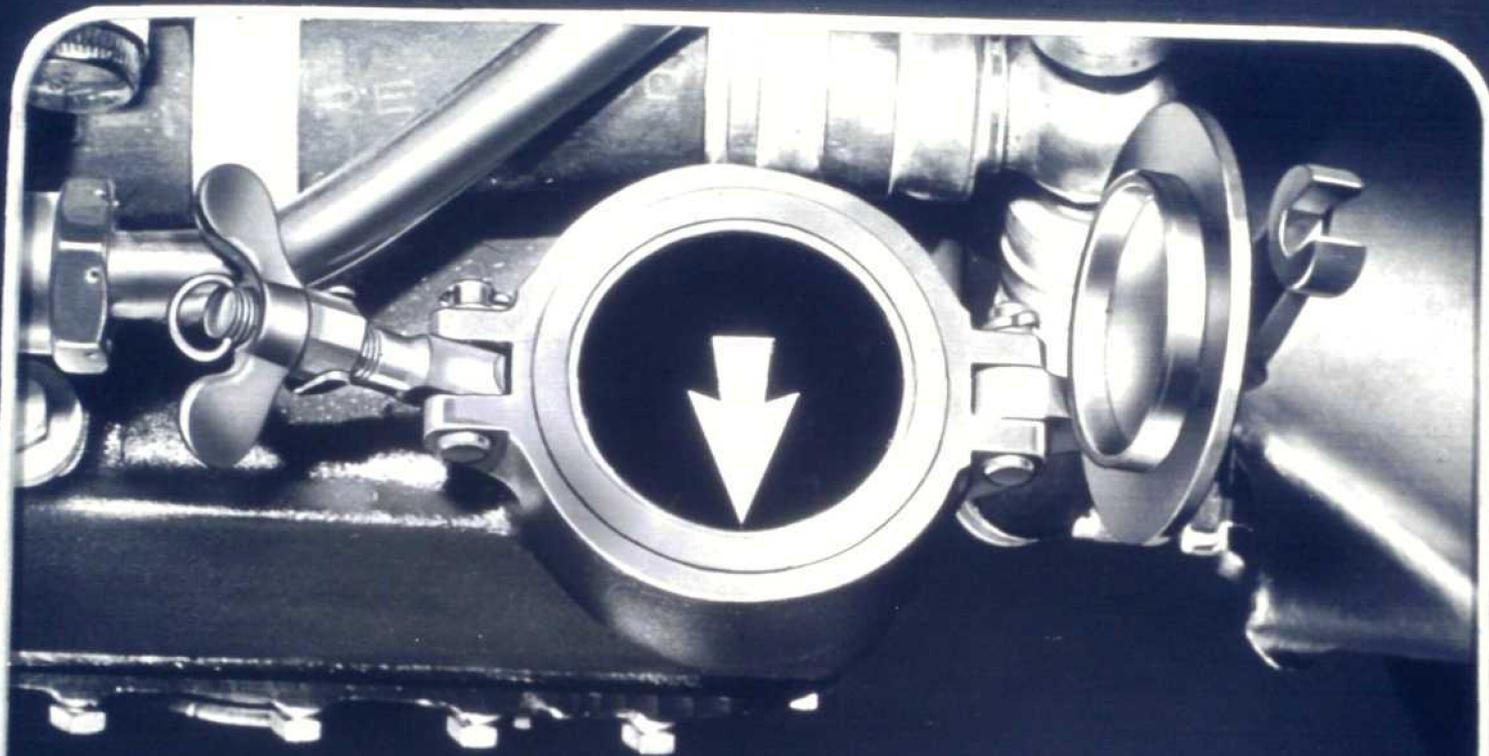
The correct level with the engine cold is up to the filler cap seat.

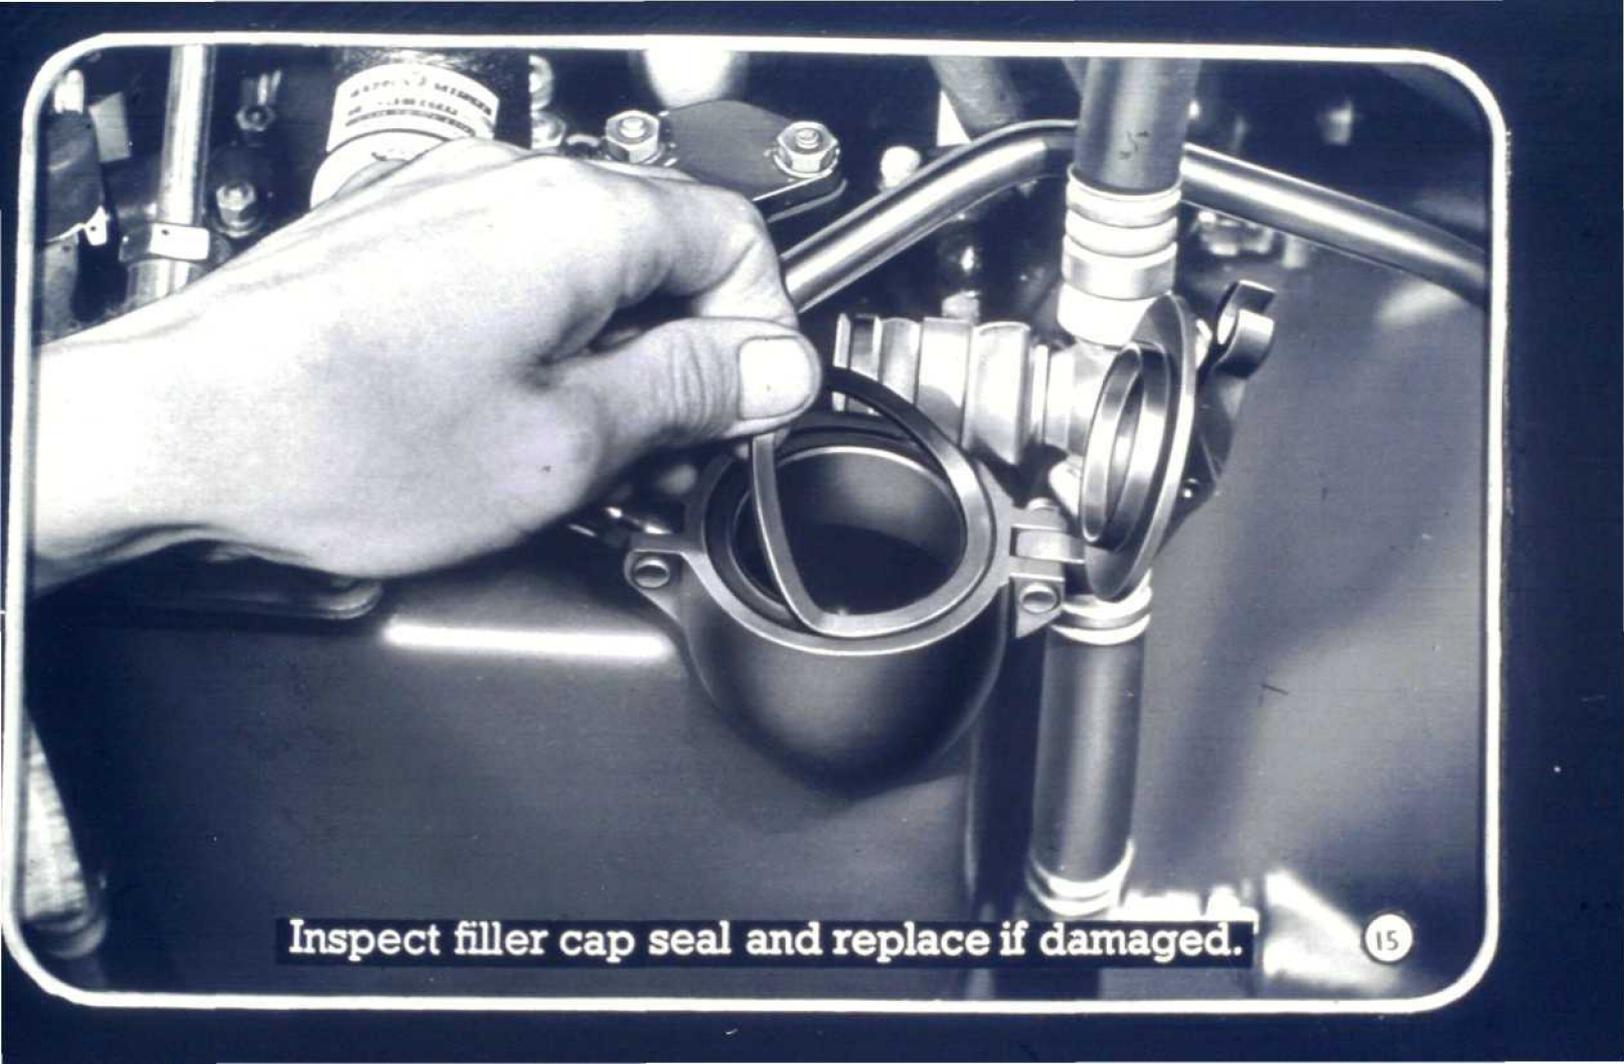
A black and white photograph showing a person's hand inspecting a circular filler cap seal on a piece of machinery. The hand is positioned to the left, with the thumb and index finger holding the edge of the cap. The cap is attached to a metal component with a threaded neck. In the background, there are various mechanical parts, including a cylindrical component with a label that partially reads "MAYTAG'S MEDICAL".

Inspect filler cap seal and replace if damaged.

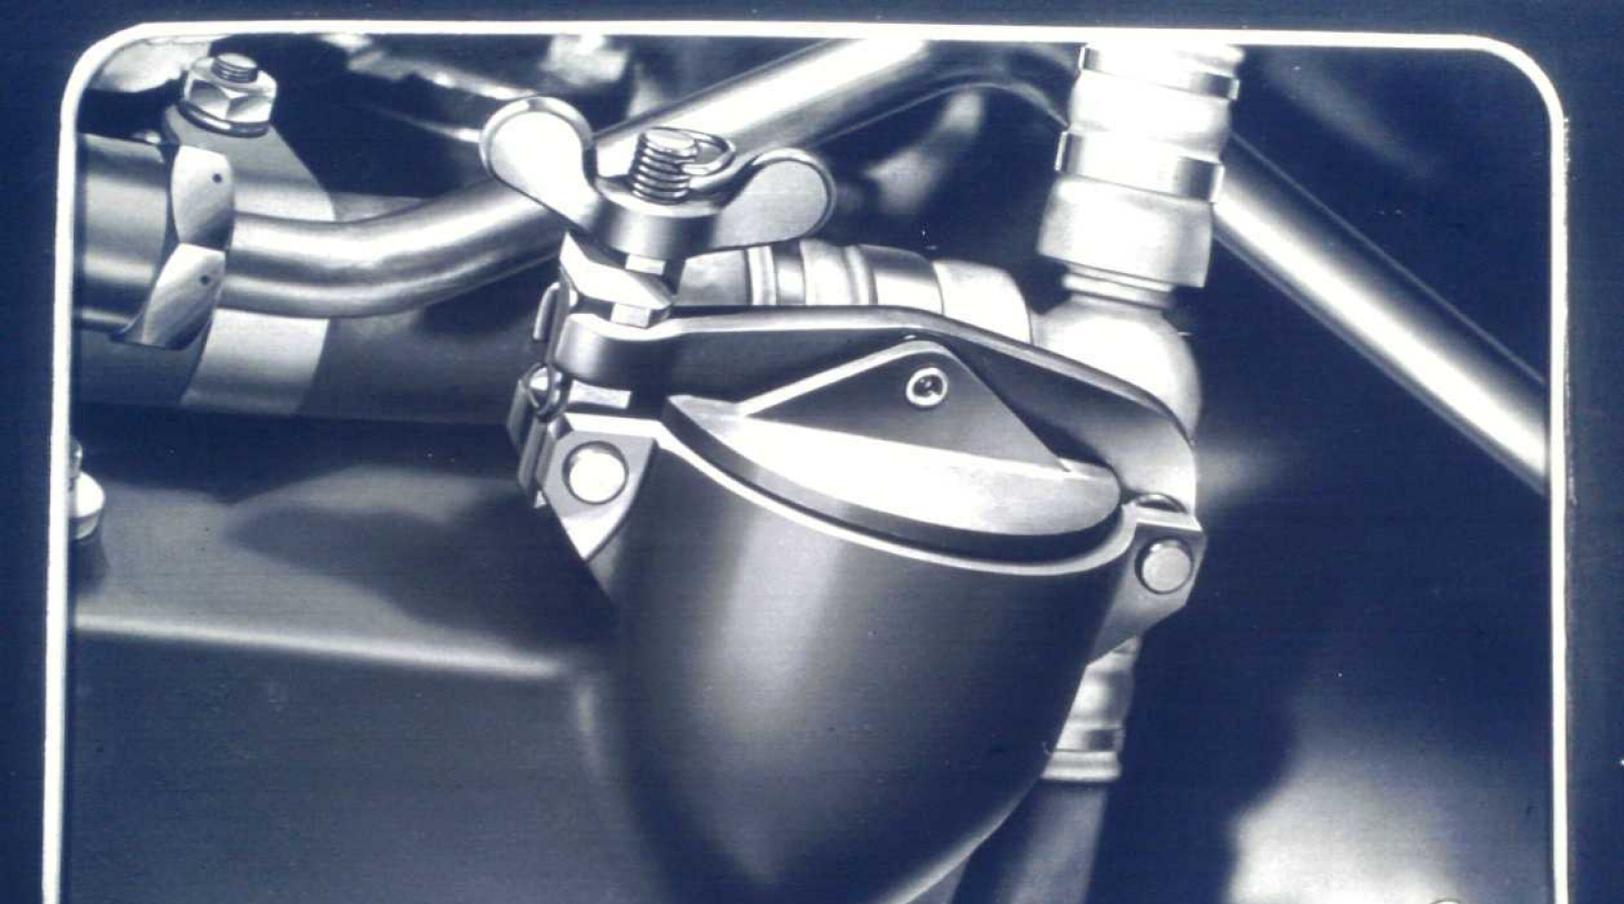
A close-up photograph of a metal assembly, likely a motorcycle handlebar or control lever. The central focus is a self-locking wing nut, which is a hexagonal nut with two curved wings. The nut is being tightened onto a bolt. The surrounding components include various metal tubes, bolts, and a cylindrical part with a textured surface. The lighting is dramatic, highlighting the metallic surfaces and the texture of the components.

Hand tighten the self locking wing nut.

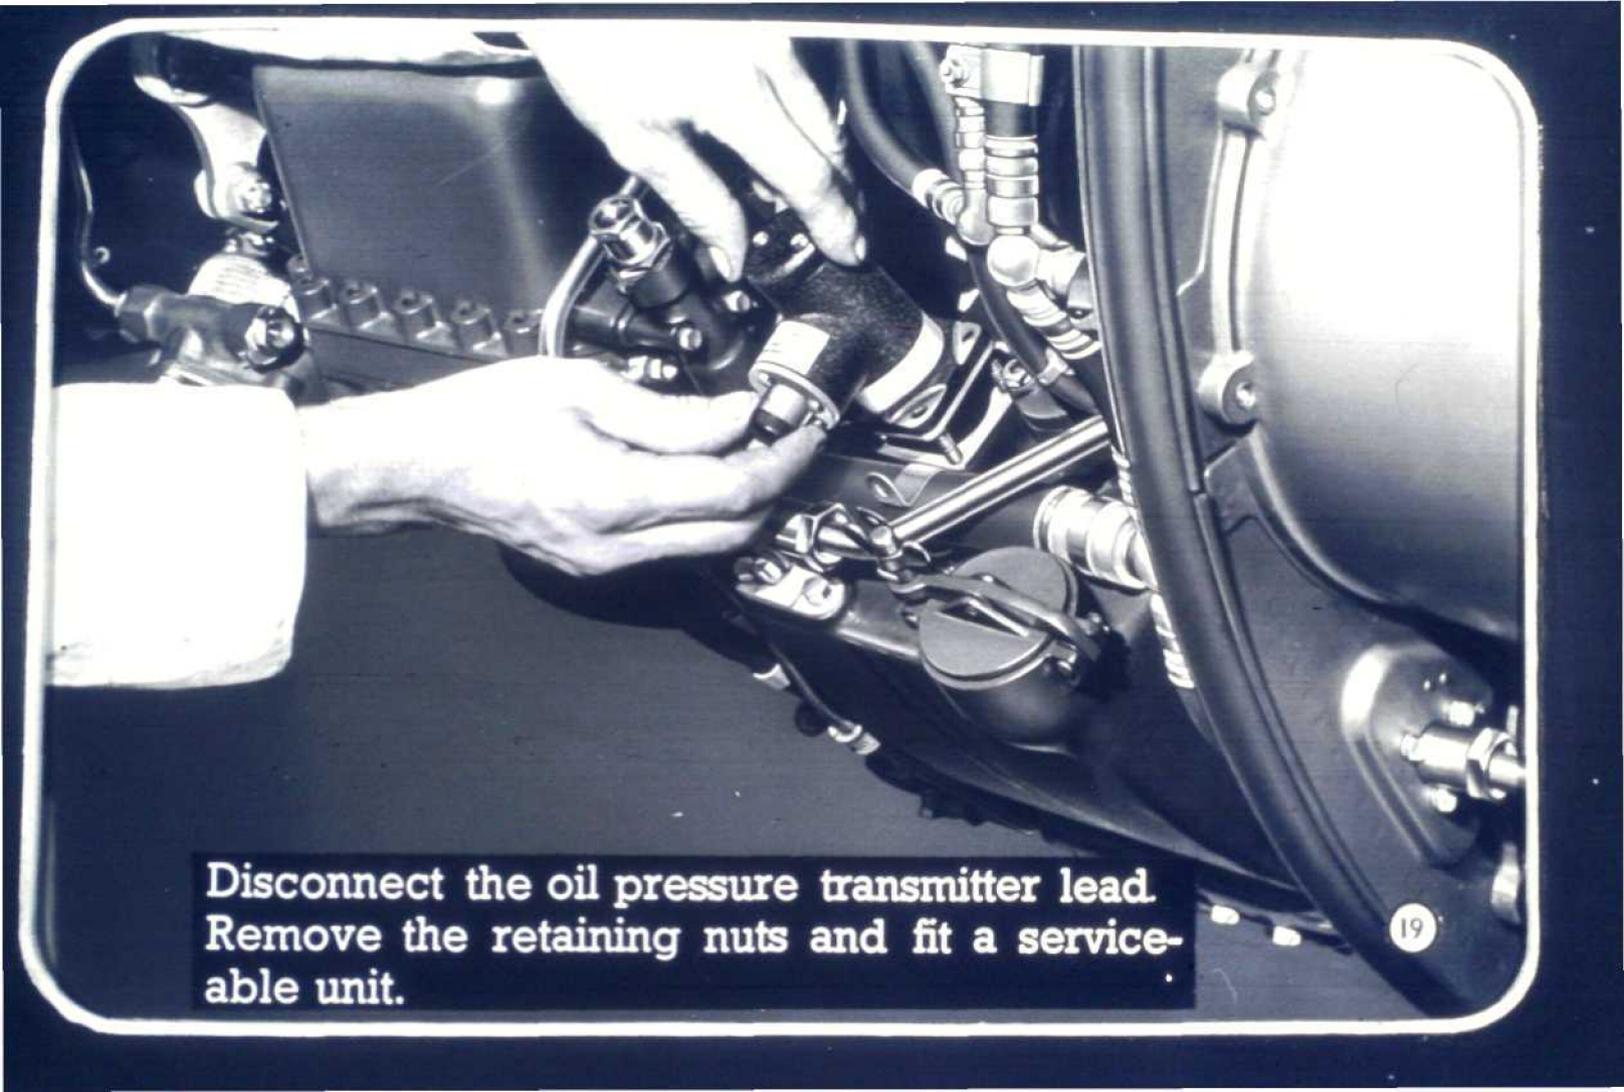
**Disconnect the oil pressure transmitter lead.
Remove the retaining nuts and fit a service-
able unit.**

Check electrical circuit to transmitter.

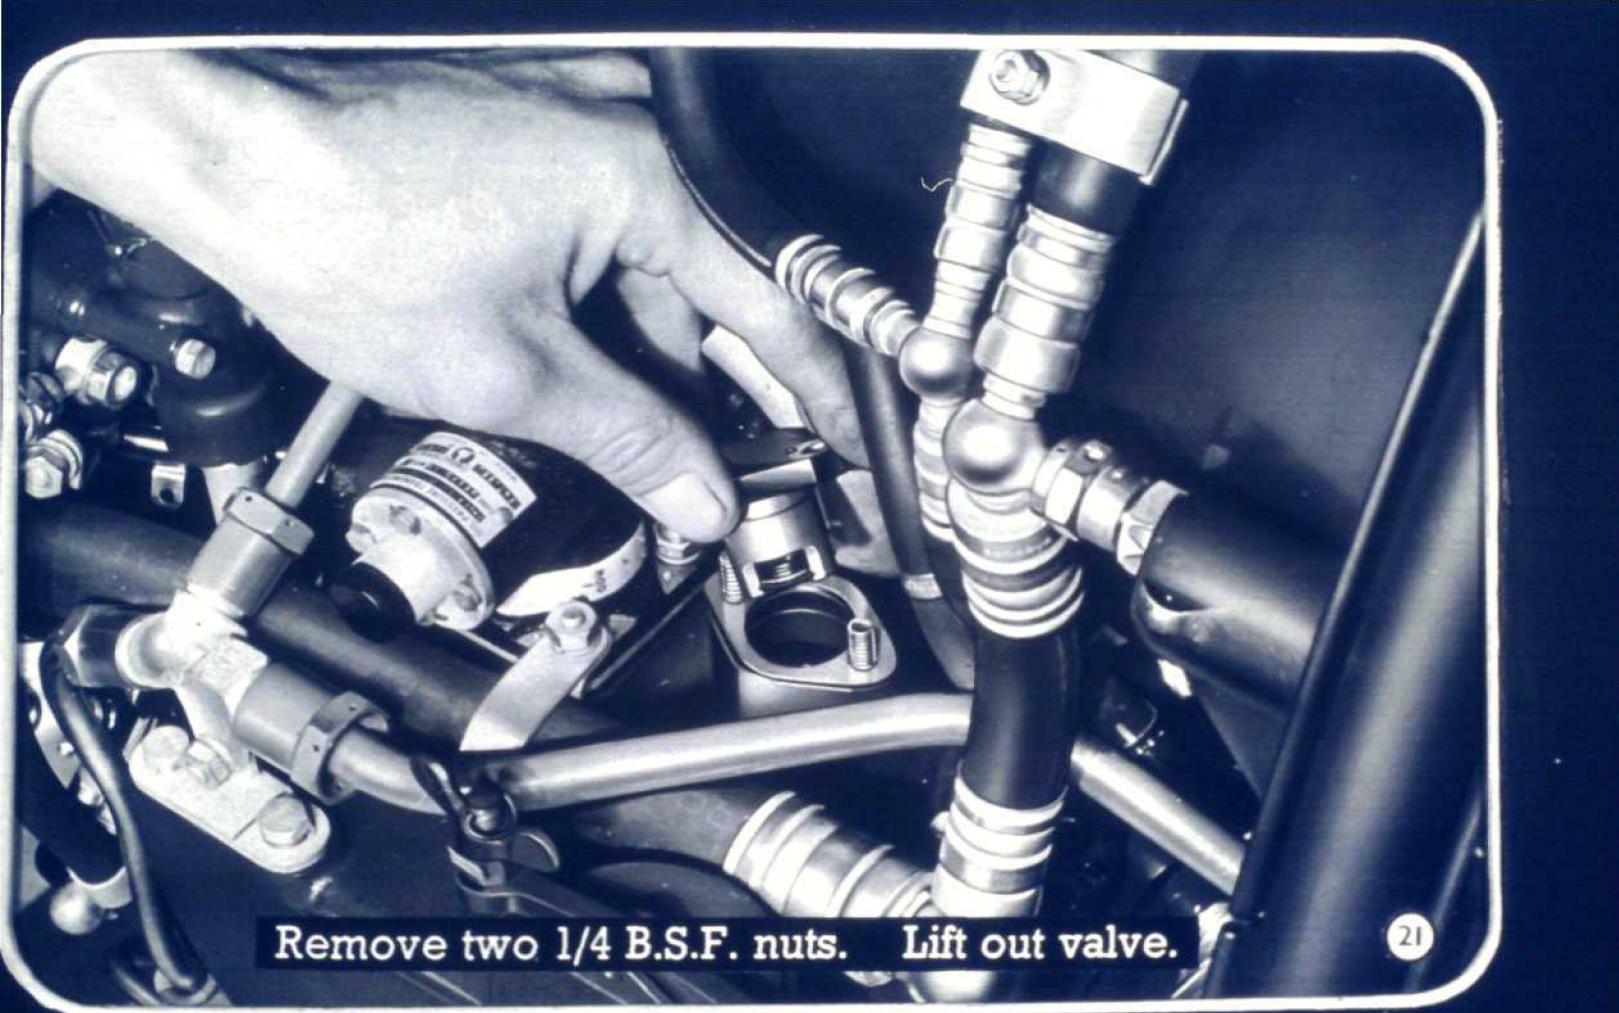
Remove two 1/4 B.S.F. nuts. Lift out valve.

If the oil pressure is still incorrect
check the relief valve and seating.

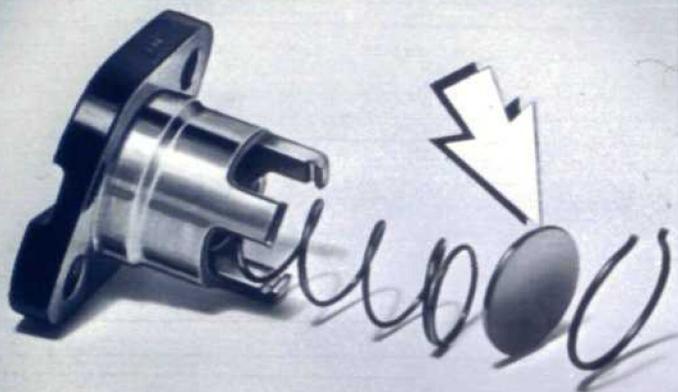
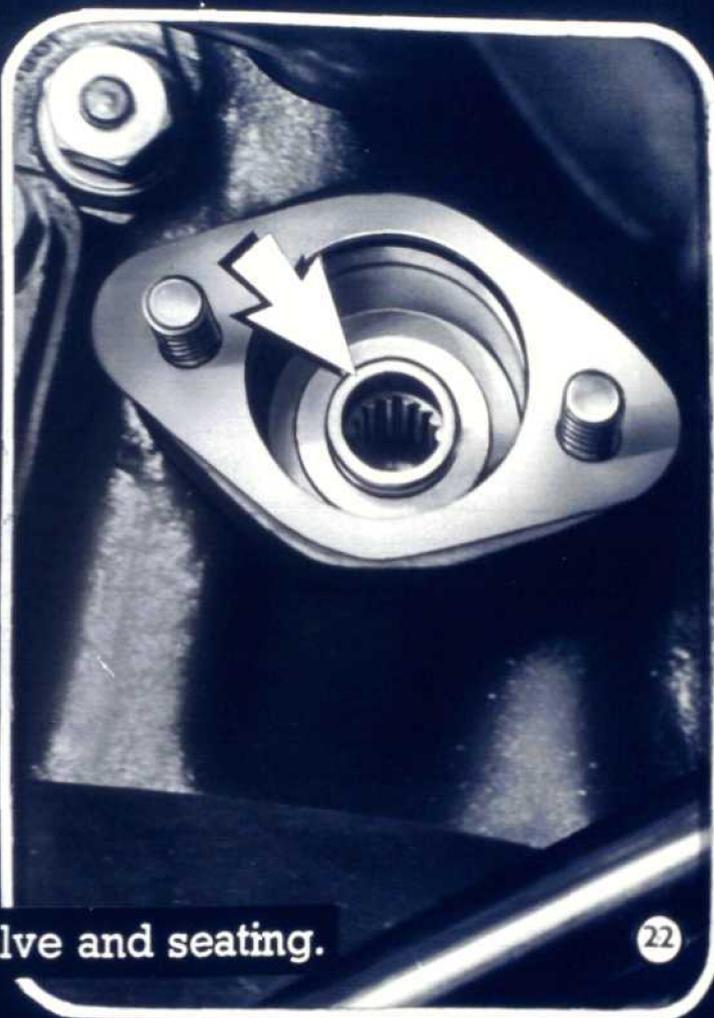
Examine the valve and seating.

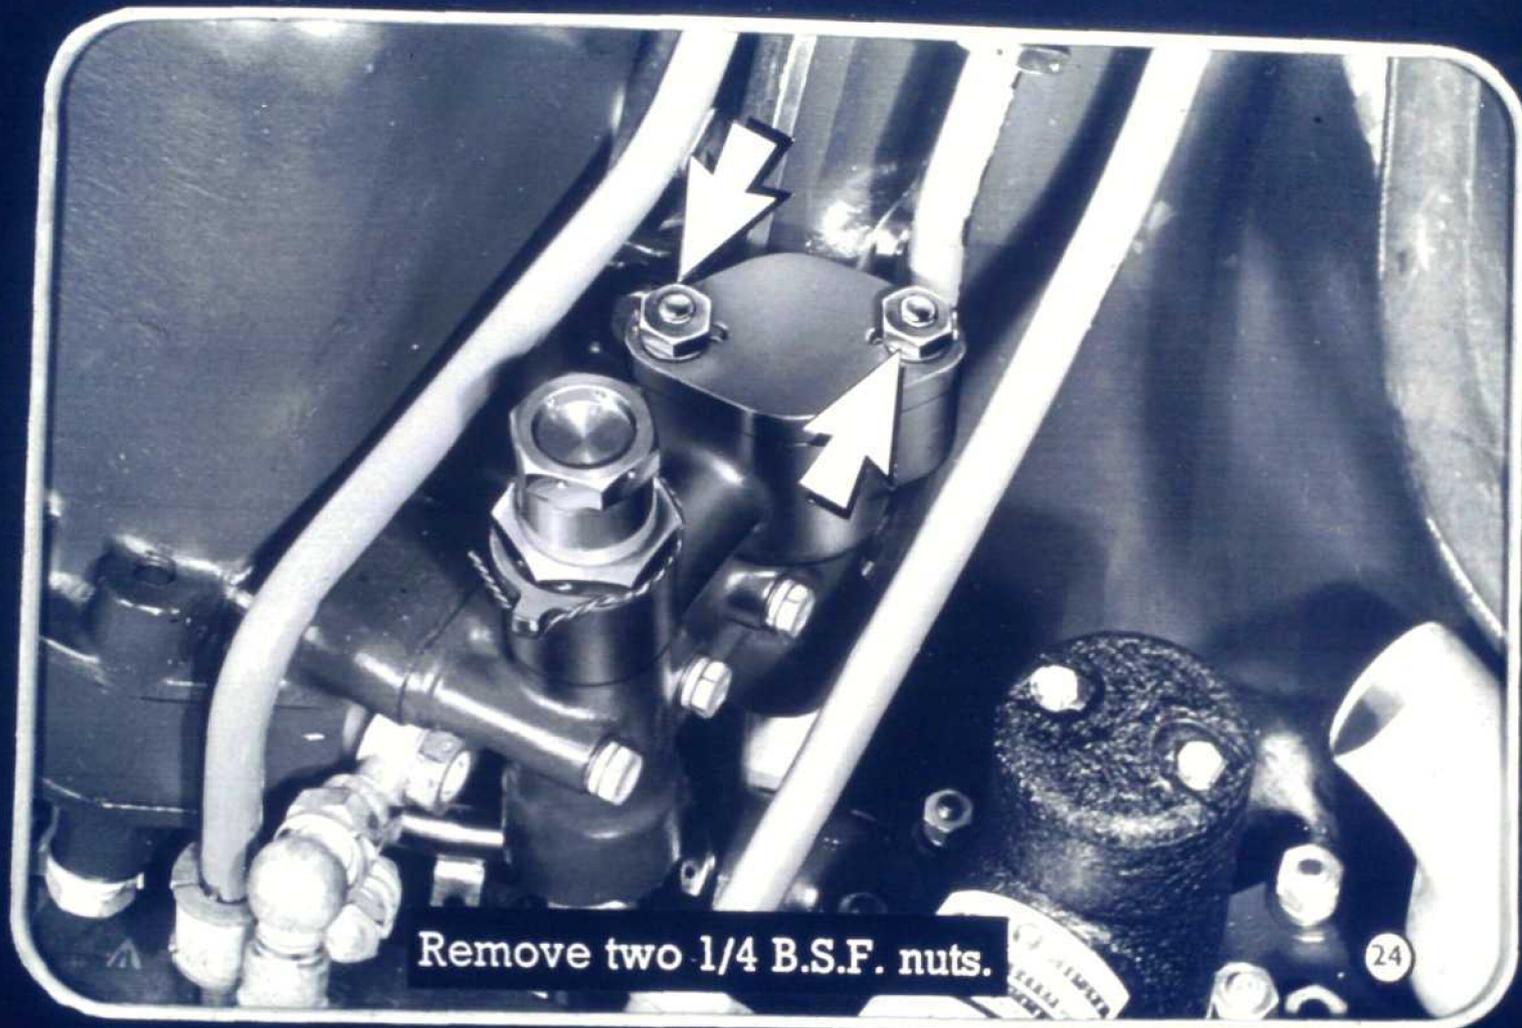
Remove two 1/4 B.S.F. nuts.

If the oil pressure is still incorrect,
check oil cooler bye-pass valve,
forward of transmitter.
