A
ROLLS - ROYCE

MAINTENANCE OF THE
AVON 1
TURBO JET AERO-ENGINE

Oil System Servicing

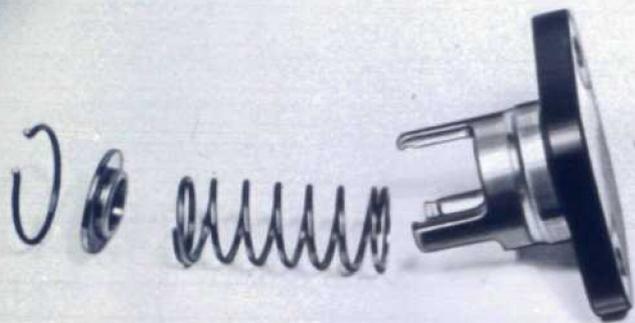
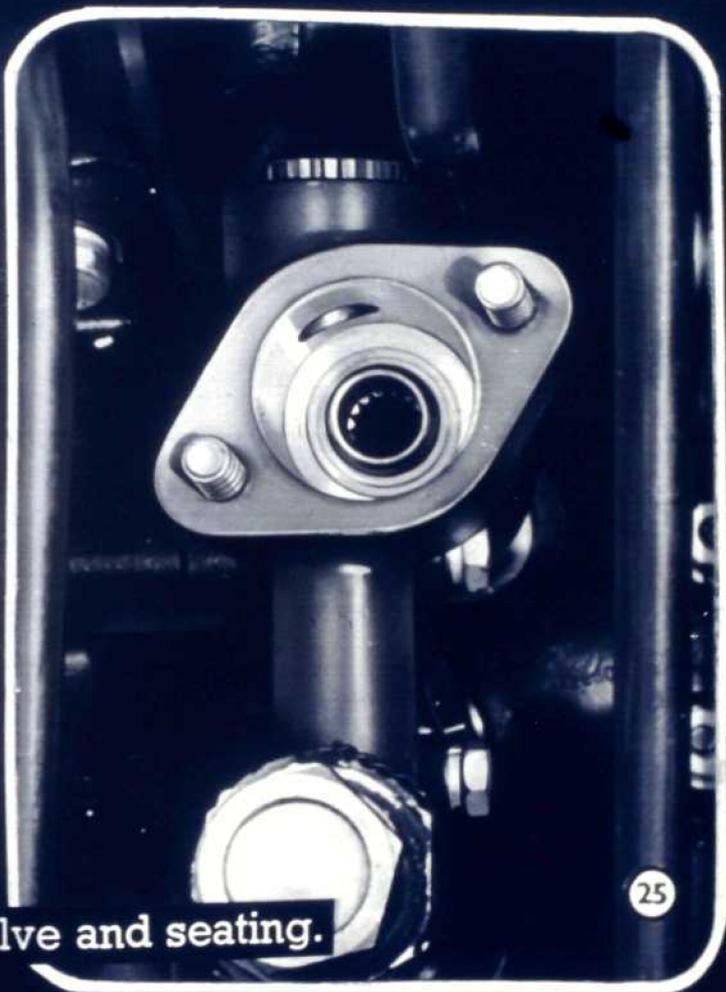
Examine the valve and seating.

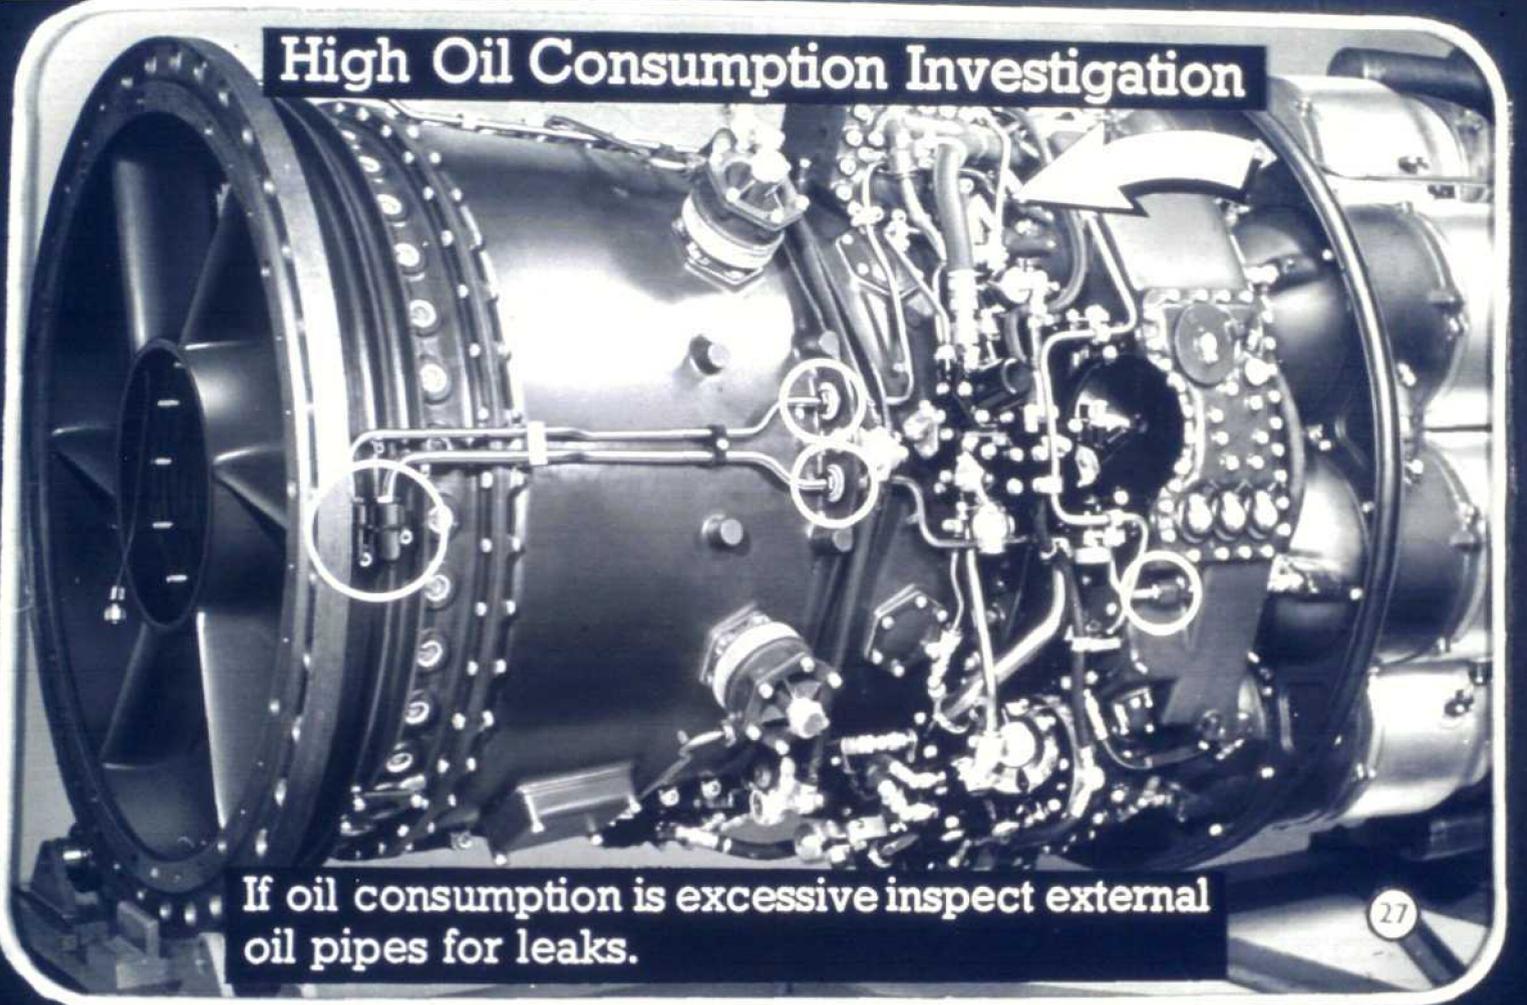
If oil consumption is excessive inspect external oil pipes for leaks.

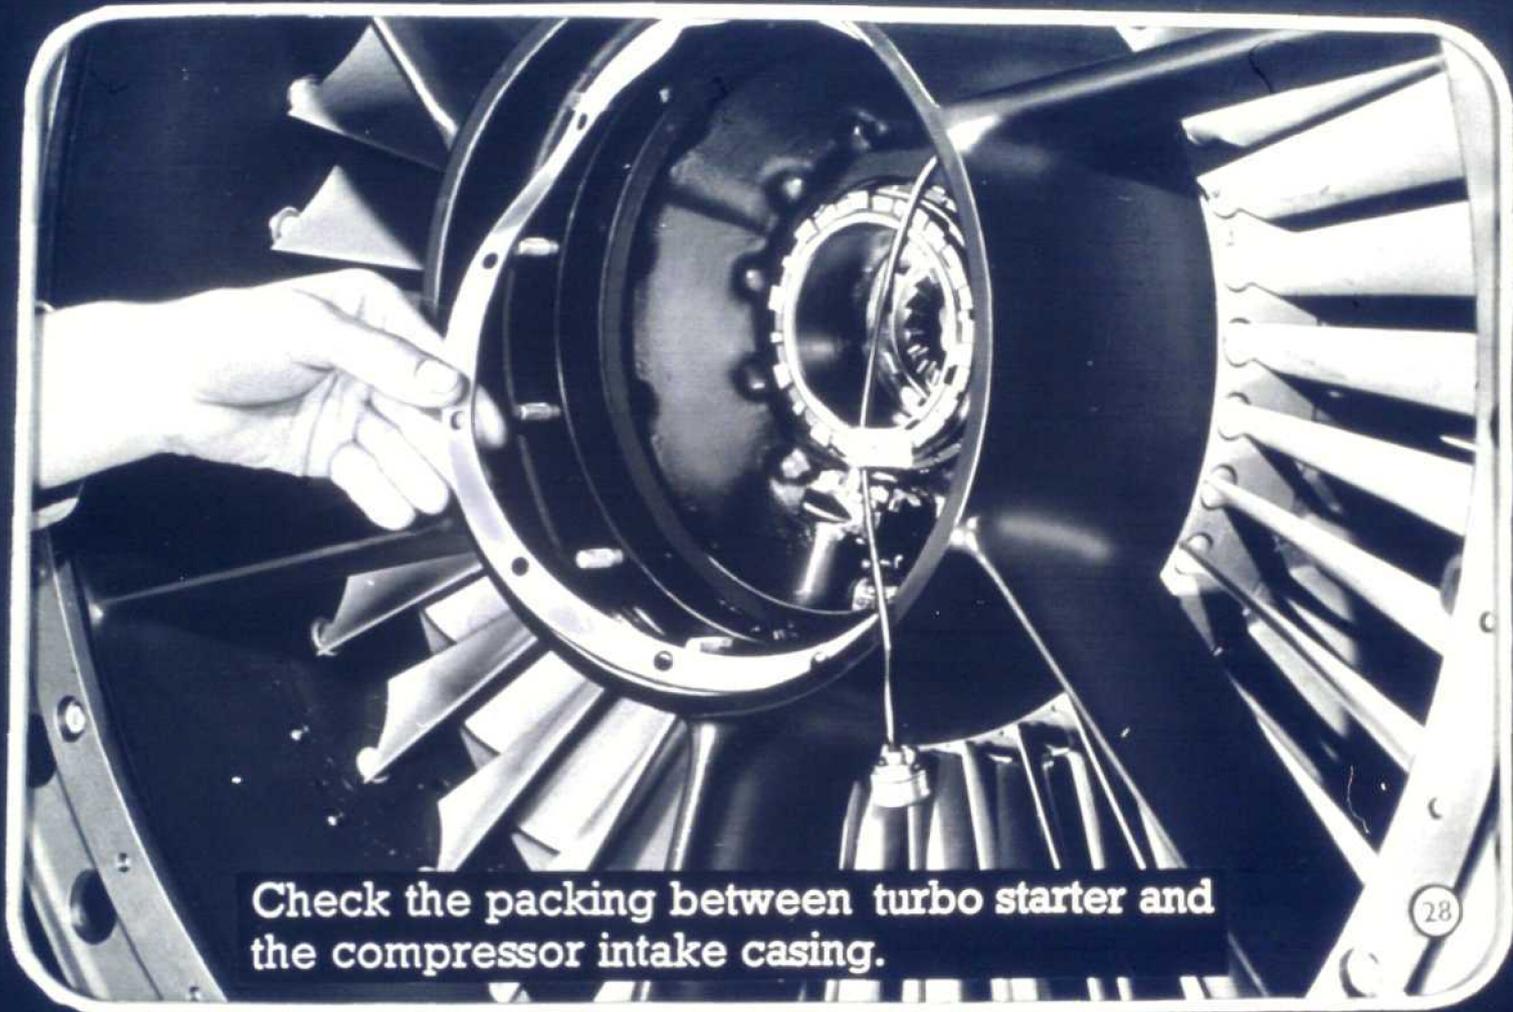
Check the packing between turbo starter and the compressor intake casing.

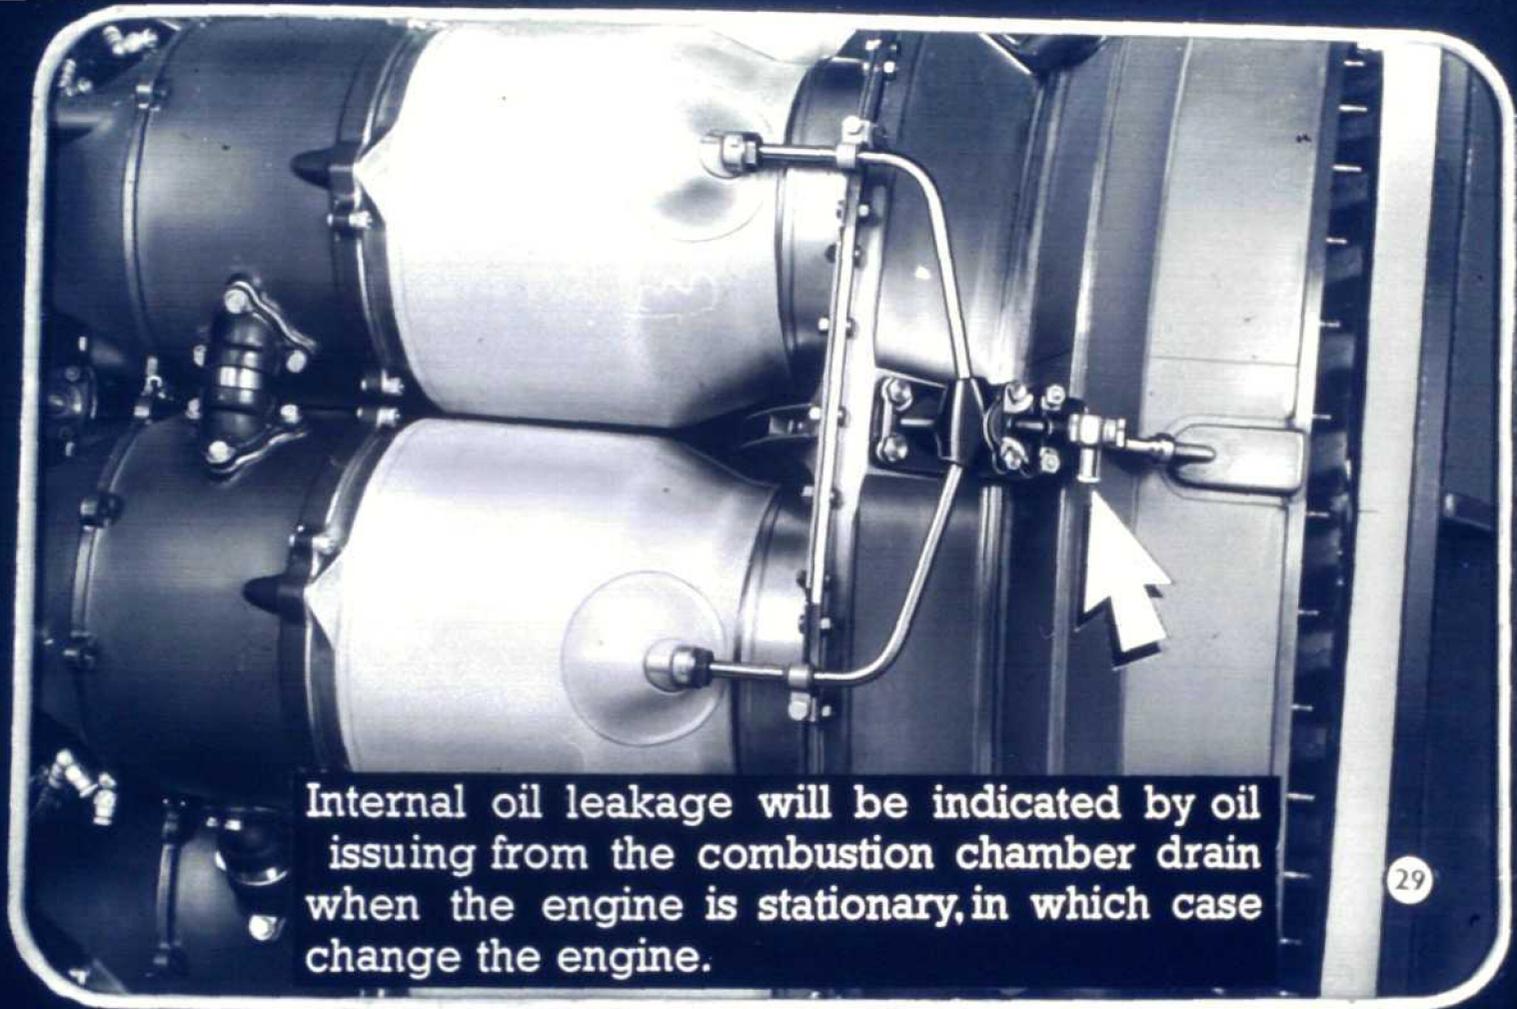
Internal oil leakage will be indicated by oil issuing from the combustion chamber drain when the engine is stationary, in which case change the engine.
