Chapter 57

FLIGHT REFUELING INDICATOR, PAGE C.5570

Chapter 59

LAMP, CABIN WARNING, TYPE V6800

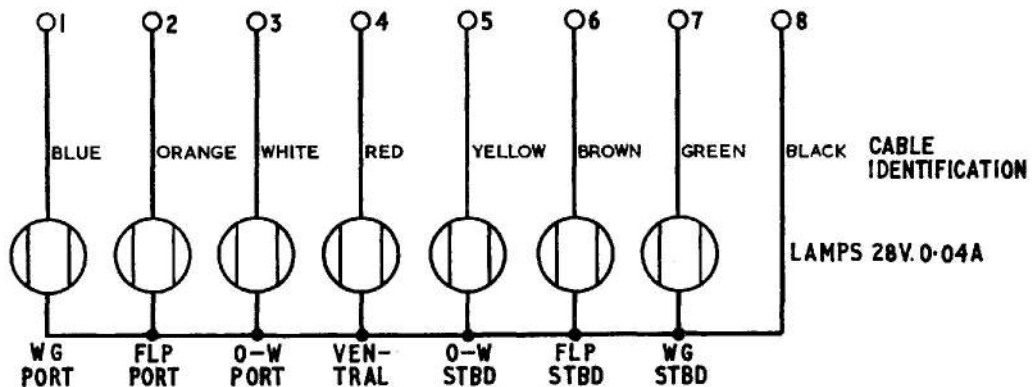
Fig. 1. Circuit diagram

2. The unit groups on one panel the appropriate number of warning lamps fitted behind a caption plate, one for each fuel tank (fig. 1).

6. Electrical connections are made to a terminal block at the rear of the unit, filament lamp connections are completed by individual spring-loaded contact plungers in the contact block.

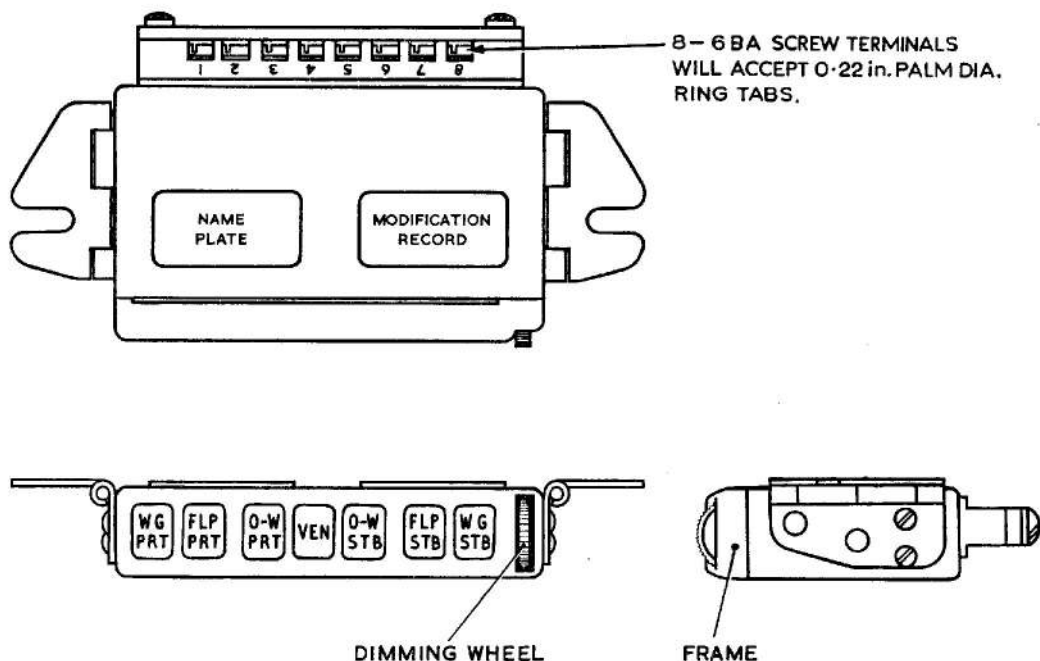
Fig. 2. Indicator unit, C5570

3. The unit comprises a rectangular case in which are located the contact block and lamp panel complete with seven filament lamps. The terminal block and cover are secured to the rear of the case by two screws.

4. The frame is a straight pull-off assembly and is fitted to the front of the unit. The frame assembly is fitted with a caption plate, a dimming device and adjusting wheel. The caption plate, which has seven apertures; each aperture covers a filament lamp denoting its particular fuel tank.

5. To dim from the undimmed condition, turn the adjusting wheel through 90 deg. in either direction.

10. Should the test reveal a defective filament lamp, replace by pulling off the front frame, then releasing the Dzus fasteners which hold the lamp panel to the case.

11. After replacing defective lamps, secure the lamp panel to the case with the Dzus fasteners and replace the frame. The indicator should now be tested in its relevant circuit, by operating the flight refuelling switch.

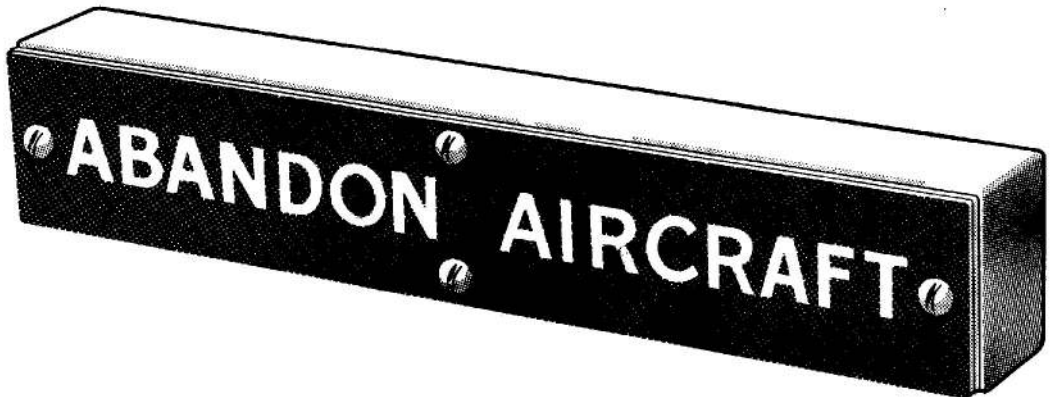
Fig. 1. General view

2. A general view of the lamp is given in fig. 1. The lamp housing is constructed of 20 gauge aluminium alloy and contains four lamp-holders bolted to a Tufnol strip. Three holes are drilled in the rear of the housing, two provide ventilation and the third, which is rubber bushed, provides the cable entry.

3. The sign plate is made in two sections. The first section is constructed of $\frac{1}{16}$ in. acrylic sheet sprayed black with the lettering left clear. When dry, the whole sheet is then sprayed red. The second section (front face) is constructed from $\frac{1}{16}$ in. opal perspex and is cemented to the lettered portion on assembly. The complete plate is then drilled to take four 4 B.A. retaining screws.

4. The lamp should be inspected for exterior damage and cracking of the sign plate around the fixing screw holes. Examine for cleanliness and for security of attachment to the aircraft. Access to the filament lamps is by removal of the four sign plate fixing screws.
