A.A.P.721:79, Vol.2, Sect.2

VAMPIRE INSTRUCTIONS

AAP 721.79, VOLUME 2, PART 1

CONTENTS TO VAMPIRE INSTRUCTIONS

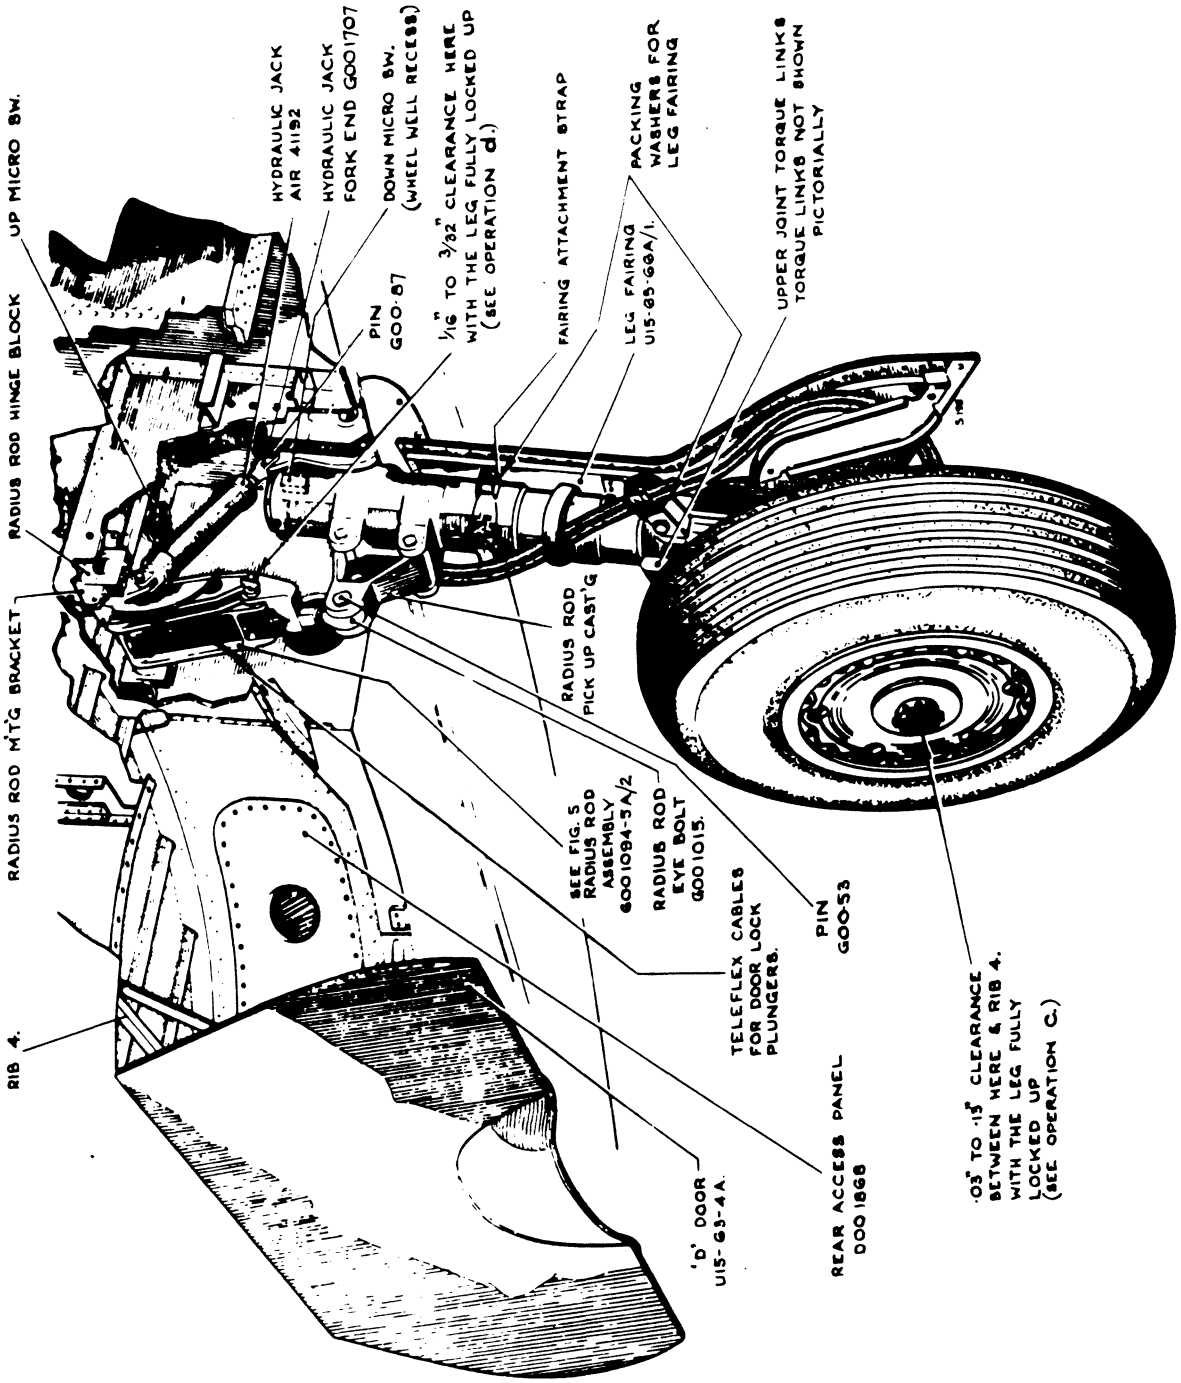
FIG. 1 MAIN UNDERCARRIAGE

1. A number of undercarriage failures have been due to the fracturing of the teleflex controls which operate the main wheel door lock plungers, these are attributed to semi-seizure of the teleflex cables inside the conduit, the lock plungers fouling the door catches, or maladjustment of the lock plungers.

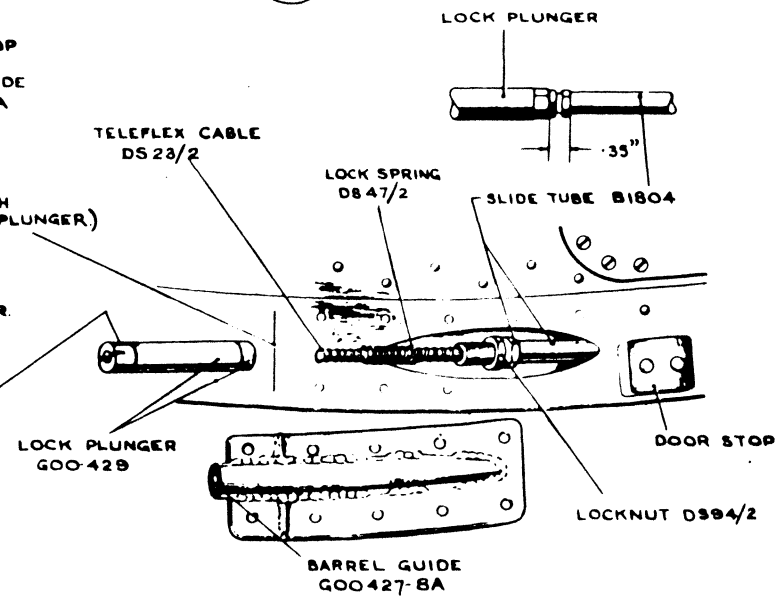
FIG. 2

(l) Grind both ends of the teleflex cable to a neat cone shape. All grinding to be done in the direction of the helix of the cable. Check that the grinding of the ends is adequate by ensuring that a new lock spring DS47/2 (figure 2) can easily be screwed on or off either end and has no tendency to pick up on the fine spacing wires of the teleflex cable (figure 6).

(iii) The length of conduit inside the 5.25" maximum dimension (figure 3) is straight and in line with the barrel guide G00427-8A (figure 3). This may be checked by ensuring that the slide tube and lock plunger (figure 2) can freely be slid back and forth on the conduit with the barrel guide temporarily assembled to the aircraft. This check should be carried out with the slide tube in various angular positions.

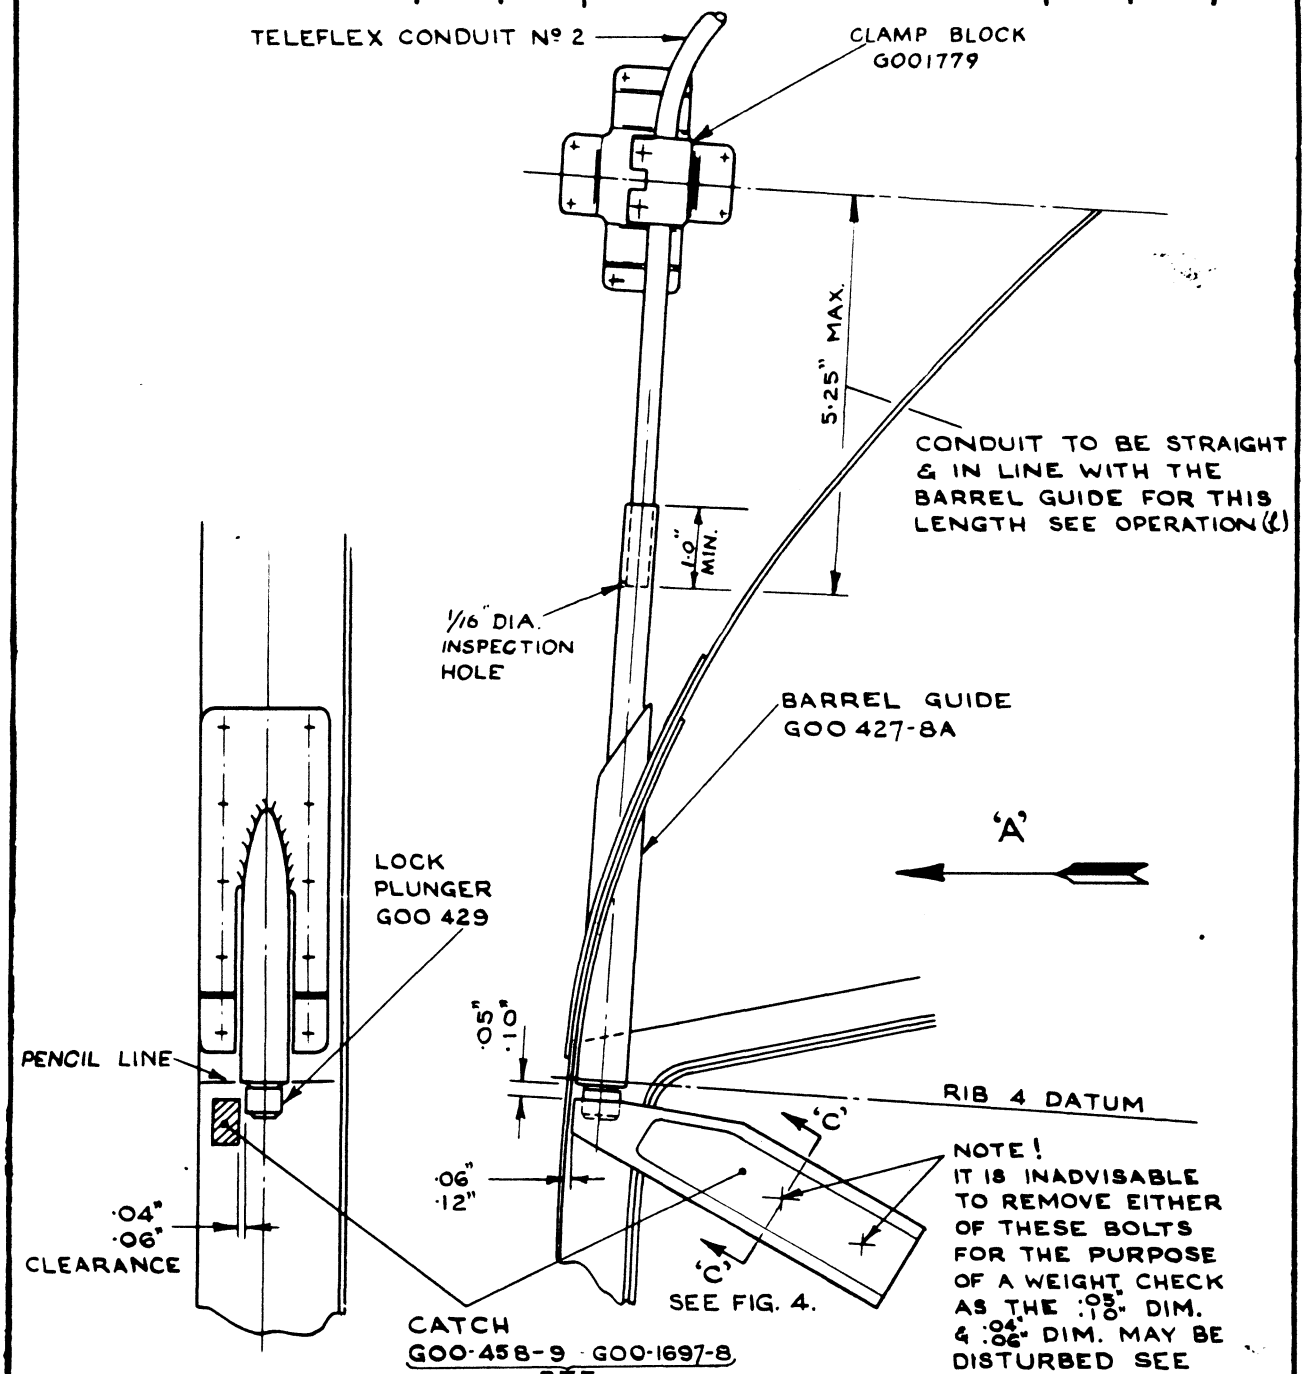
FIG. 3.

(g) Refer to figure 3 and draw a pencil line on the wheel well wall to coincide with the outboard face of the barrel guide G00427-8A. Remove the barrel guide.

(i) The 5.25" maximum dimension (figure 3) is maintained.

(ii) The 1.0" minimum dimension (figure 3) is maintained. This may be checked through the 1/16" diameter inspection hole (figure 3) if the lock plunger and slide tube are temporarily assembled using the .35" dimension and the pencil line shown on figure 2.

(w) Raise the "D" door by hand and hold against stops. Manually move the plungers to the locked position by rotating the radius rod. (Note: If radius rod has not be disconnected in operation (v), $\begin{matrix}.500" \\ .495"\end{matrix}$ diameter rods should be fitted in the barrel guides G00427-8A to represent the lock plungers G00429). Check the $\begin{matrix}.05" \\ .10"\end{matrix}$, $\begin{matrix}.04" \\ .06"\end{matrix}$ and $\begin{matrix}.06" \\ .12"\end{matrix}$ clearances shown on figure 3. If necessary refer to figure 4 and repack or move the door catches G00458-9, G001697-8 (figure 3).

Note: The bolt holes for the catches G00458-9, G001697-8 (figure 3) are not to be used as this could alter the adjustment carried out in operation (w).

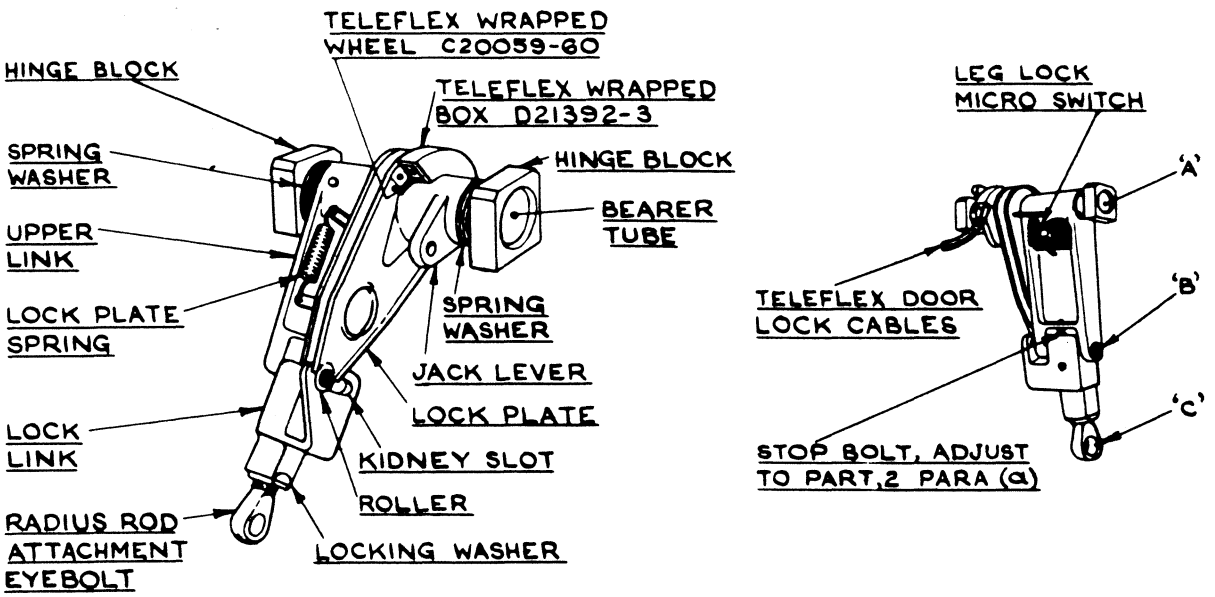
FIG. 5
VIEW ON RADIUS ROD ASS'Y

(j) Spring the end of the teleflex cable out of the hole in the wrapped wheel C20059-60 (figure 5).

(n) Screw the teleflex cable into the wrap box by hand. The cable is not to be formed into a knot to enable additional torque to be applied, neither are pliers or a chuck to be used. The radius rod may be moved back and forth to ease fitment, but if the cable cannot be fitted by hand the radius rod must be removed and the teleflex wrap box D21392-3 and wrapped wheel C20059-60 (figure 5) examined for damage.

(o) Spring the teleflex cable into the hole in the wrapped wheel C20059-60 (figure 5). It is to protrude .1" to .5" beyond the hole.

(iv) The top end of the inboard conduit is fully home in the wrap box D21392-3 (figure 5). This may be checked through the 1/16" diameter inspection hole in the wrapped box.

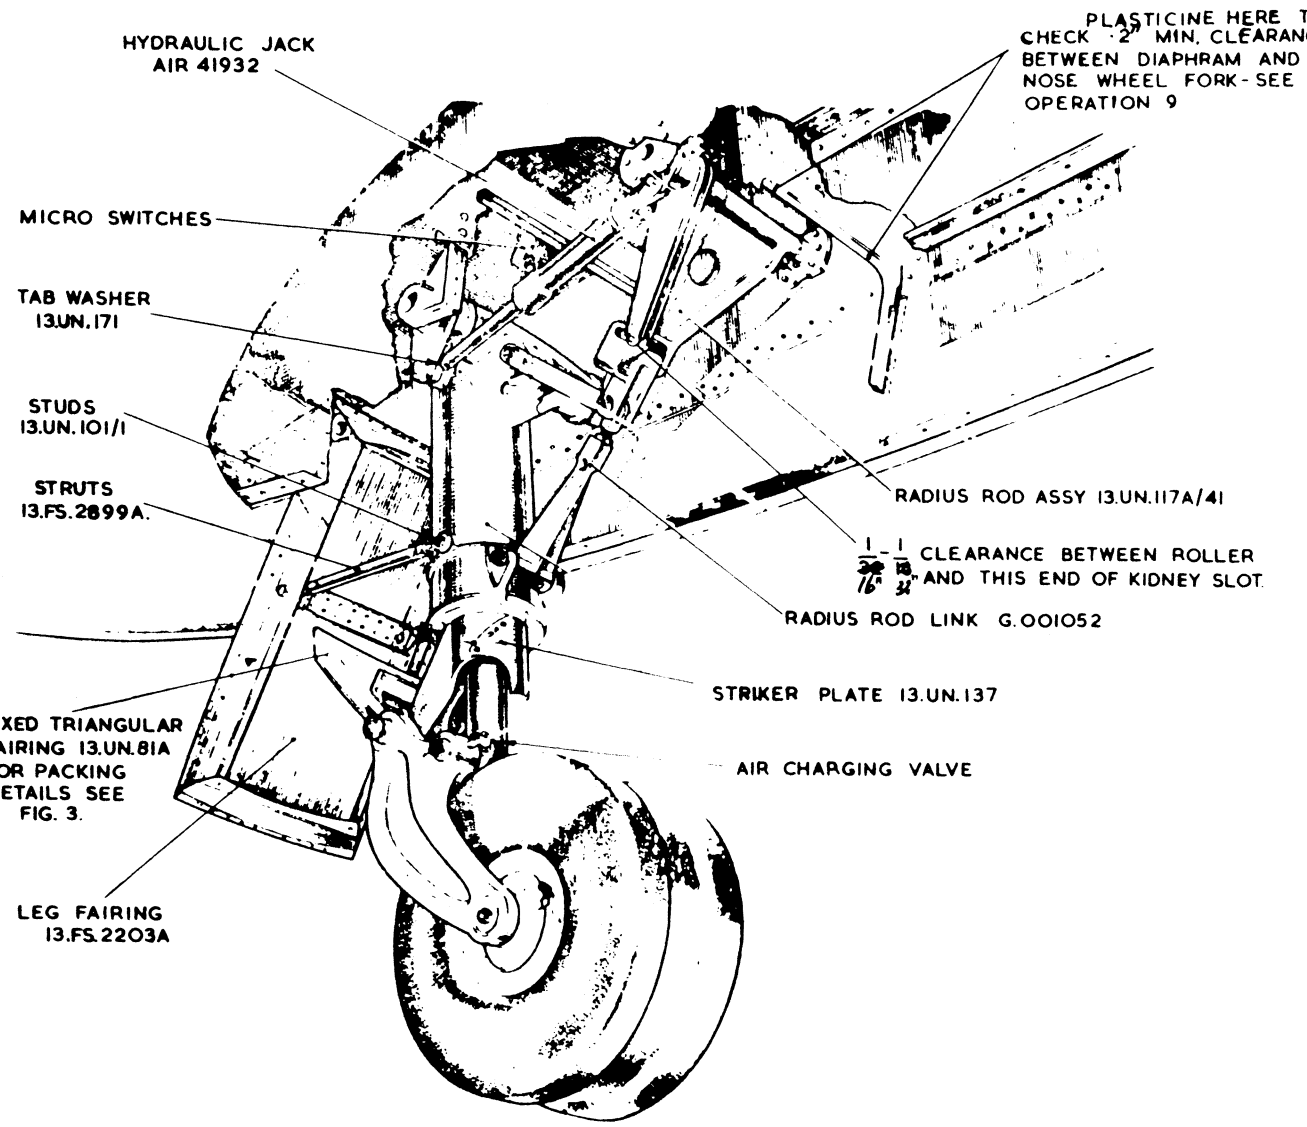
FIGURE 2.

(m) With the nose wheel retracted, check that the fixed triangular fairing 13UN81A (Fig 2) lines up with the fuselage contour.
If necessary - due to the adjustment in operation (j) - add packing 13UN95 as shown in Fig 3.

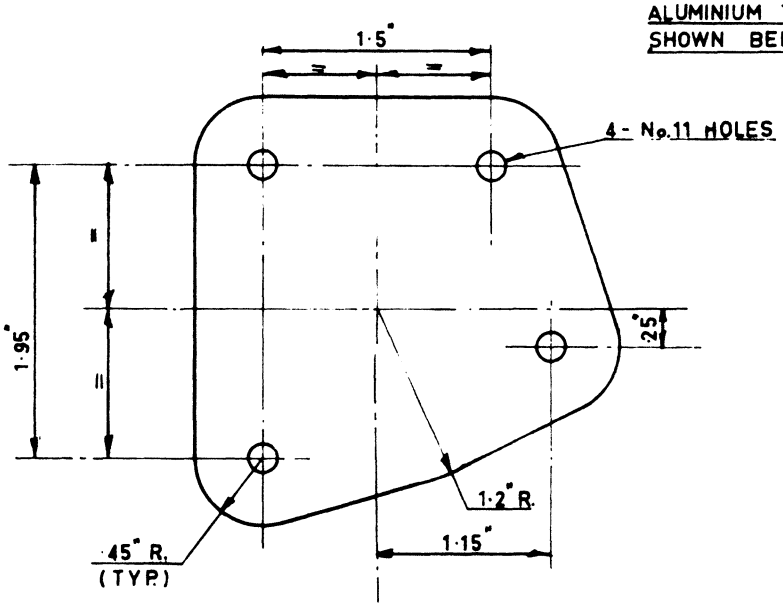
FIG. 3

ADD IF REQUIRED IN OPERATION 8.—MAKE FROM 18 S.W.G. L16 ALUMINIUM TO THE DETAIL SHOWN BELOW

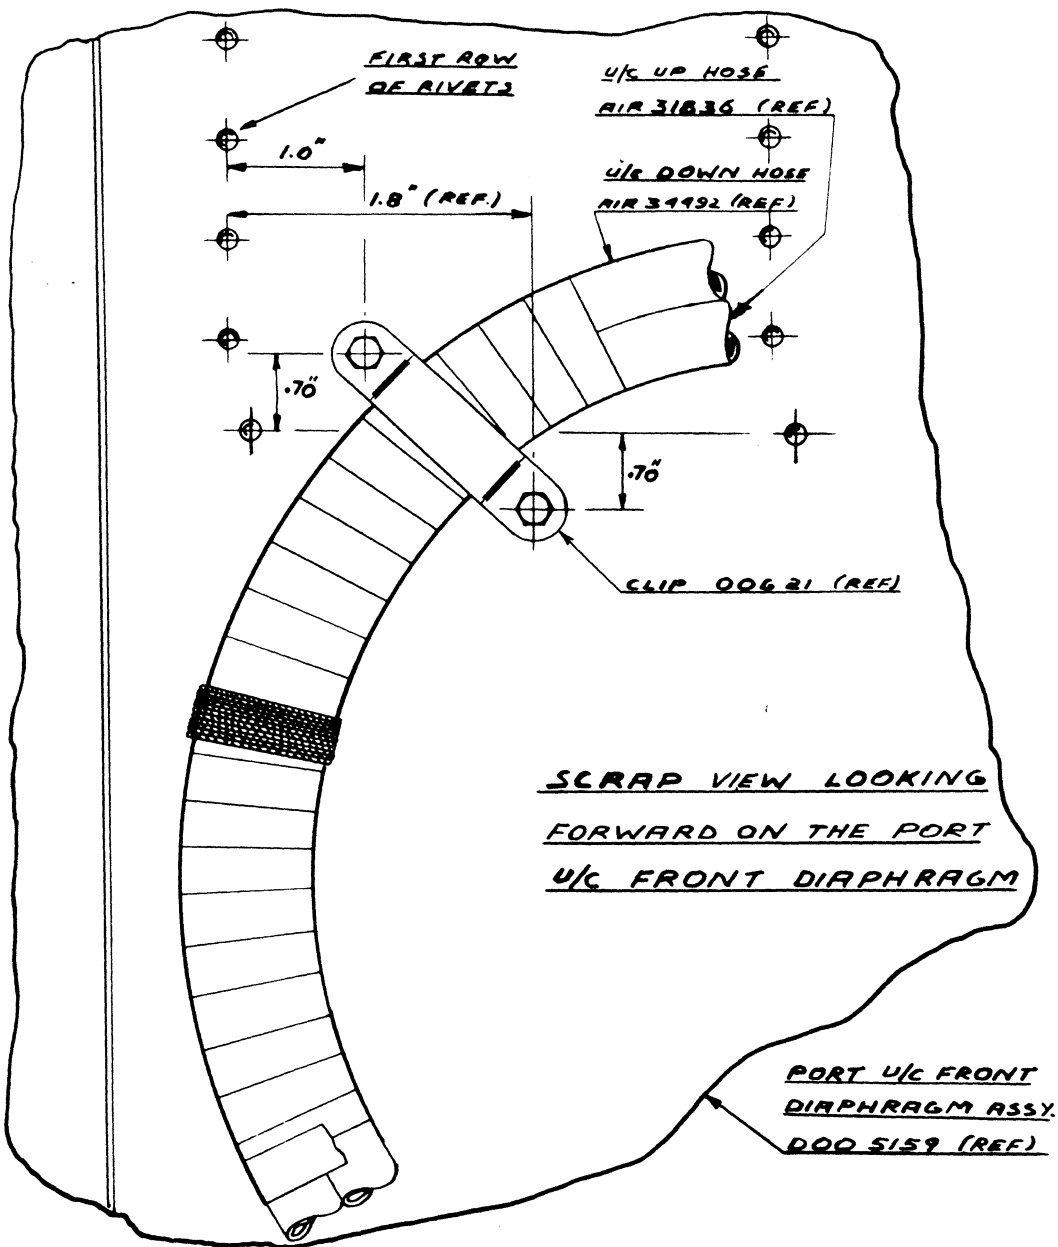
REFERENCE	ISSUED BY	TITLE
	DEPARTMENT OF AIR DIRECTOR GENERAL OF ENGINEERING	ASSEMBLY OF HYDRAULIC HOSES ON MAIN UNDERCARRIAGE ASSEMBLY

1. Chafing of the hydraulic hose AIR.31836 on the undercarriage 'UP' line has been observed on many service aircraft. In some cases chafing gave rise to splitting of the hose and the loss of hydraulic fluid. This type of failure can be eliminated if the procedure detailed below is observed during re-assembling of the hydraulic lines.

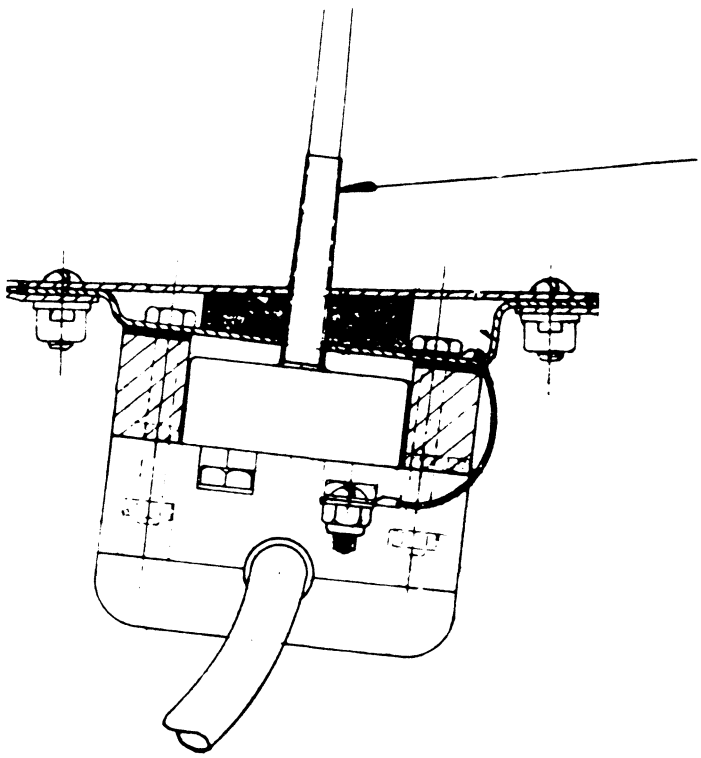
NOTE:- NYLEX TUBE AS SHOWN AROUND AERIAL MUST NOT BE PAINTED WHEN APPLYING SILVER FINISH EXTERNALLY ON AIRCRAFT.
